FUNCTIONAL ASSESSMENT OF THE MANCOS RIVER WATERSHED: MANCOS VALLEY AND ADJACENT AREAS

PETER STACEY
UNIVERSITY OF NEW MEXICO

Prepared Under Contract with the
Mancos Conservation District
Mancos, Colorado
April, 2007

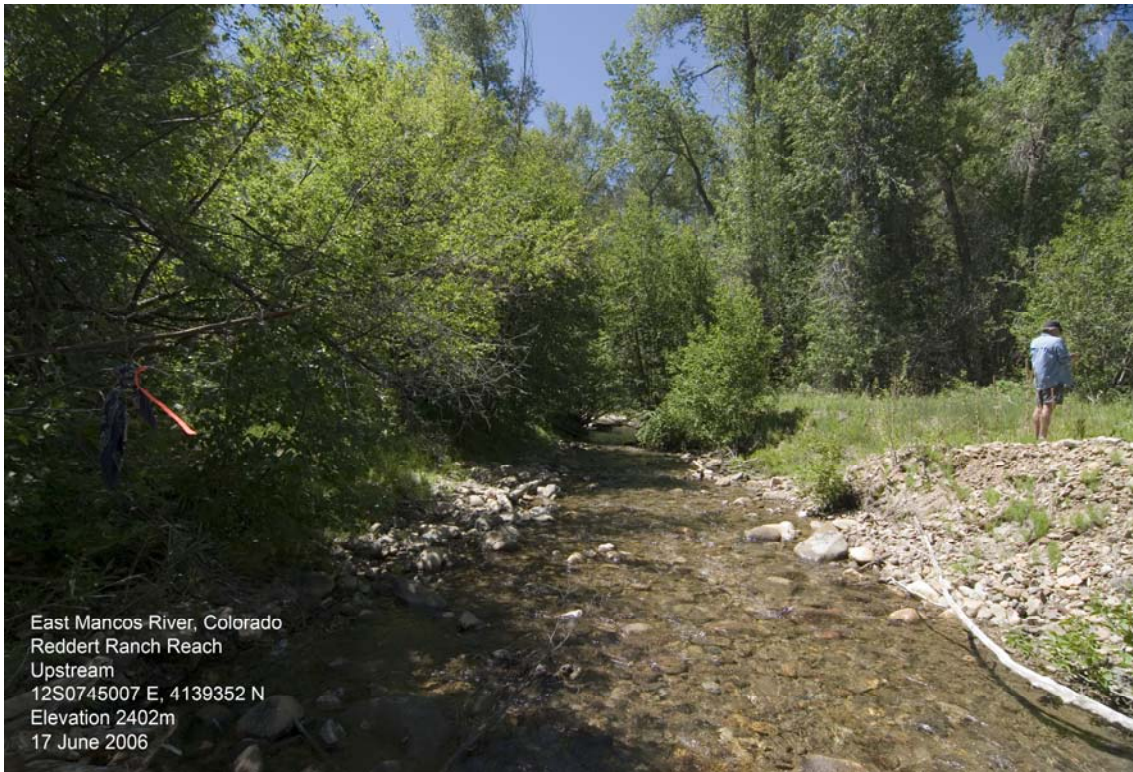
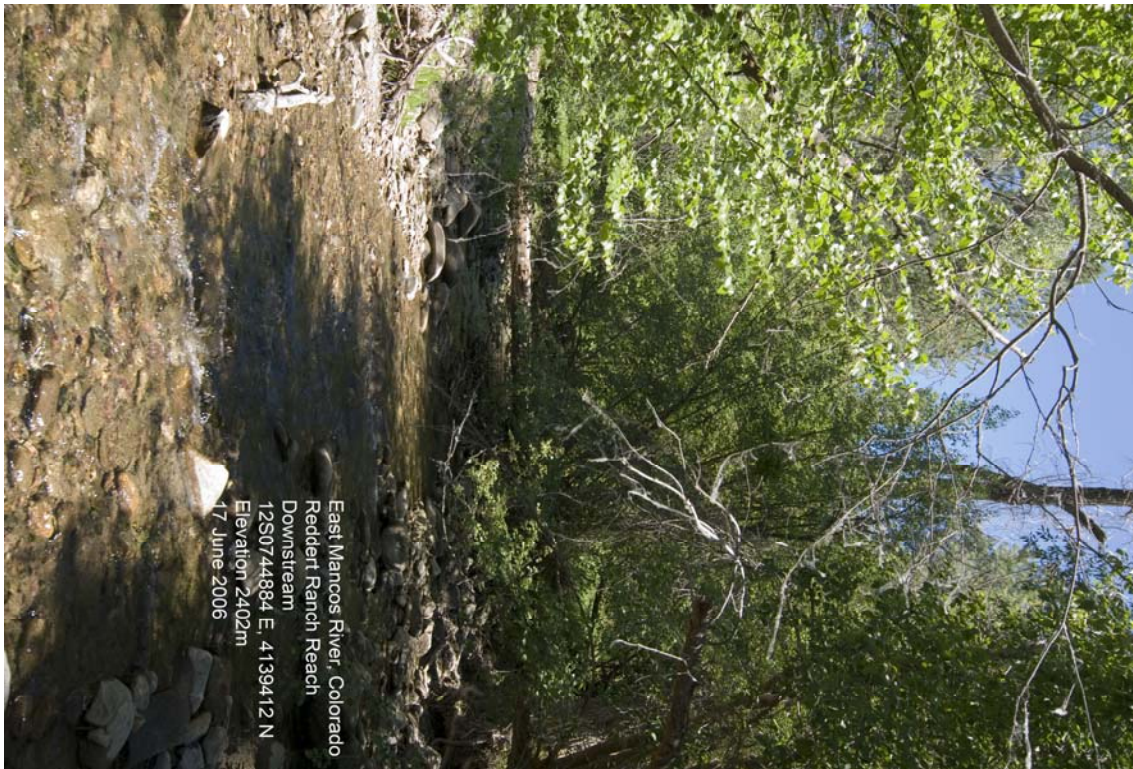
Figure 5. Reference Photos for the upstream and downstream ends of the Reddert Ranch Reach, East Mancos River.

The reach is generally in good to excellent condition, with some exceptions. Nonchemical Water Quality was good, with the expected amount of algae, and with dense overhanging vegetation providing good solar shading. Hydrogeomorphology was generally very good, although the channel was incised more than what would be expected, suggesting that there have been high flow events in the past that have produced some downcutting. There appears to be little active erosion at present. There are no beavers in the assessment reach, but there is an active colony just across the road at the mouth of the Middle Mancos. It is likely these beavers will colonize the area in the near future, if not removed by humans.

Fish/Aquatic Habitat was uniformly excellent, with the exception that there was no macroinvertebrate fauna found in the stream. In addition, no fish were observed during the assessment, despite the fact that this is excellent habitat, and that fish are found in the Middle Mancos where it joins the East Mancos. This indicates that there is probably something in the water that is killing the insects, and this should be examined in greater detail by more detailed chemical studies (see also note to West Mancos-Weber Diversion assessment, below).

Riparian Vegetation and Terrestrial Wildlife Habitat was generally good to very good. There was a lack of shrub cover in much of the reach. This may be due to the heavy browsing levels that were observed on shrubs and small trees. There was little evidence of current livestock use, which suggests that most browsing at present is from mule deer and elk.

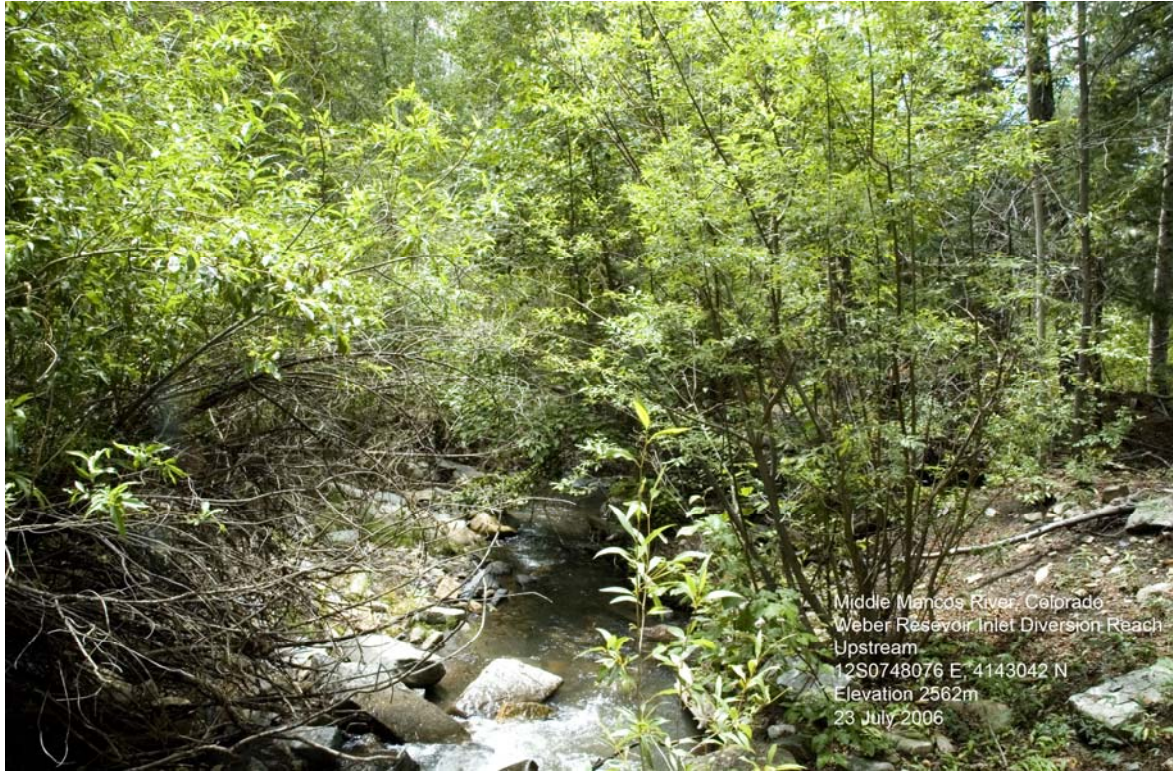
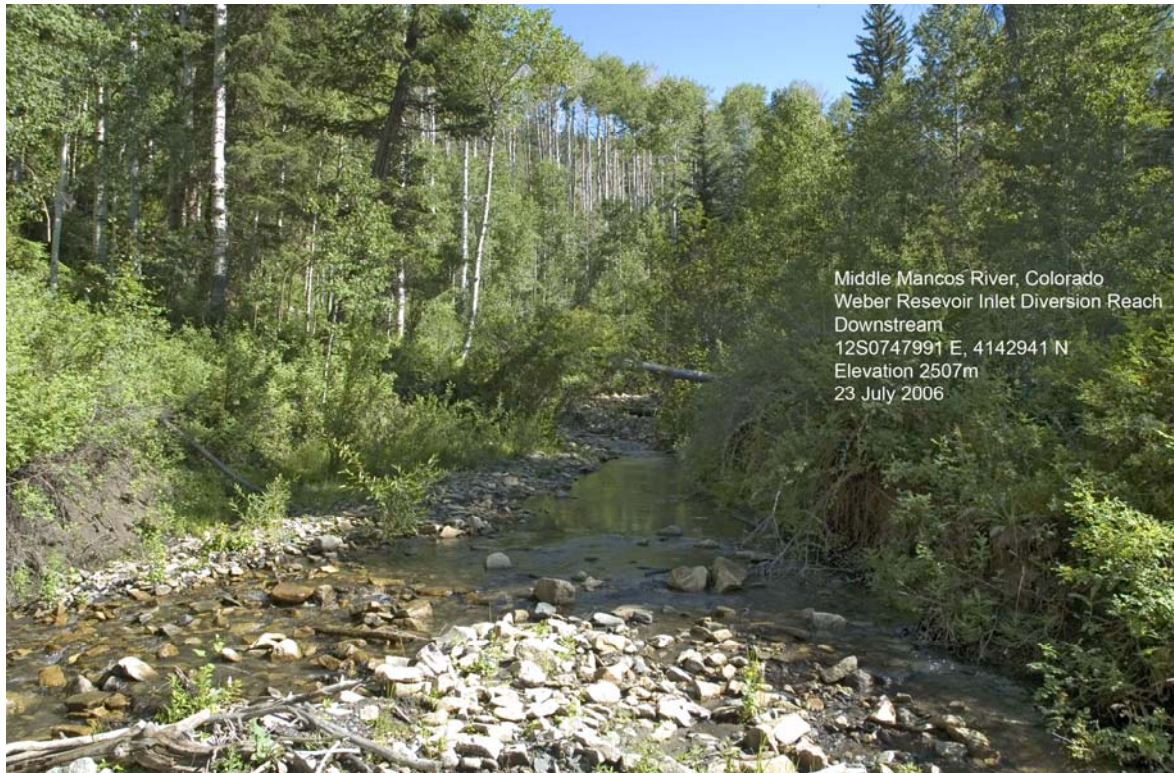
Figure 7. References Photos for the Weber Reservoir Inlet Diversion Reach, Middle Mancos River.

This reach is in excellent condition overall and can serve as a reference reach for similar size and gradient streams in this elevation range in the Mancos Watershed.

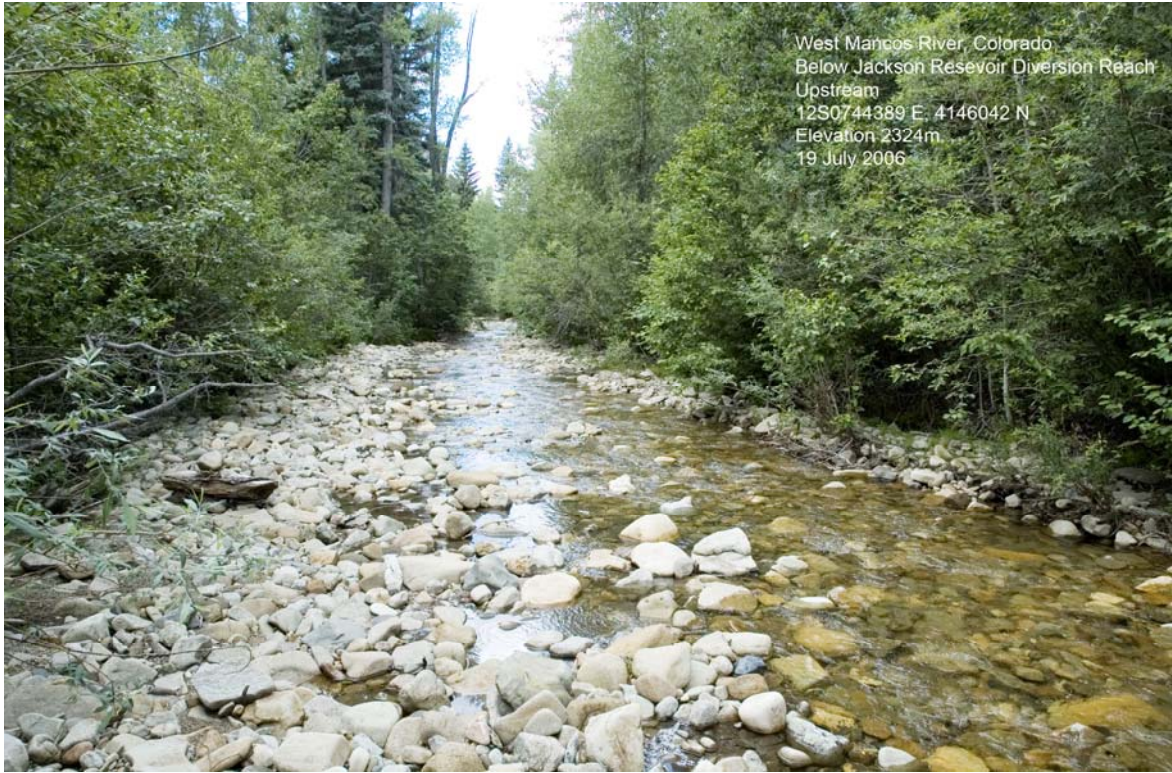
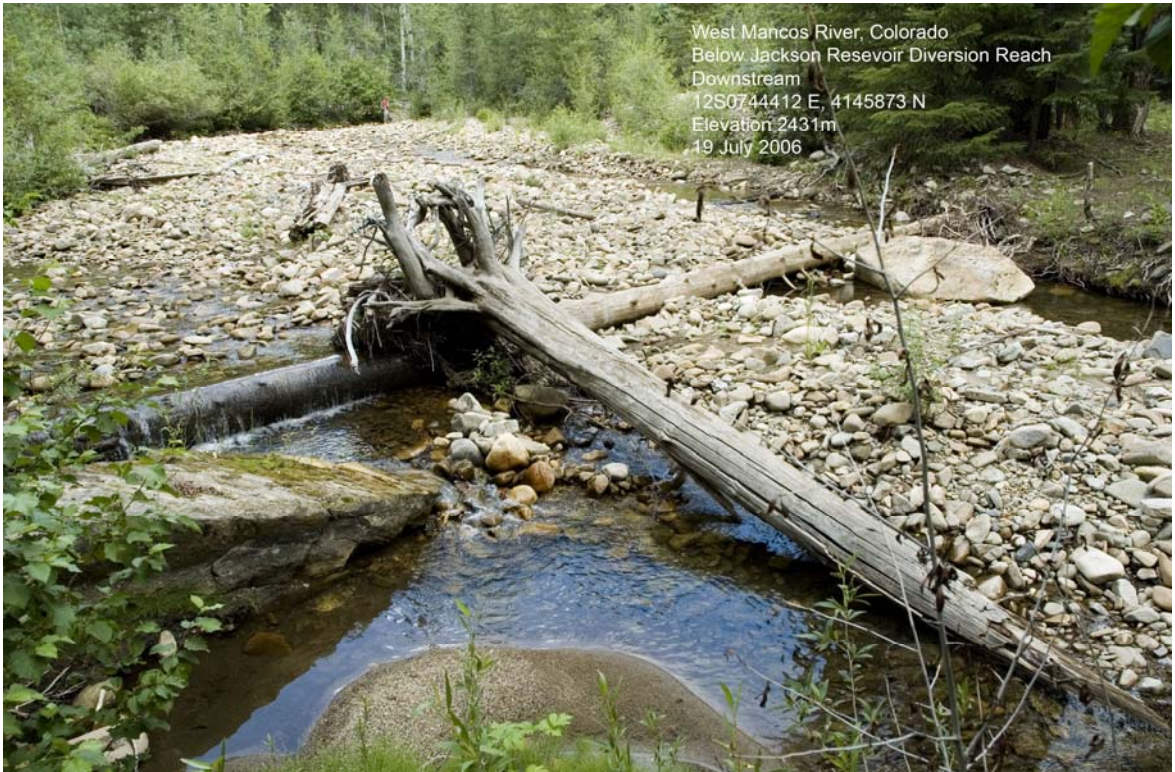
Figure 11. Reference photos for the Below Jackson Reservoir Diversion Reach, West Mancos River. The Mesa Verde diversion pipeline crosses the stream channel in the lower

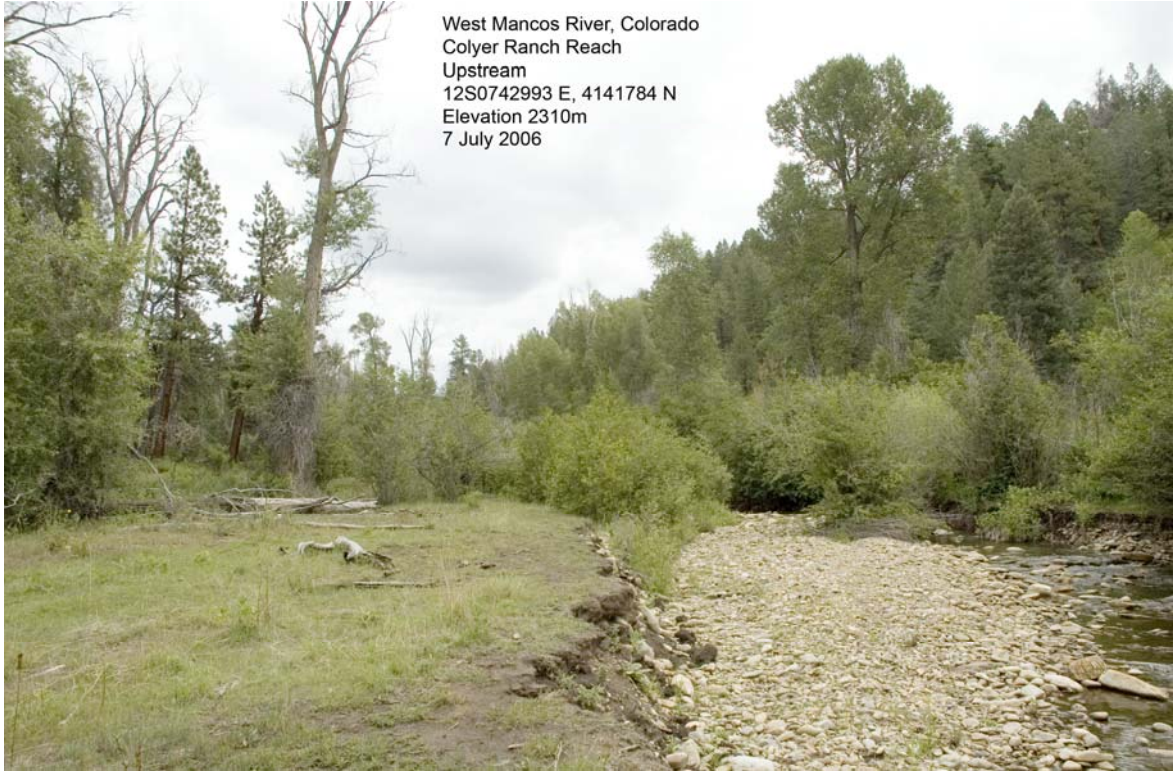
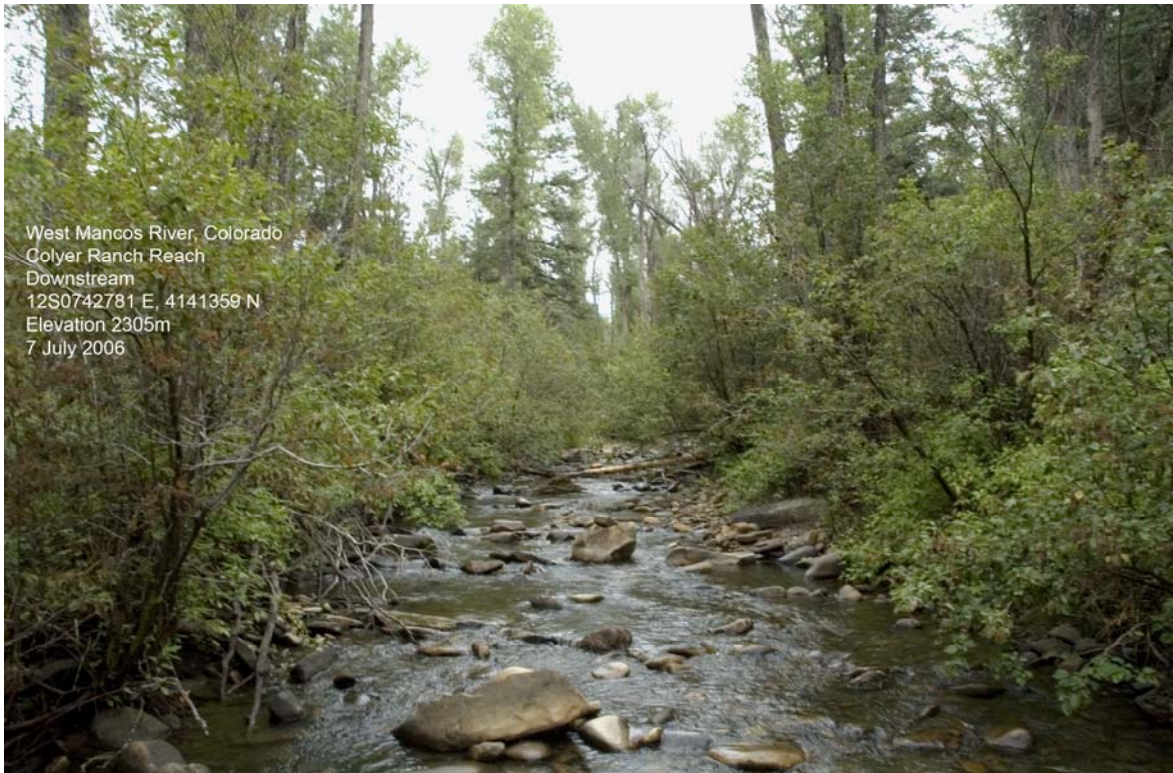
Figure 13. Reference Photos for the Colyer Ranch Reach, West Mancos River.

Algal growth was high in this section relative to the reaches further upstream, leading to a rating of fair. Cow manure was observed in the stream itself, suggesting there is nutrient loading in this reach from livestock use. Channel shading, in contrast, was very good.

Riparian Vegetation was generally very good. The only issues were the lack of vegetative cover in the lower riparian zone, which was the result of the levees, and the levels of grazing (only good) and browsing by livestock and deer and elk (poor). Sixty-three per cent of the shrubs and small trees had been browsed in the sample transect. This level of browsing could lead to a failure in the recruitment of new shrubs and trees in the riparian zone along this reach in the future.

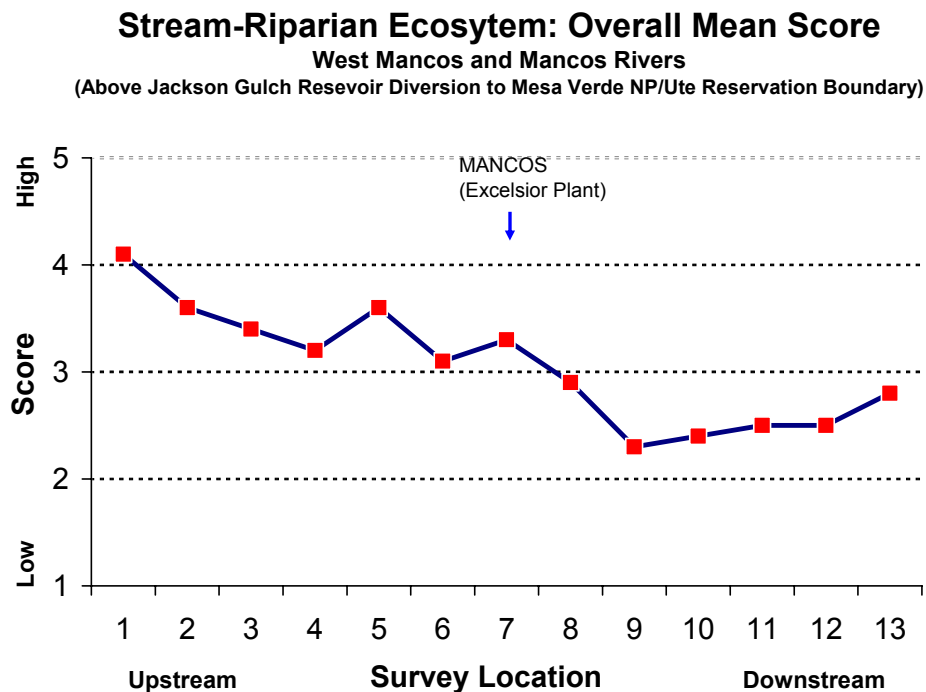
All of the reaches that were surveyed have been impacted to some extent by human activities. The trend in Figure 39 suggests that not only are these impacts most intense at the lower part of the Valley, but that some of these impacts (such as water diversions) may also have a cumulative effect on the river ecosystem. Since the overall mean score is simply a composite of individual scores, any interpretation of this pattern must consider all of the variables included in the RSRA survey. These are presented below.

Figure 39. Overall mean score for the functional condition of the survey reaches in the Mancos Valley and adjacent upstream and downstream areas (see text).

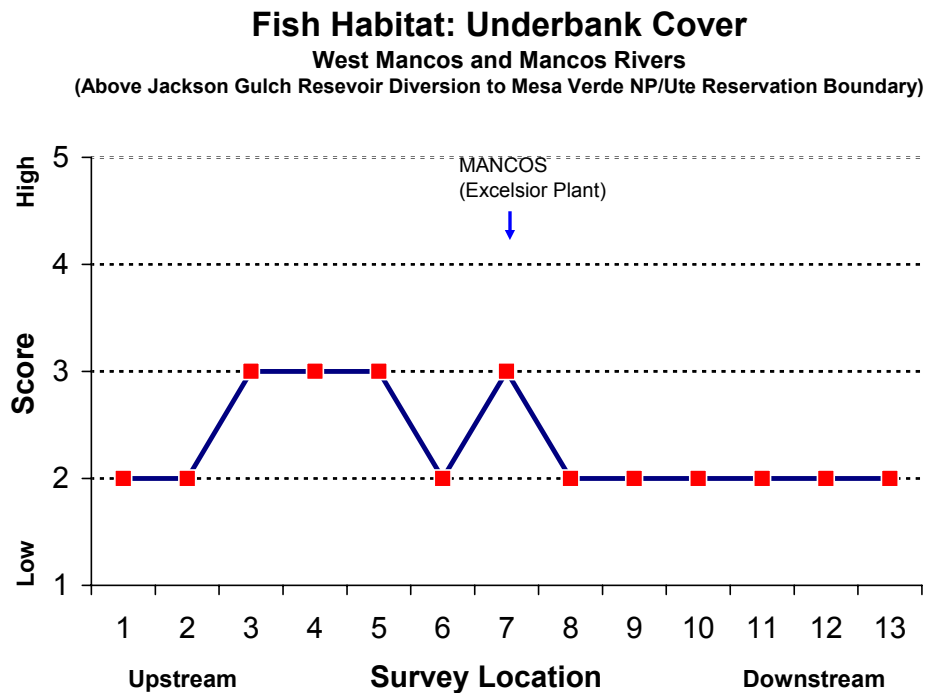
There was only limited underbank cover for fish and other aquatic species throughout the Valley, as well as in the upstream reaches (Figure 51). This was primarily a result of levee construction (including in parts of the upstream reaches), although in a few areas downstream it was also the result of a wide and shallow channel morphology combined with only limited riparian vegetation along the banks.

Figure 51. Scores for Underbank Cover for reaches in the Mancos Valley and adjacent upstream and downstream areas (see text).

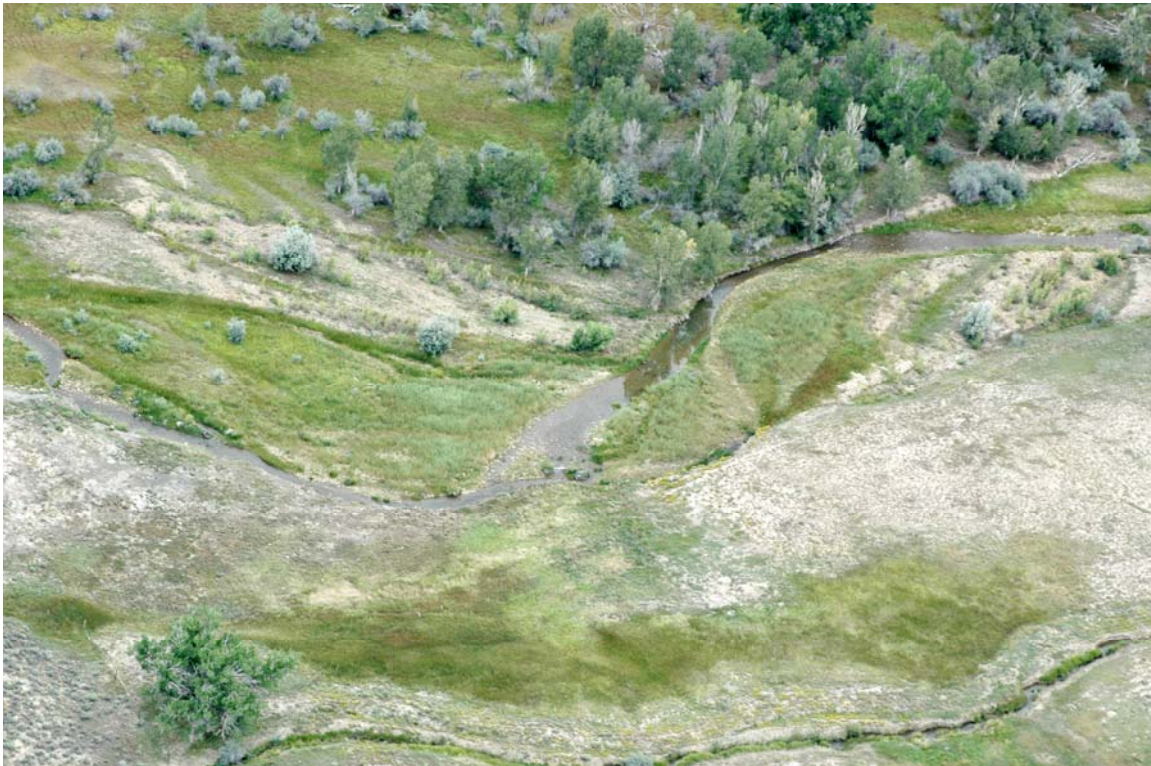
Figure 78. An illustration of the role played by leakage from unlined irrigation ditches in maintaining moist conditions throughout the riparian zone of the Mancos River in Mancos Valley. The wet meadow at the bottom of the picture is located in the upper and normally drier part of the flood plain. However, it is present because of water leaking from the ditch that runs just above it. The river in this reach (Perry Ranch) is not channelized and does not have levees. As a result, there are also the wet areas that would normally be expected to be present immediately adjacent to the stream, and which result from both overbank flooding and underground water flowing next to the channel. Between the two wet areas is a dry zone with very little vegetation (photo by Pete Cruser).
