# **Mancos Watershed Plan**

5/24/2011

## **Mancos Valley Watershed Group**

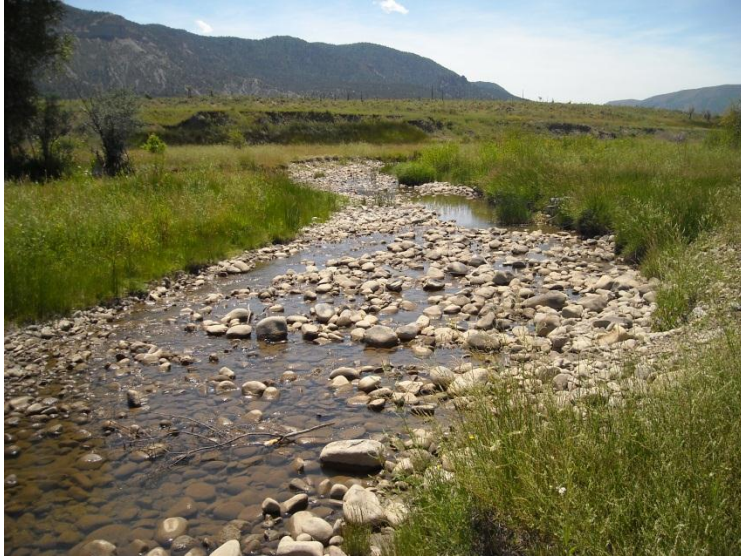
**Figure 1. Typical late summer flows below the town of Mancos**

The fourth identified issue was the low flows during late summer irrigation season (*i.e.*Figure 1). These low flows result in elevated water temperatures, isolated fish and populations, and further isolation of the stream water from the riparian community

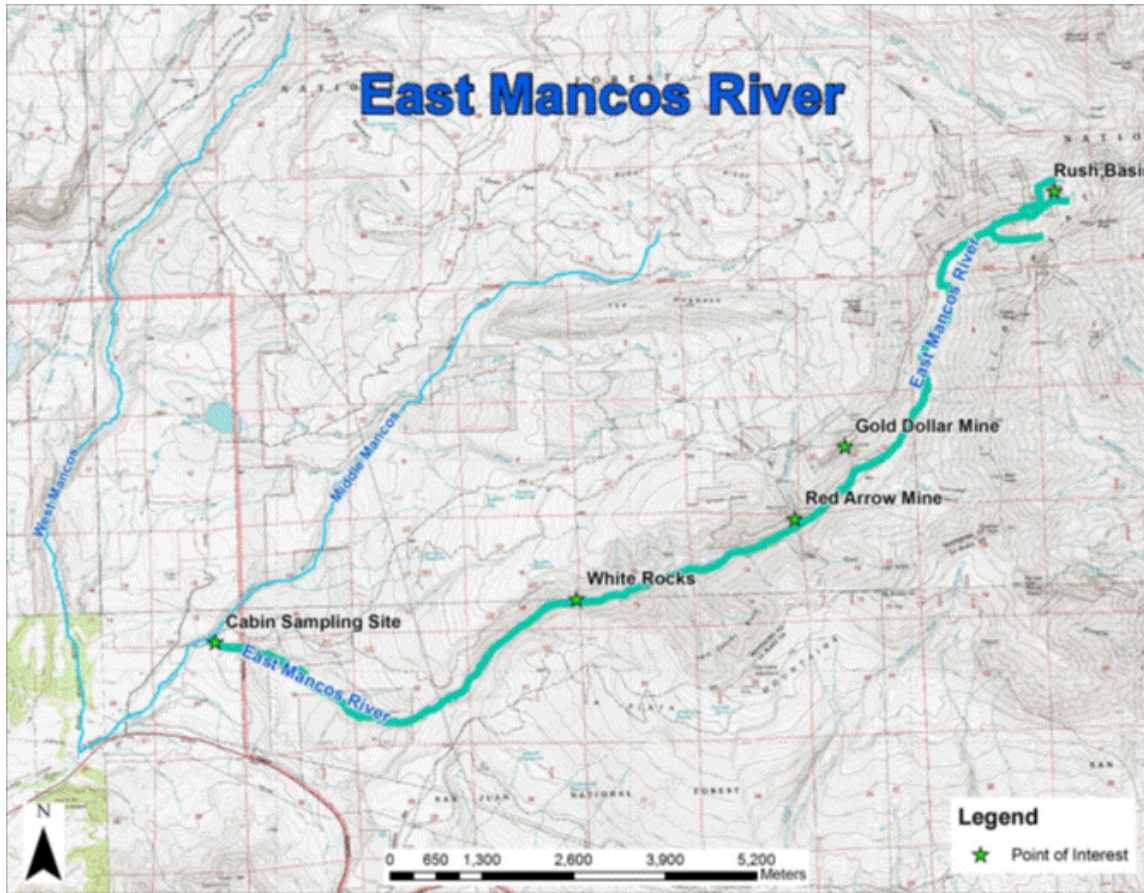
**Figure 3. Map of the East Mancos River showing mine sites and Rush Basin, a relatively un-mined area from which much of the poor water quality emanates.**

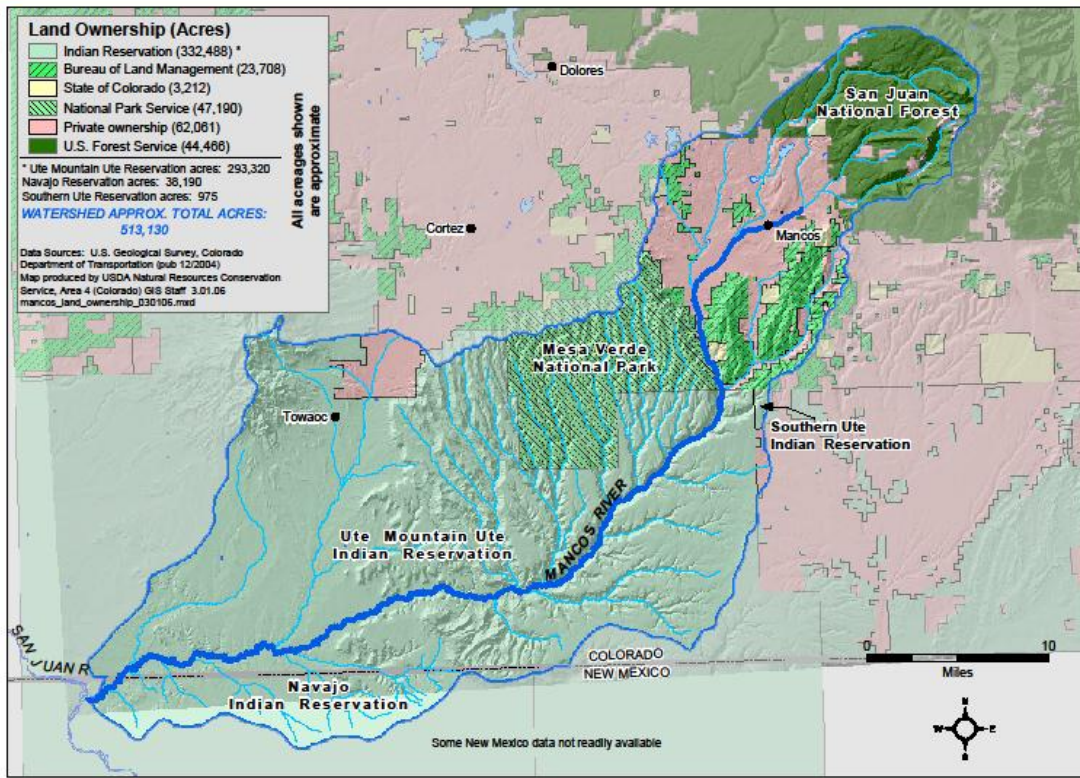
**Figure 4. Land ownership in the Mancos Watershed.**

The major landowners in the Mancos Watershed, other than owners of private property, include the U.S. D. A. Forest Service, Mesa Verde National Park, and the Ute Mountain Ute Indian Tribe. Each entity is addressing watershed and water quality issues within their portion of the watershed. The Forest Service is addressing sediment issues with a Travel Management Plan, MVNP is addressing native fisheries, water quality and riparian habitat issues as is the Ute Mountain Ute Indian Tribe. The issues that the Mancos Conservation District is addressing best represent the private property owners and the primary users of water in the watershed and their efforts to protect and best utilize the water. Efforts for each entity are described below.

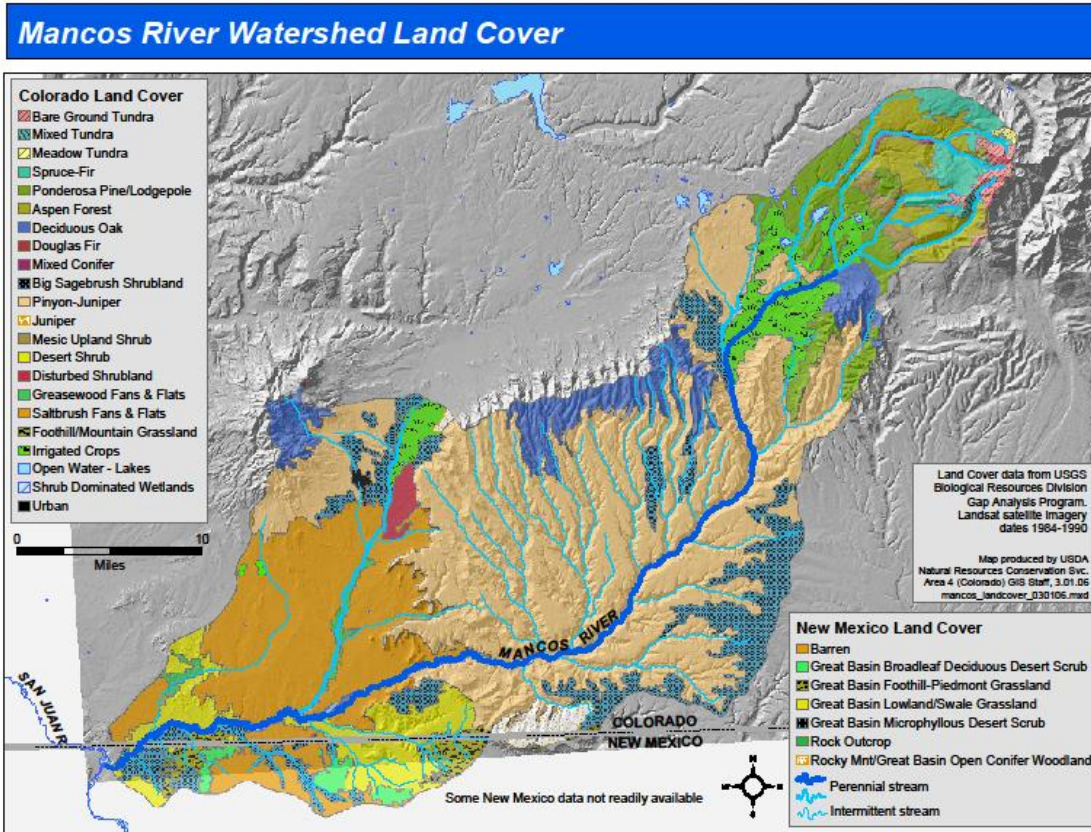
**Figure 5. Vegetation cover of the Mancos Watershed.**

The Mancos River travels through almost all of the major vegetation life zones found in the Colorado Plateau region including the Alpine tundra, subalpine, spruce-fir forest, aspen forest, ponderosa pine forests, pinyon-juniper forests, plains-mesa grasslands, savannah (now primarily converted to agriculture) and desert scrublands (Figure 5). Very little of the watershed is urban.

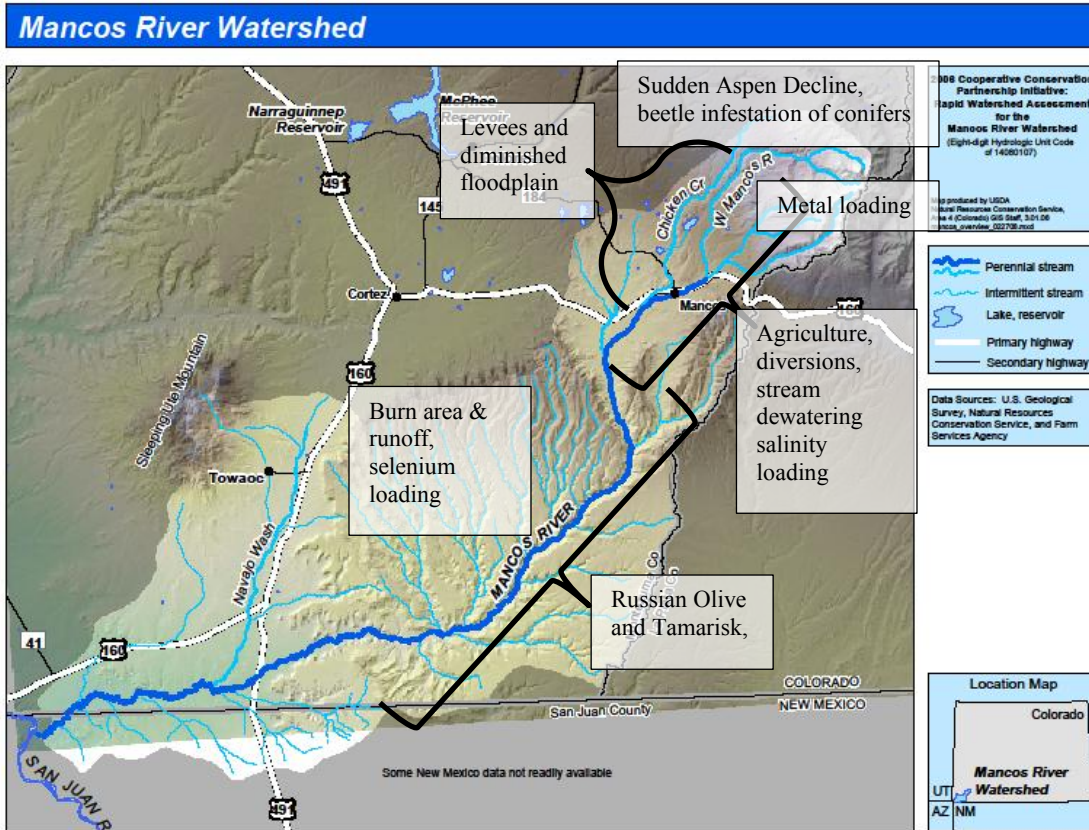
Figure 6. Major impacts to Mancos River

Both the land and water composing this watershed suffer from divergent needs and piece-meal management with the watershed area being fractioned into, tribal, national park, Forest Service, Bureau of Land Management, municipal, ranch, and small family farm lands. Some of the primary issues affecting the watershed include: the recent drought that has stressed all of the systems: conifers at multiple elevations experiencing beetle infestations, aspens dyeing from sudden aspen decline, invasive weeds that are gaining a stronghold in the overly dry and disturbed soils in the lower watershed and runoff from hillsides struck by forest fires carrying heavy sediment loads into the streams and river. During the summer months, dewatering of the stream in the Mancos Valley when water is diverted for irrigation is hard on fish, wildlife and riparian ecosystems. Other types of degradation can be seen in the severe braiding in the lower watershed, heavy stream bank erosion, diminished flood plain areas, and the spread of Russian olive and tamarisk in the Mancos Valley and the lower part of the watershed.

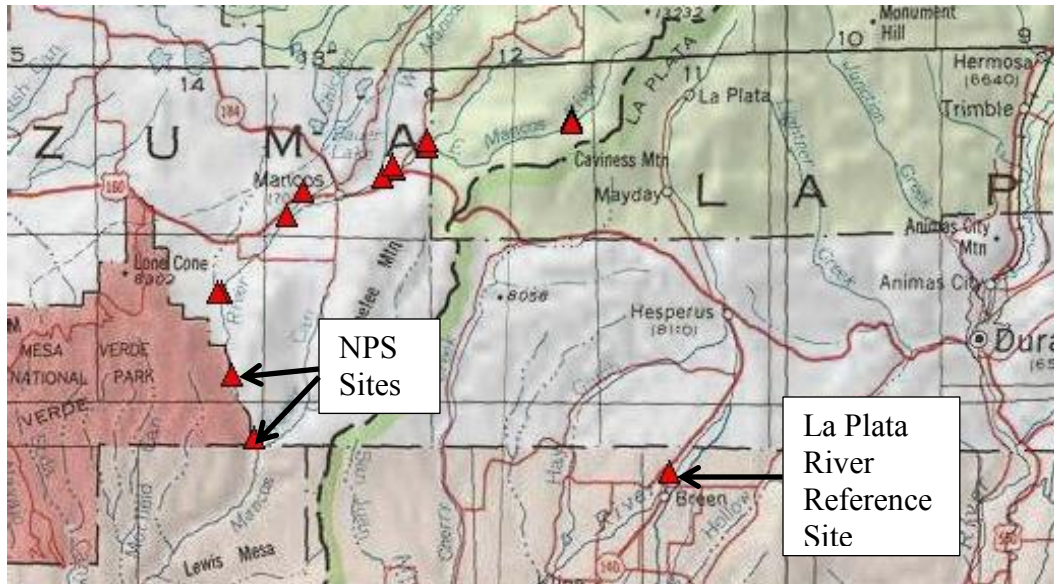
**Figure 7. Overview map of the eleven sites collected in the Mancos River Watershed. The two National Park Service (NPS) sites collected in 2007 and 2008 are also shown along the southeast border of Mesa Verde National Park. The La Plata 1 site is also shown north of Breen. Details of sites are found in Figure 8 and Figure 9.**

There are both short-term goals and long-term goals to consider (Table 8). The short-term water quality goals would include: measuring the loading of copper (lbs/d) upstream of the confluence of the East Mancos with the Middle Mancos and upstream of the confluence of the East Mancos with the West Mancos and then somewhere below the mixing zone, such as at the Highway 160 bridge. Procedures for monitoring should follow the SAP/QAPP developed by the Mancos Valley Watershed Group and approved by the state WQCC (2008). Another short term goal to measure every 3 years are the benthic macroinvertebrates as outlined in the Sampling and Analysis Plan (B.U.G.S. Consulting 2010) along with a reference the site (Figure 7, Figure 8 and Figure 9).

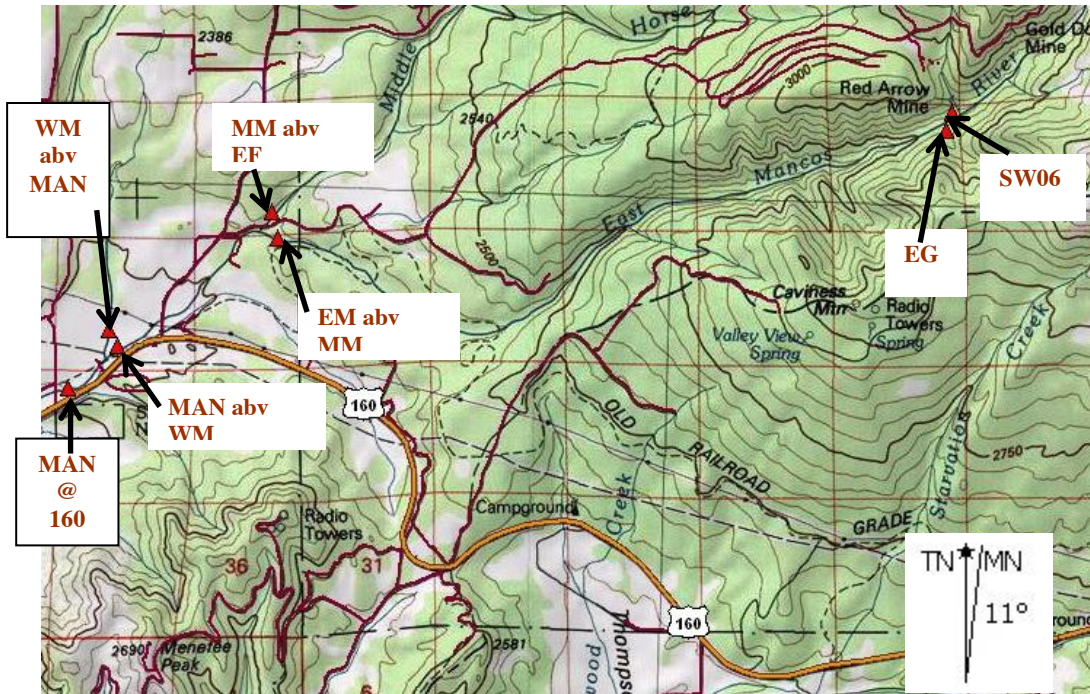
Figure 8. Map of upper seven sites collected in the Mancos River Watershed (MM= Middle Mancos, WM = West Mancos, Man = Mancos River, EG = East Gulch, EM = East Mancos).

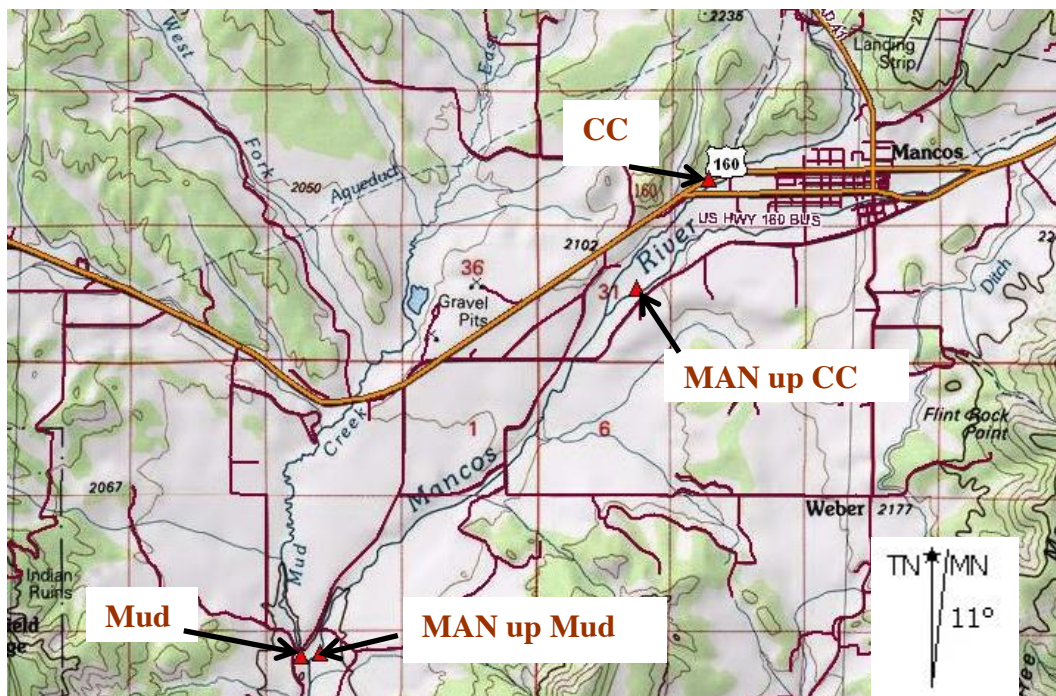
Figure 9. Map of lower four sites collected in the Mancos River Watershed (CC = Chicken Creek, Mud = Mud Creek, MAN = Mancos River,

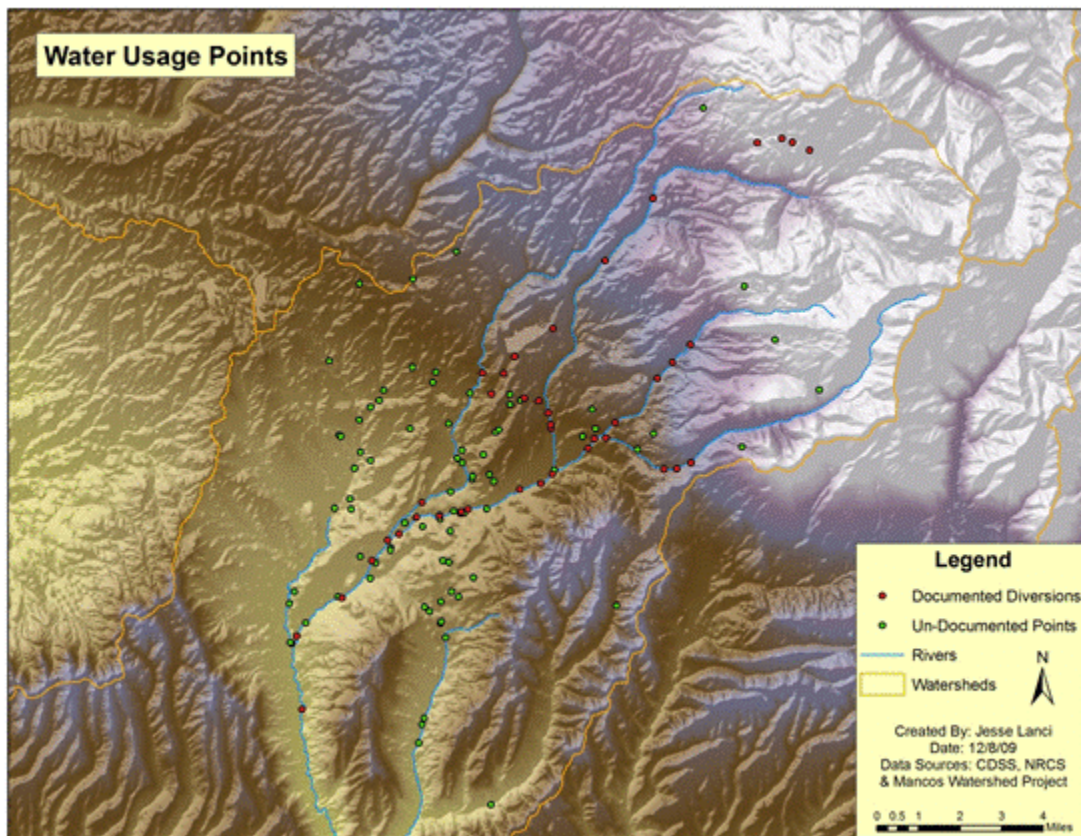
**Figure 10. Inventoried diversion structures. Red dots are those that were documented with photos, location, descriptions, and problems associated with the diversions. Prioritized diversions for repairing are illustrated below.**

Below is a list of 12 diversion structures out of over 50 structures that were inventoried. Based on observations of head-cutting, bank-cutting drying of surrounding riparian area, and obstruction of fish passage, these 12 structures were prioritized as having some of the greatest amount of impact to the functioning capacity of the river and are in a place where they could do the most to benefit the river if repaired properly.

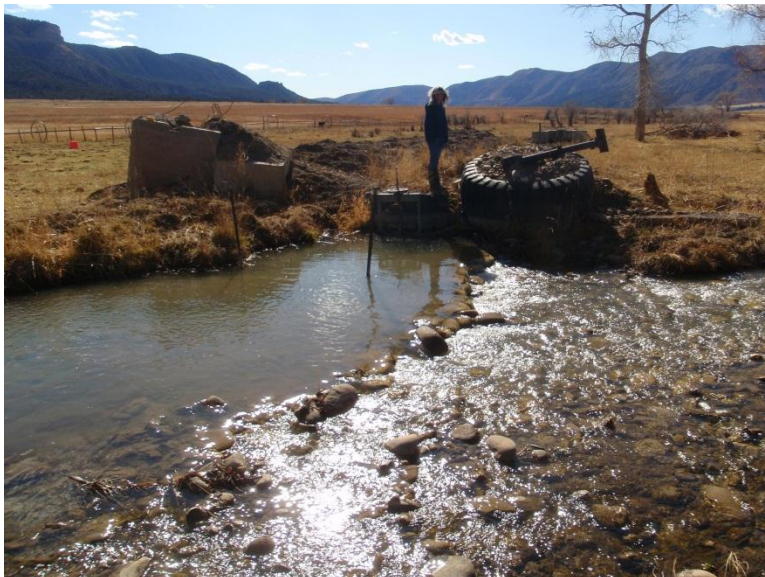
## **Glassglow & Brewer Diversion (Figure 16)**

Barrier: The barrier is small, made up of sand bags; it allows fish passage and creates a small pool above it (minnows are noted below the diversion). There are five large tires in the diversion area; 3 above the diversion (probably for bank stabilization) and the other 2 are at the 1<sup>st</sup> gate (probably also for stabilization).

River: Diversion is located in a heavy cattle area; there is little vegetation along the banks, along with looser soil due to cattle. The river is at a constant gradient; with a cobble bottom, small rapids and pools.

Other: Fencing around the structure and riparian area, have the ability to keep the cattle out.

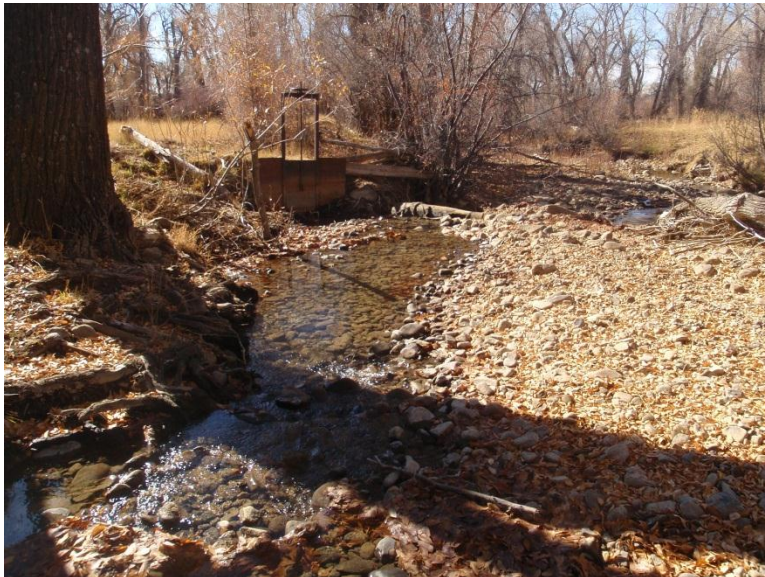
## **Graybeal Diversion (Figure 14)**

Head Gate & Ditch: There is no water flowing in the ditch. I am told by Walley and Marty that the gate needs to be replaced, the wheel does not turn and the gate will not open.

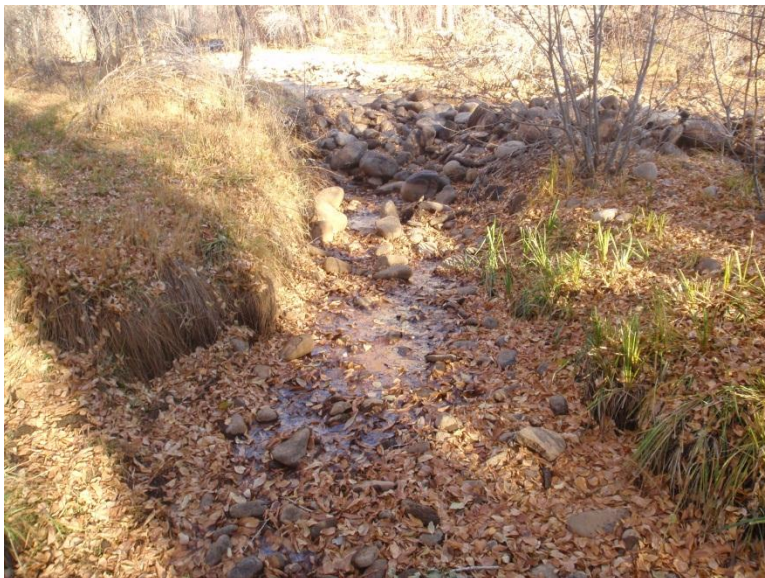
## Lee Diversion (Figure 15)

River: I has been observed that the river is changing courses and has moved its channel more to the left below the diversion (about 50 – 100 yards), thus creating a very large cut-bank; which has concrete and pipe (used for culverts) to try and help with stabilization. The banks are shallow, only 1 or 2 cut-banks with a height of about 2-3 feet (this of course is excluding the very large cut-bank farther down-stream), mostly composed of medium round-river rocks. Gradient is very constant; there is very easy access to both sides of the river.

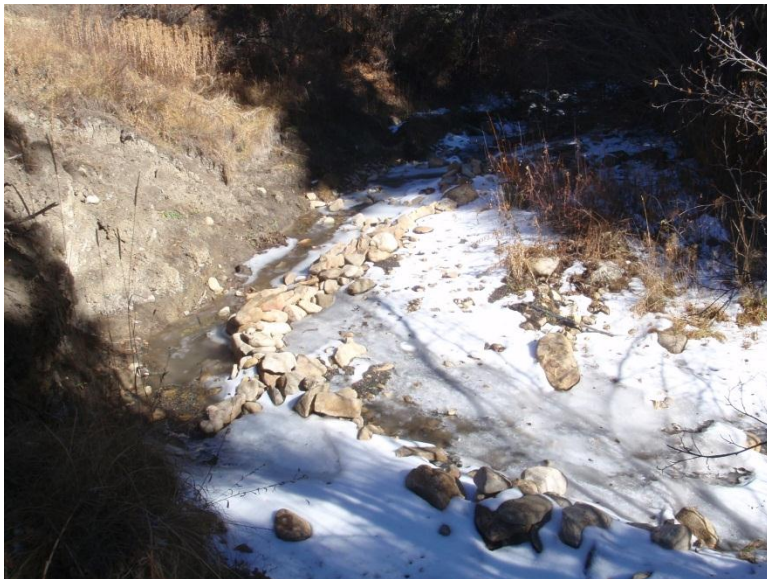
## **Smouse Diversion (Figure 14)**

Barrier: It is a small and thin diversion barrier; it allows water to pass through, and is made out of medium sized river rocks. I have found two shovels (pictured) indicating to me that is how they improve their barrier.

Head Gate & Ditch: No water running through the ditch. I have found no head-gate.

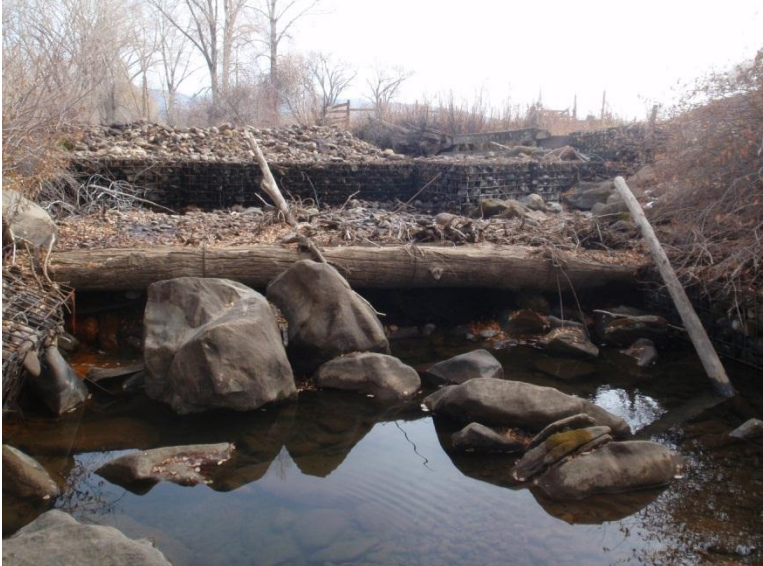
## **Webber Diversion (Figure 14)**

Head Gate & Ditch: There is a pool about 2-3 feet deep and about 50 yards long (fish were noted in this pool). The pool has 2 exit channels, both walled up with pieces of lumber/wood; the pooled up water flows over both wooden barriers (both drop about 2 feet) into a small channel (which drops another 2 feet) and finally into the channel. The head-gate is made of wood, with open slots; this means that there is no way of completely shutting off the water with the gate alone, it's always flowing.

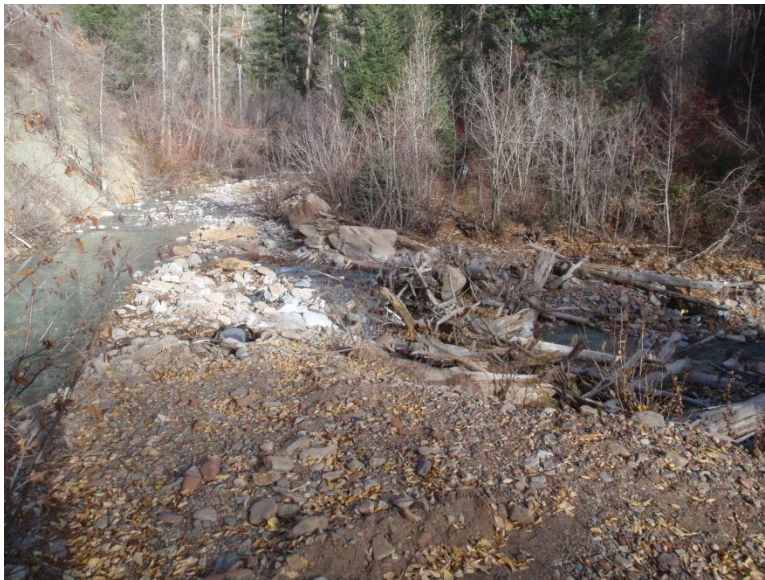
## **Williams Diversion (Figure 14)**

Other: There are also excelsior rolls that look as if they’re placed as if their trying to slow down high flows.

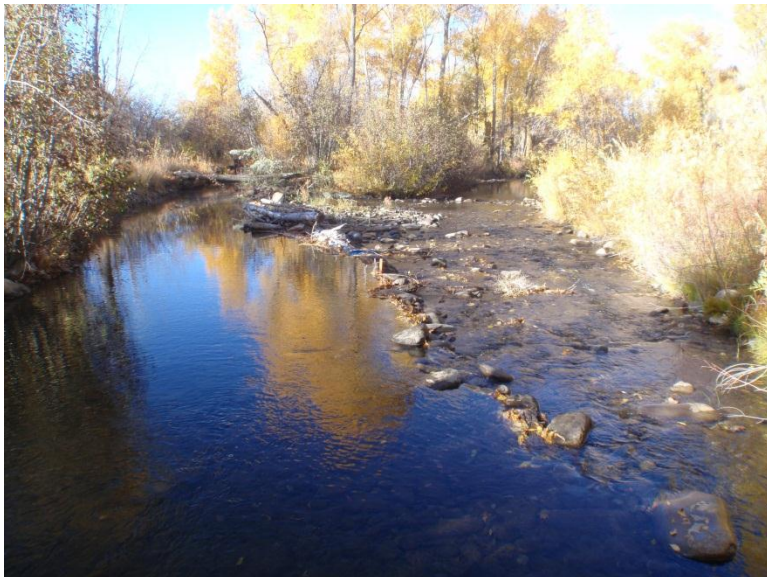
## **Willis Diversion (Figure 15)**

River: It does provide a gentle gradient of flowing water, to get around the barrier. Up-stream looks to be 2 well-constructed man-made pools; there are segments of the walls that are loose. There does not seem to be much cut-bank issues.
