EAST MANCOS RIVER WATERSHED MONTEZUMA COUNTY, COLORADO

AQUEOUS METAL SOURCES, CONCENTRATIONS, MASS LOADING, AND AQUATIC IMPACTS

MANCOS CONSERVATION DISTRICT

SEPTEMBER 25, 2020

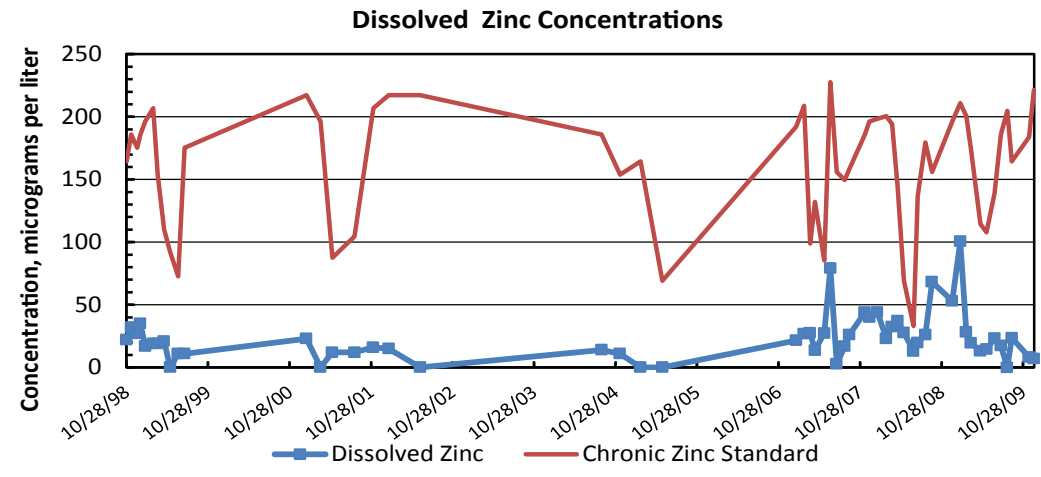
East Mancos River Above East-West Confluence, 1998-2009

Figure 1-3. Historical water-quality data for the East Mancos River (combined CDPHE and River Watch data).

mouth of the watershed, combined from CDPHE and River Watch during 1998-2007, show fluctuations in dissolved copper, manganese, zinc, and hardness over time (**Figure 1-3**). Streamflow discharge measurements were not always performed by these entities; therefore, dissolved-metal mass loading estimates were not available. Dissolved copper, manganese, and zinc concentrations appear to increase from 1998 to 2009; however, this might be caused by more frequent sample collection during 2006-09. Throughout the period, dissolved-copper concentrations exceeded the chronic and acute water-quality standards, dissolved manganese exceeded the standard, but dissolved zinc did not exceed the standards (**Figure 1-3**). Hardness concentrations also fluctuated over time, occasionally decreasing to a low of about 50 mg/L.

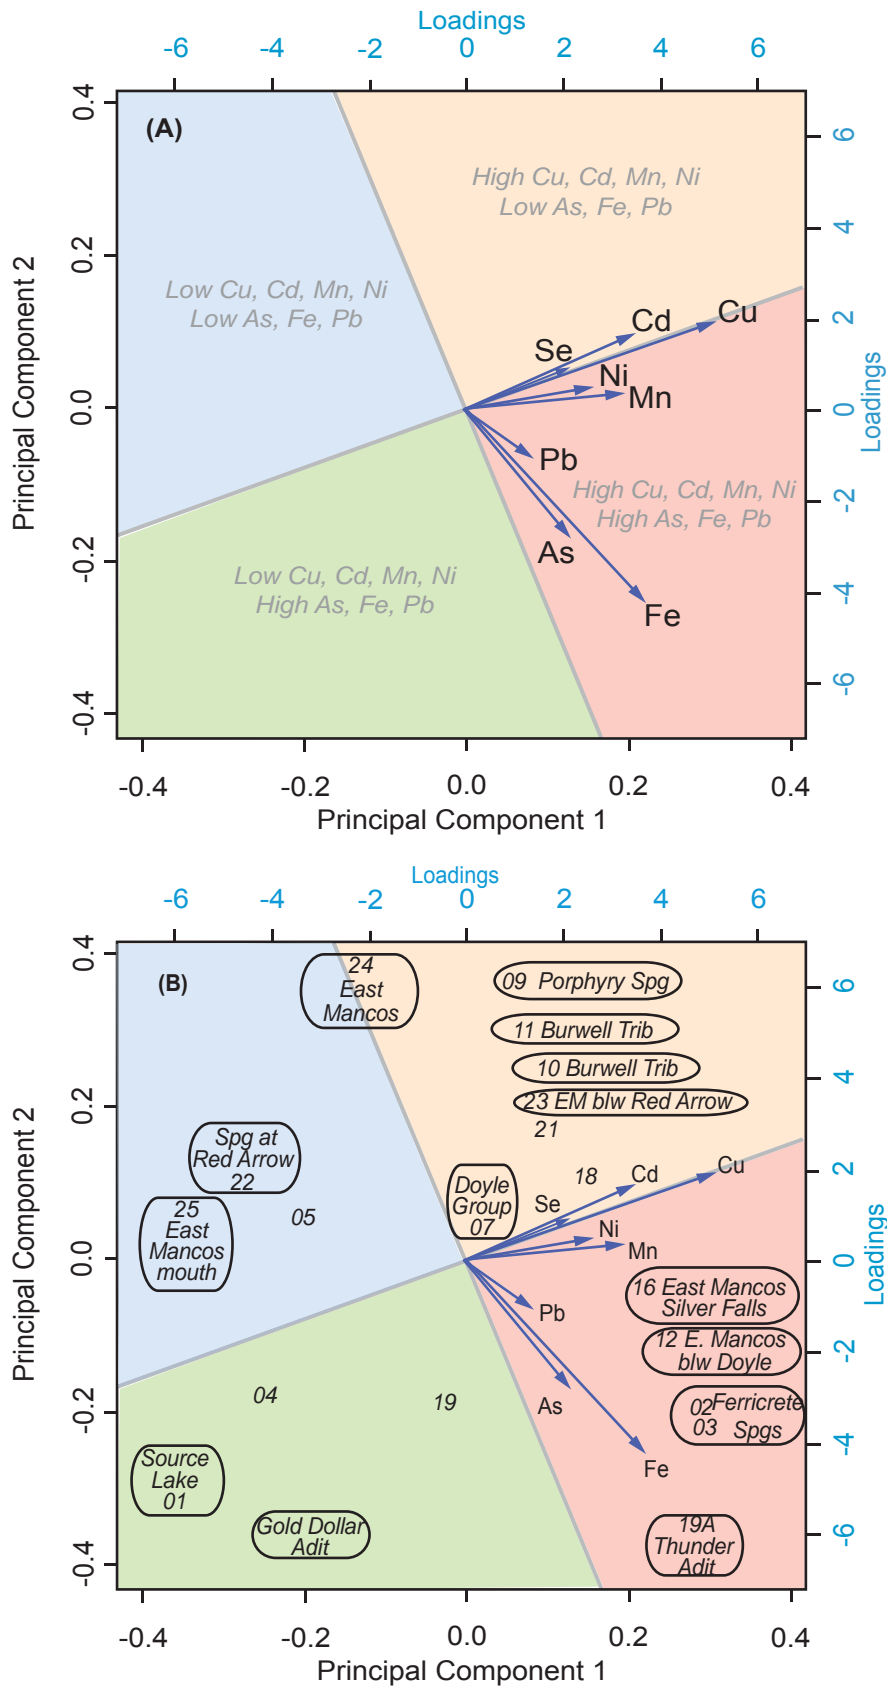
Figure 2-2. Principal components analysis biplot (A) showing rotated axes oriented according to groupings of dissolved metals, and (B) PCA biplot with site locations shown.

For East Mancos samples collected during low-flow conditions of September 2018, using logarithmic transformations of dissolved chemical concentrations, the PCA identified two distinct groupings related to mineralization (**Figure 2-2**). The vectors showing iron (Fe), arsenic (As), and lead (Pb) likely relates to arsenopyrite mineralization. The vectors surrounding copper (Cu), cadmium (Cd), manganese (Mn), nickel (Ni), and selenium (Se) relate to porphyry mineralization (**Figure 2-2A**). Therefore, values in the upper right of the biplot show sites with high concentrations of Cu, Cd, Mn, Ni, and Se, while in the lower right of the biplot show sites with high concentrations of Fe, As, and Pb. For example, in the lower right corner of the biplot, drainage from the Thunder Mine plots the furthest along the Fe axis, while the opposite end of the Fe axis shows site 24, which has low Fe concentration (**Figure 2-2B**). Sites in the Burwell Trib (09, 10, and 11) plot in the area with high Cu, Cd, Mn, Ni, and Se (**Figure 2-2B**). Sites 05, 22, and 25 plot in the area with low Cu, Cd, Mn, and Ni (**Figure 2-2B**). Sites 02, 03, and 12 are a mix of high concentration Fe, but also containing high concentrations of Cu and Cd. Mixing of waters from upstream sources results in the East Mancos at Silver Falls (site 16) having a mixed signature of upstream sites (**Figure 2-2B**). East Mancos River near mouth (site 25) has the lowest principal component loadings of all the dissolved metals (**Figure 2-2B**).

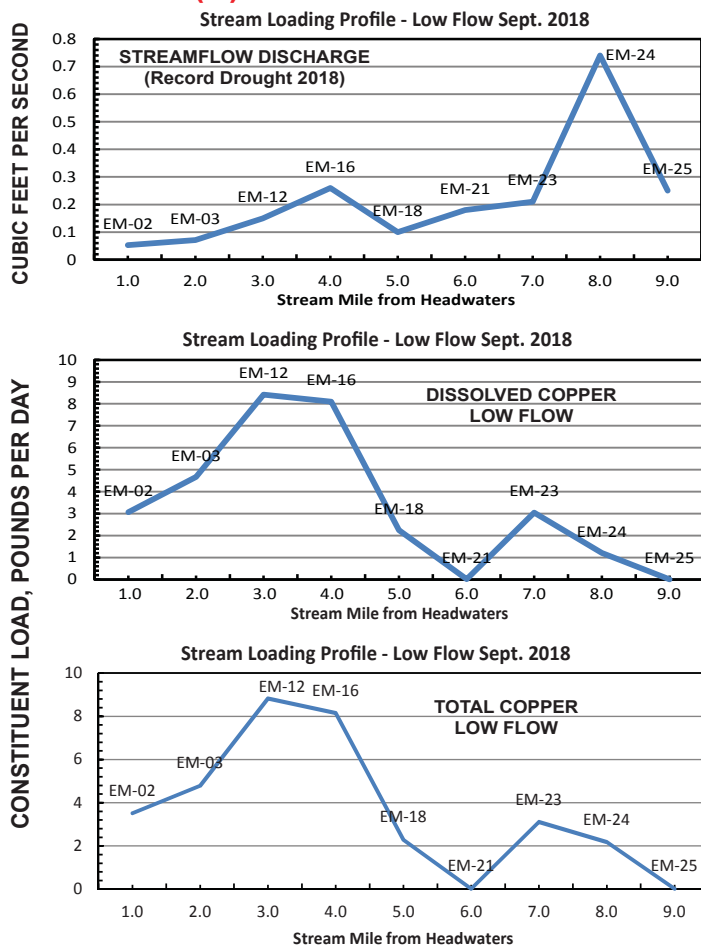
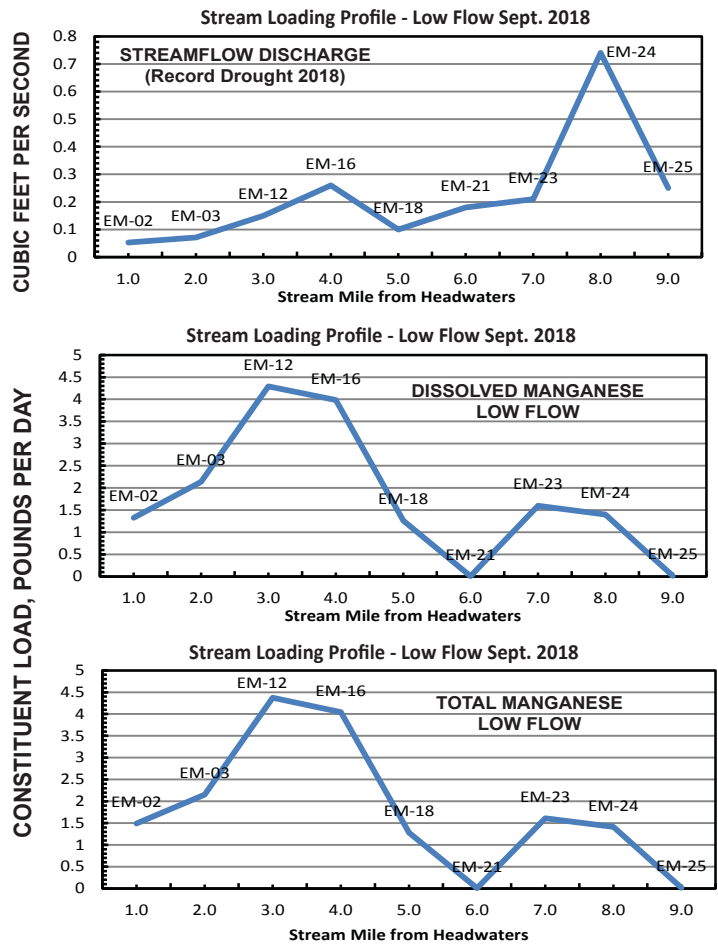
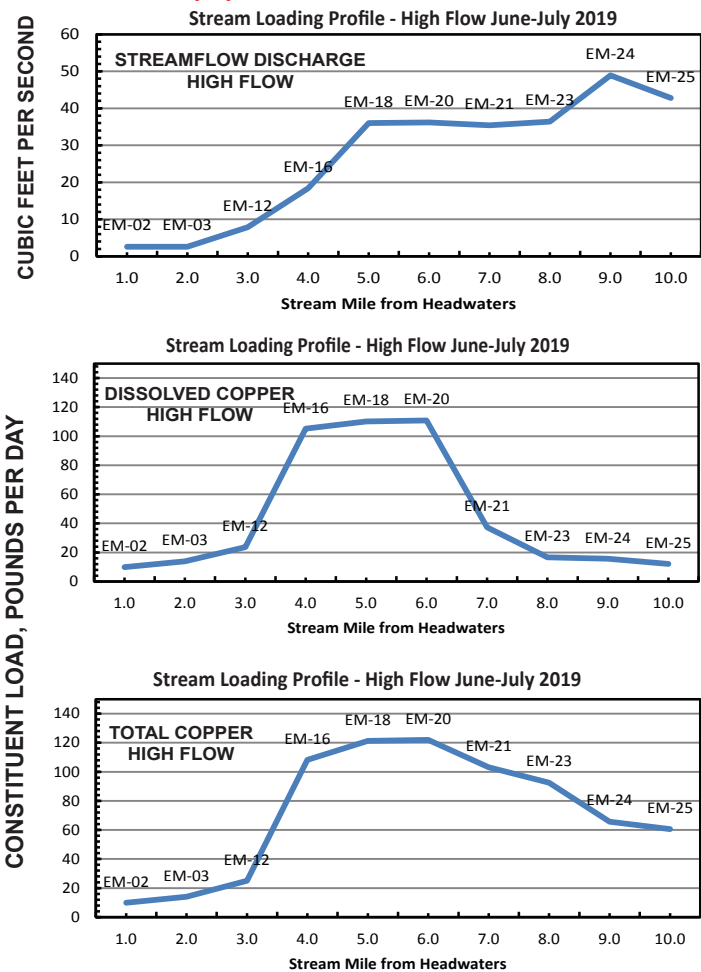
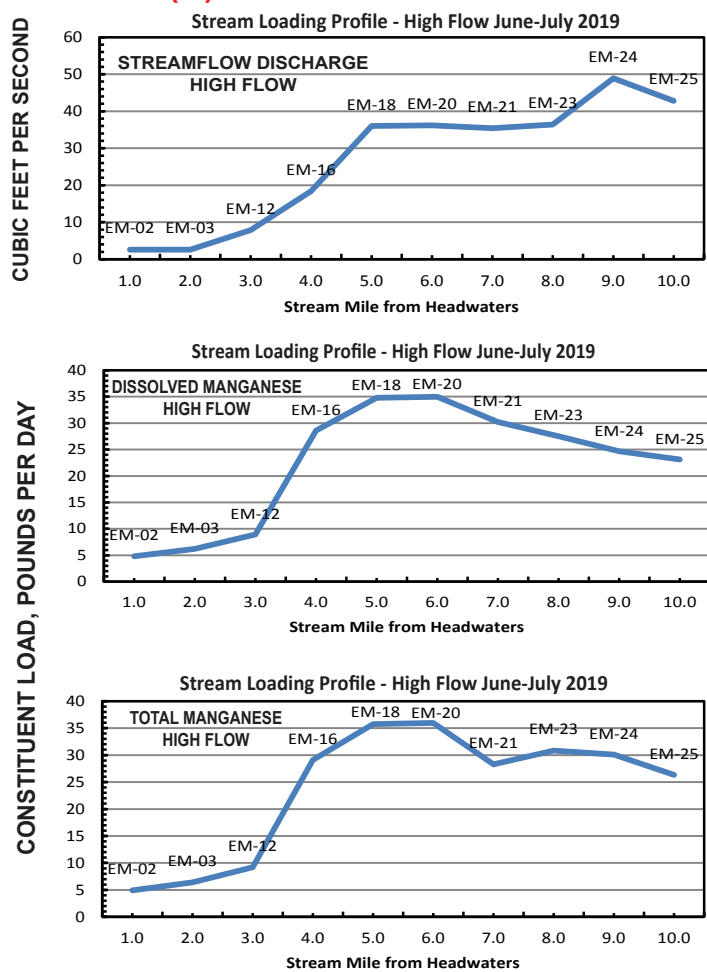
Figure 2-12. Longitudinal stream profiles during low and high flow showing discharge, dissolved and total copper loads, and dissolved and total manganese loads.

Focusing on copper and manganese (**Figure 2-12**), longitudinal stream profiles of dissolved and total mass loadings during low- and high-flow conditions show increasing and decreasing loads through the East Mancos River mainstem. During low-flow conditions of September 2018, dissolved and total copper and manganese loads increased through the upper basin (**Figures 2-12A and 2-12B**) as the stream has incised canyons through geologically altered rocks, and mining-impacted waters possibly enter the stream diffusely from the Jackson Ridge area (although there were no draining mines documented along Jackson Ridge during low flow 2018). During low flow, dissolved and total copper and manganese decrease through the middle East Mancos due to chemical reactions and metal attenuation (**Figures 2-12A and 2-12B**); loads increase slightly towards the end of the middle reach; and metal loads are almost removed by the end of the lower reaches (mouth of the watershed) (**Figures 2-12A and 2-12B**). During high-

flow conditions of June-July 2019, there were significant increases in discharge and mass loadings between sites EM-12 and EM-16 (**Figures 2-12C and 2-12D**). [This is the stream reach past Gibbs Peak, where there is known geologic alteration and mineralization due to porphyry intrusions (**Figure 1-6**). More information are needed for this reach of the East Mancos during low- and high-flow conditions.] During high flow, dissolved copper loads were significantly attenuated in the lower reaches; however, total copper loads were less affected by attenuation (**Figures 2-12C and 2-12D**). Dissolved and total manganese were not significantly attenuated in the lower reaches (**Figures 2-12C and 2-12D**).

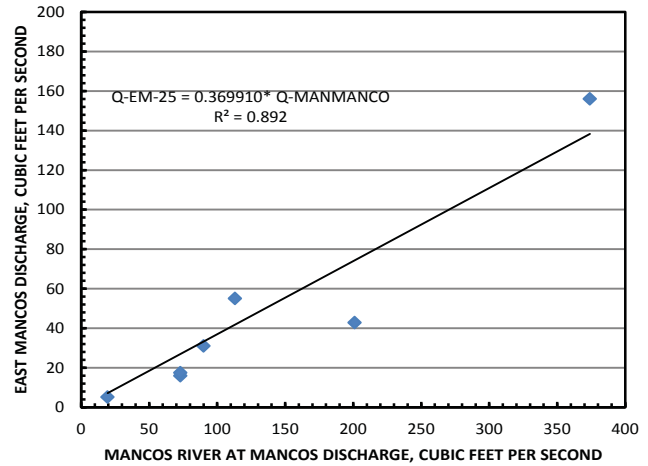
Figure 2-13. (A) Snowmelt runoff hydrograph for the Mancos River near Mancos, Colorado (actual data); (B) Correlation of streamflow discharges in Mancos River with East Mancos River (EM-WQ-25); and (C) modeled snowmelt runoff hydrograph for East Mancos River near mouth.

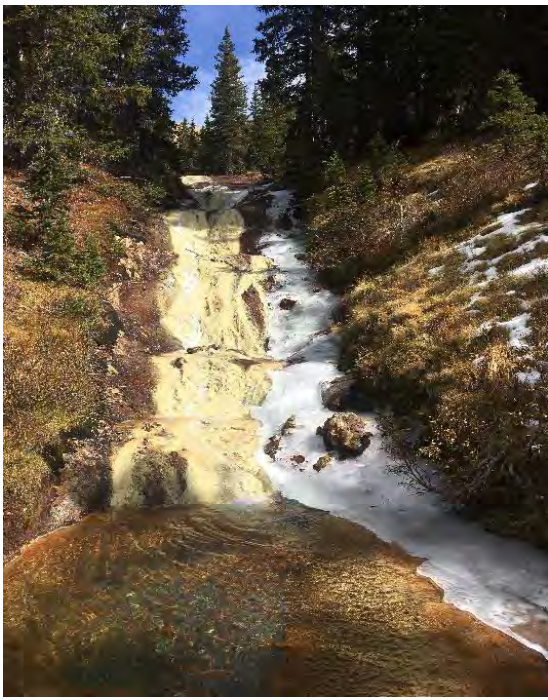
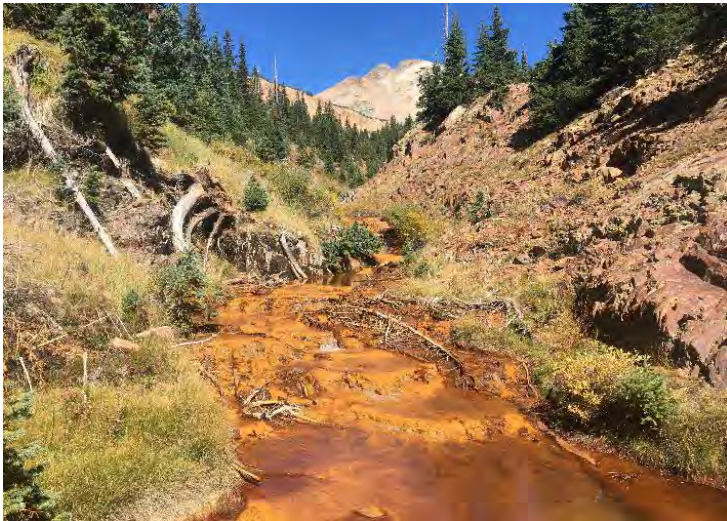
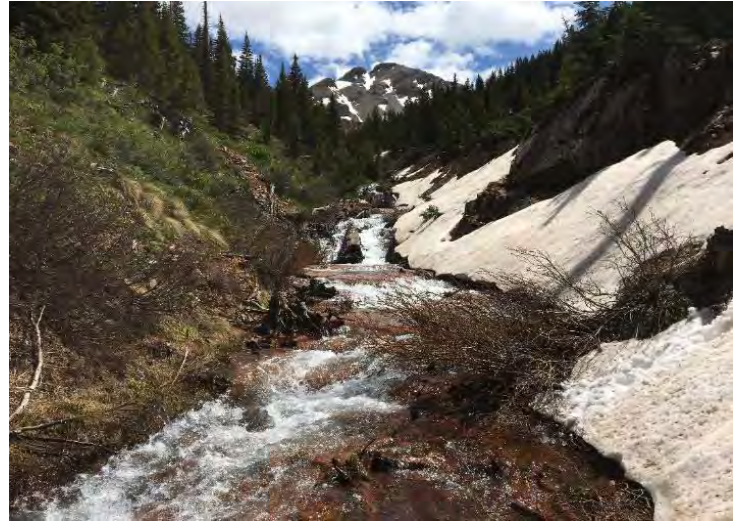
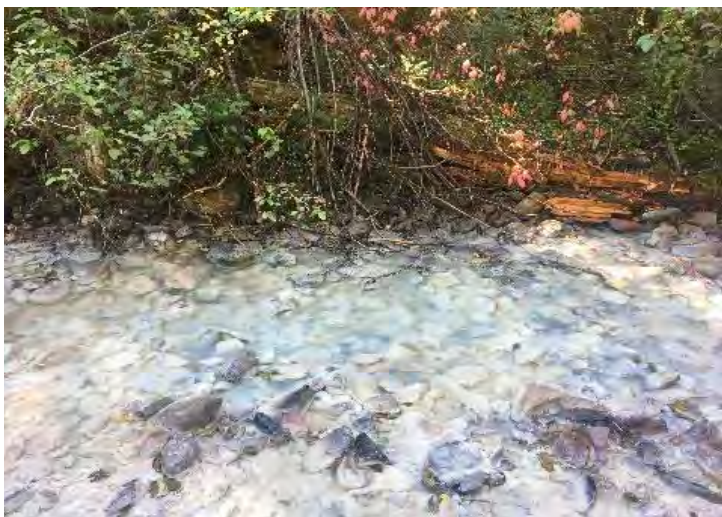
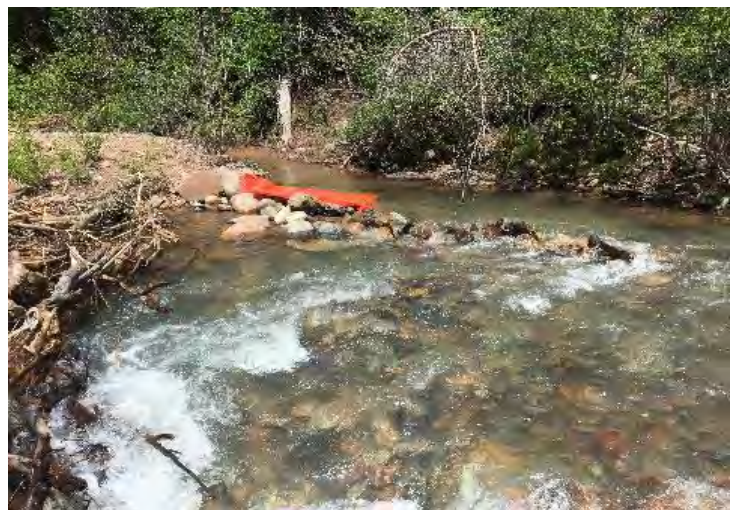
Figure 2-15. Photocomparison of the East Mancos River before snowmelt runoff showing mineral precipitates, and after snowmelt runoff showing that mineral precipitates had been scoured from the streambed. Mineral solids were transported out of the basin, and samples of this runoff was captured at site EM-WQ-25 during March-July 2019 (photos by Scott Roberts).

Phreeqc modeling results show supersaturation and precipitation of several iron clay mineral species, including potassium nontronite (KFeAlSiO_2) and jarosite (KFeSO_4). Using the Phreeqc model, mineral mass precipitation was calculated between stream sites (from upstream to downstream), and the resulting precipitated mass was multiplied by streamflow discharge to obtain the weight of mineral precipitated between stream sites. Results indicate that during low-flow conditions of September 2018, cupric ferrite, nontronite, and jarosite precipitation occurred throughout the length of the East Mancos River. Up to 18 tons per day (tons/d) of cupric ferrite, 6.5 tons/d of nontronite, and 58 tons/d of jarosite were precipitated between stream sites (**Figure 2-19**). Deposition of the minerals during low flow was confirmed by field observations (**Figure 2-17**), and during snowmelt runoff these mineral solids were scoured from the streambed and transported out of the watershed (**Figure 2-15**).

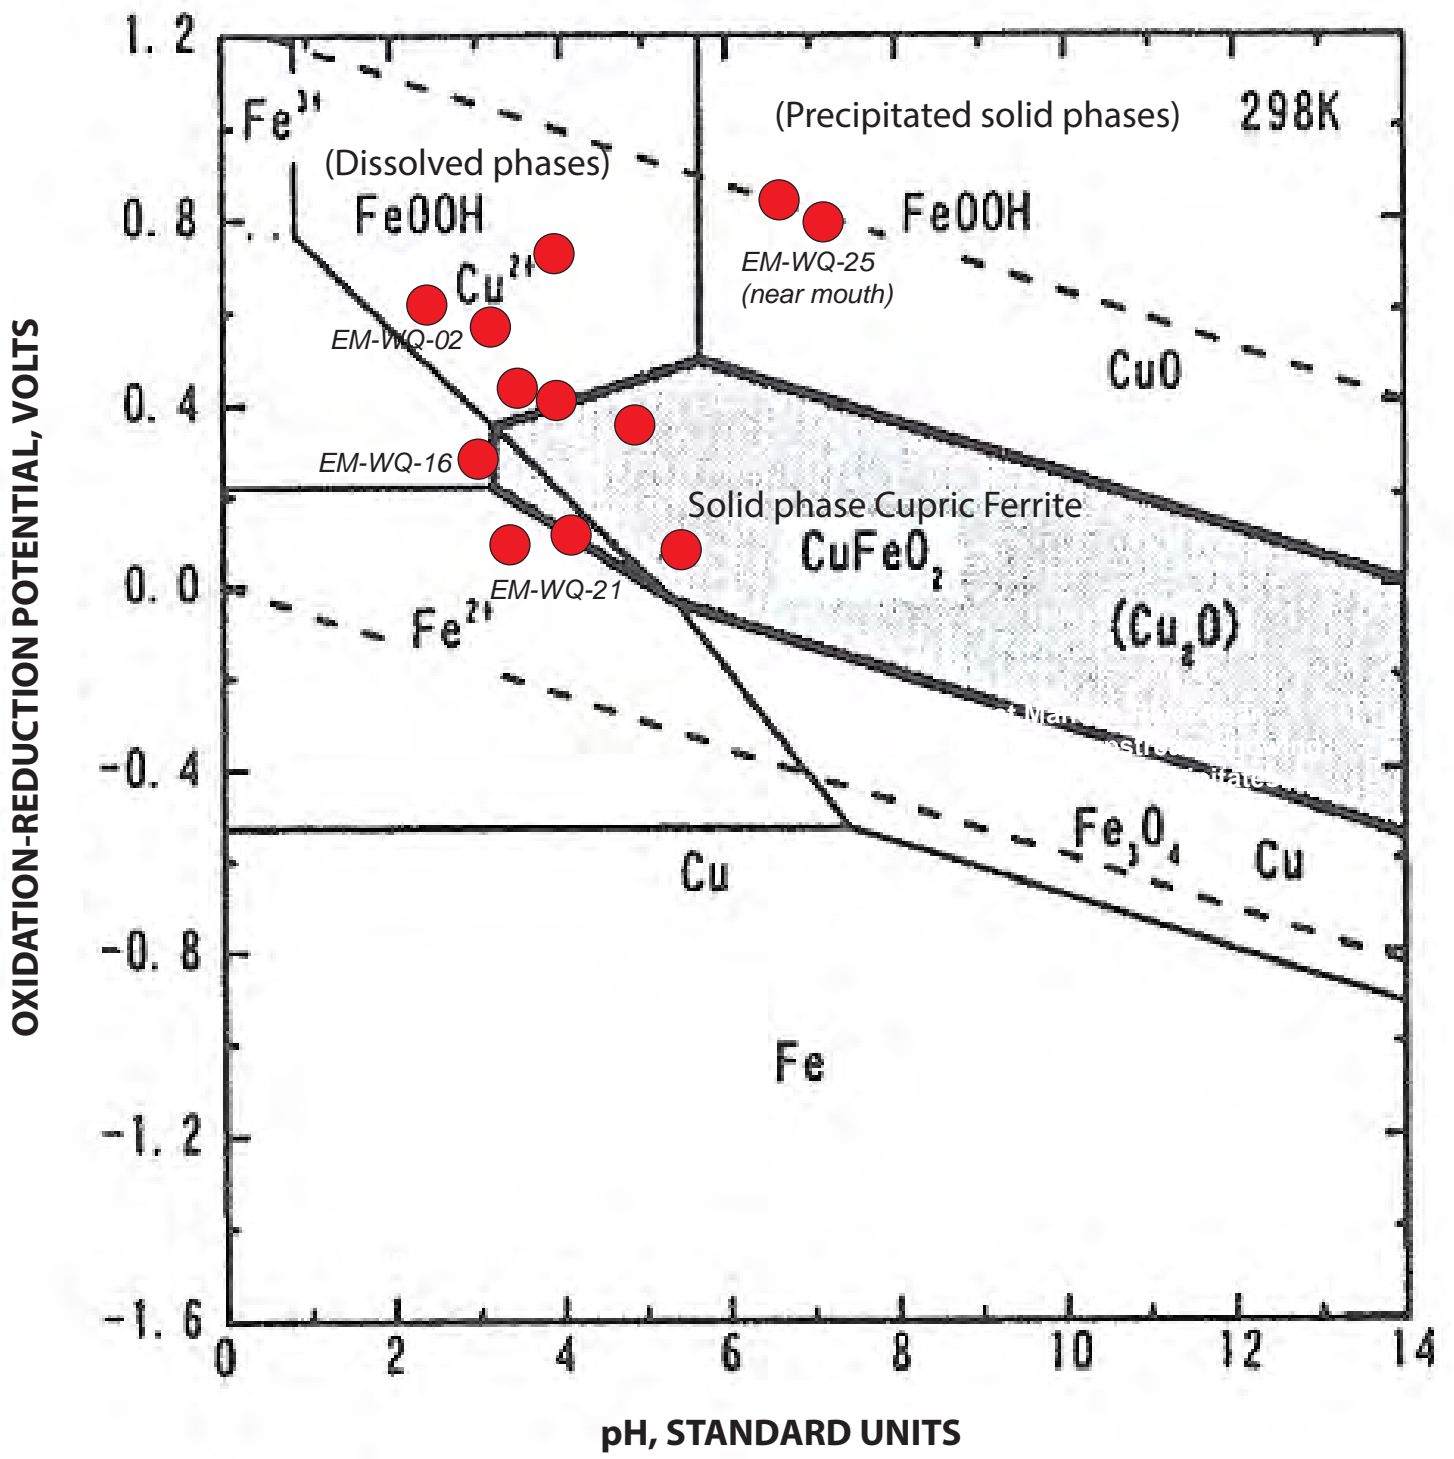
Figure 2-16. Stability field diagram for iron (Fe) and copper (Cu) dissolved and solid phases. Circles indicate data points for water from springs and streams in the East Mancos watershed.

Aqueous mineral species, which are represented in the water-quality sample, can describe the source rocks and minerals that result from chemical weathering. Aqueous mineral speciation represents compounds that are dissolved in the water samples under certain water-chemistry conditions, and yet under different water-chemistry conditions, clay particles or colloids can precipitate from stream water onto the streambed, and colloids can be transported downstream for many miles. The colors of precipitates reflect the chemical composition of the water: Red and orange indicate presence of iron in the water; black and dark brown indicates manganese; blue-green, aqua-blue, and rust-brown indicates copper; yellow precipitates indicate sulfur and sulfates; and white precipitates represent aluminum (likely as aluminum sulfate). Plotting East Mancos data points on the stability field diagram for copper and iron compounds shows that the cupric ferrite in water from some sites was present in the dissolved phase (**Figure 2-16**). As the

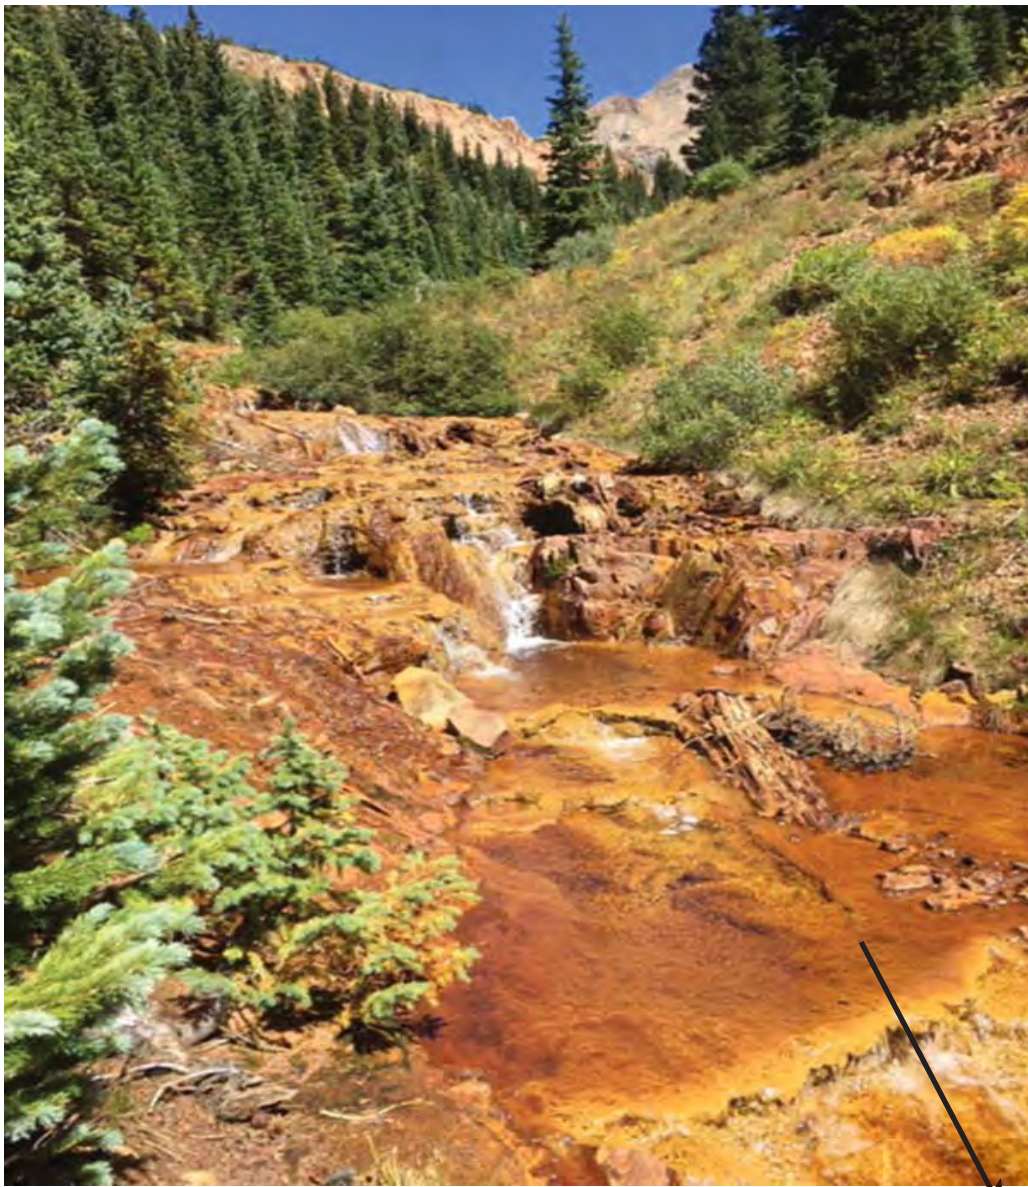
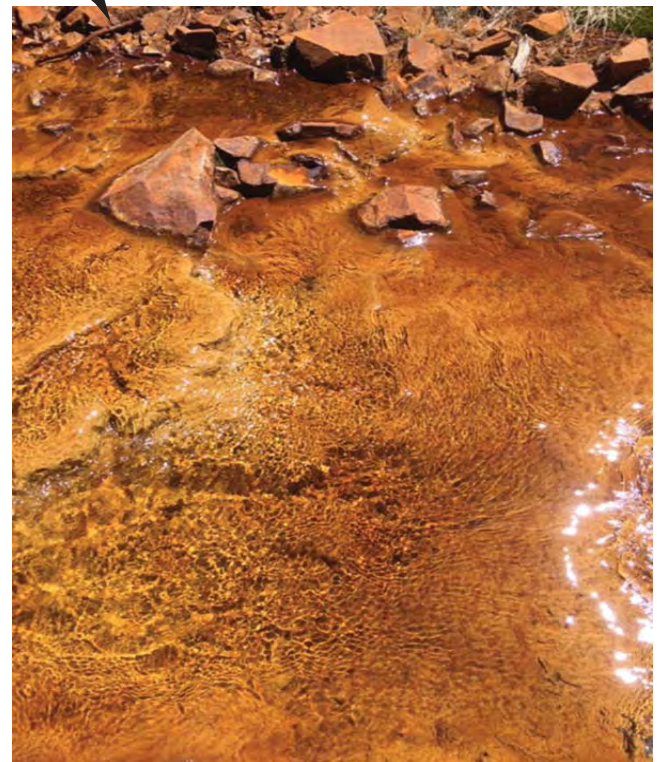
Figure 2-17A. East Mancos River downstream from Rush Basin showing voluminous amounts of copper and iron mineral precipitates on the streambed during low flow conditions of September 2018.

Figure 2-17B. East Mancos River downstream from Rush Basin showing red- orange, and copper-rust colored mineral precipitates on the streambed.

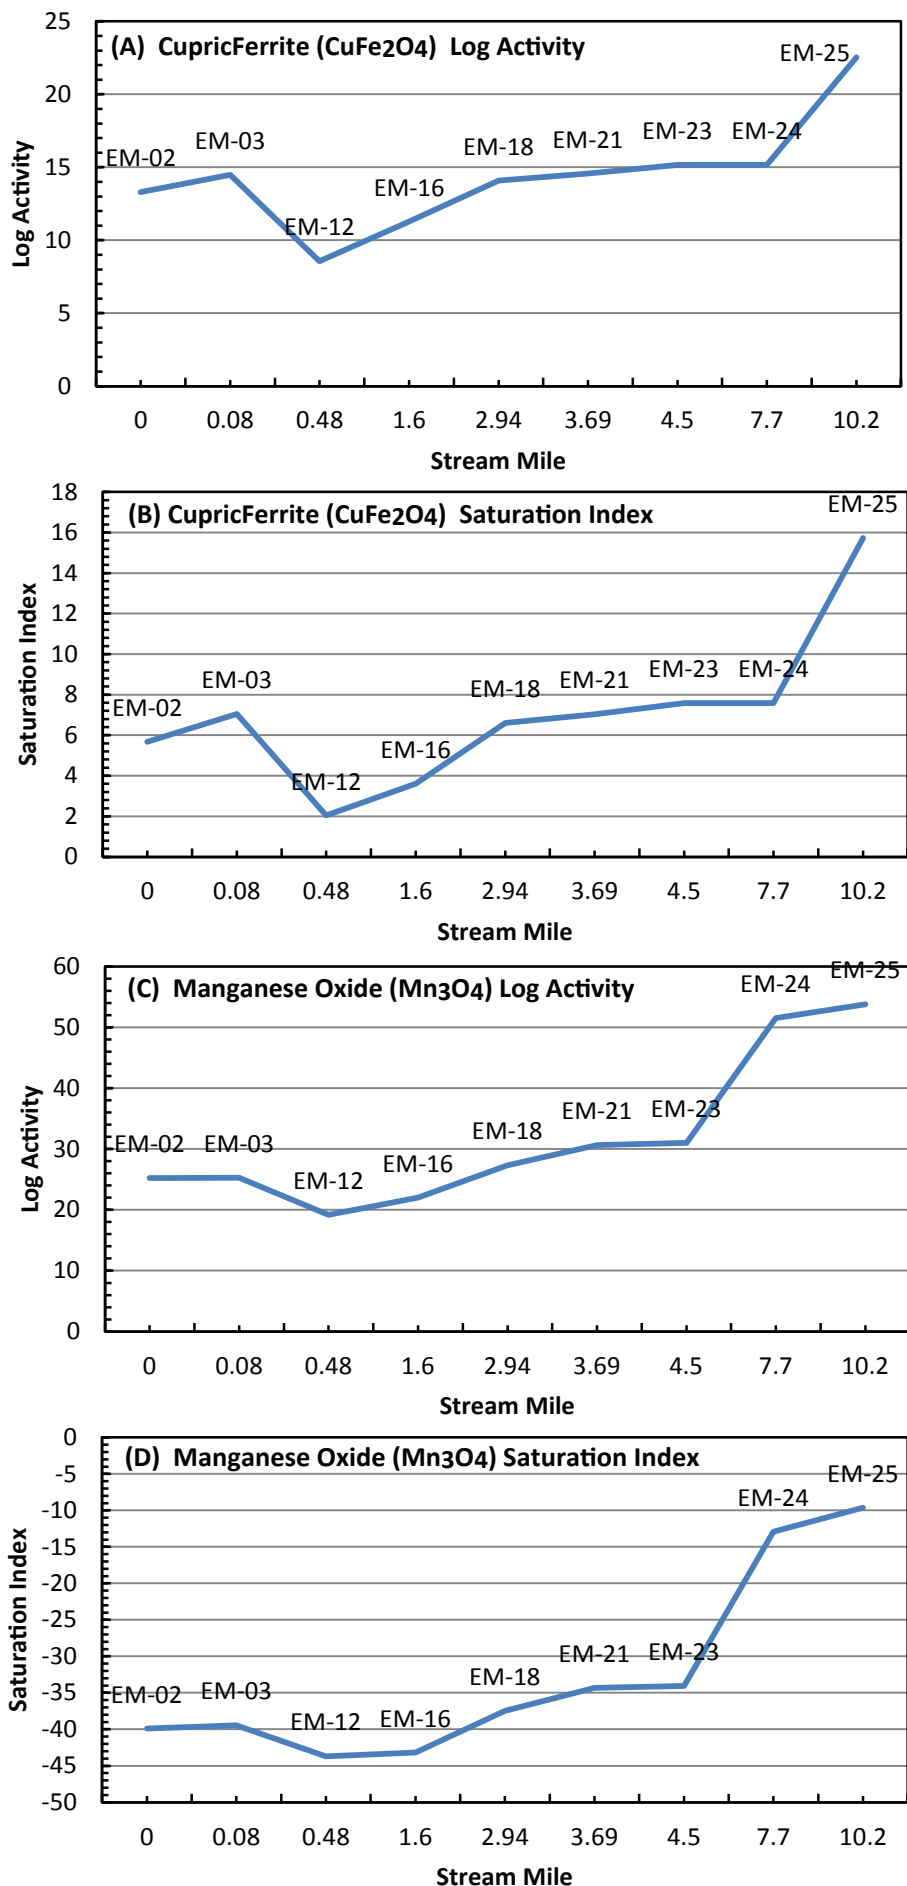
Figure 2-18. Longitudinal stream profile of cupric ferrite and manganese oxide log activity and saturation index, East Mancos River, low-flow samples September 2018.

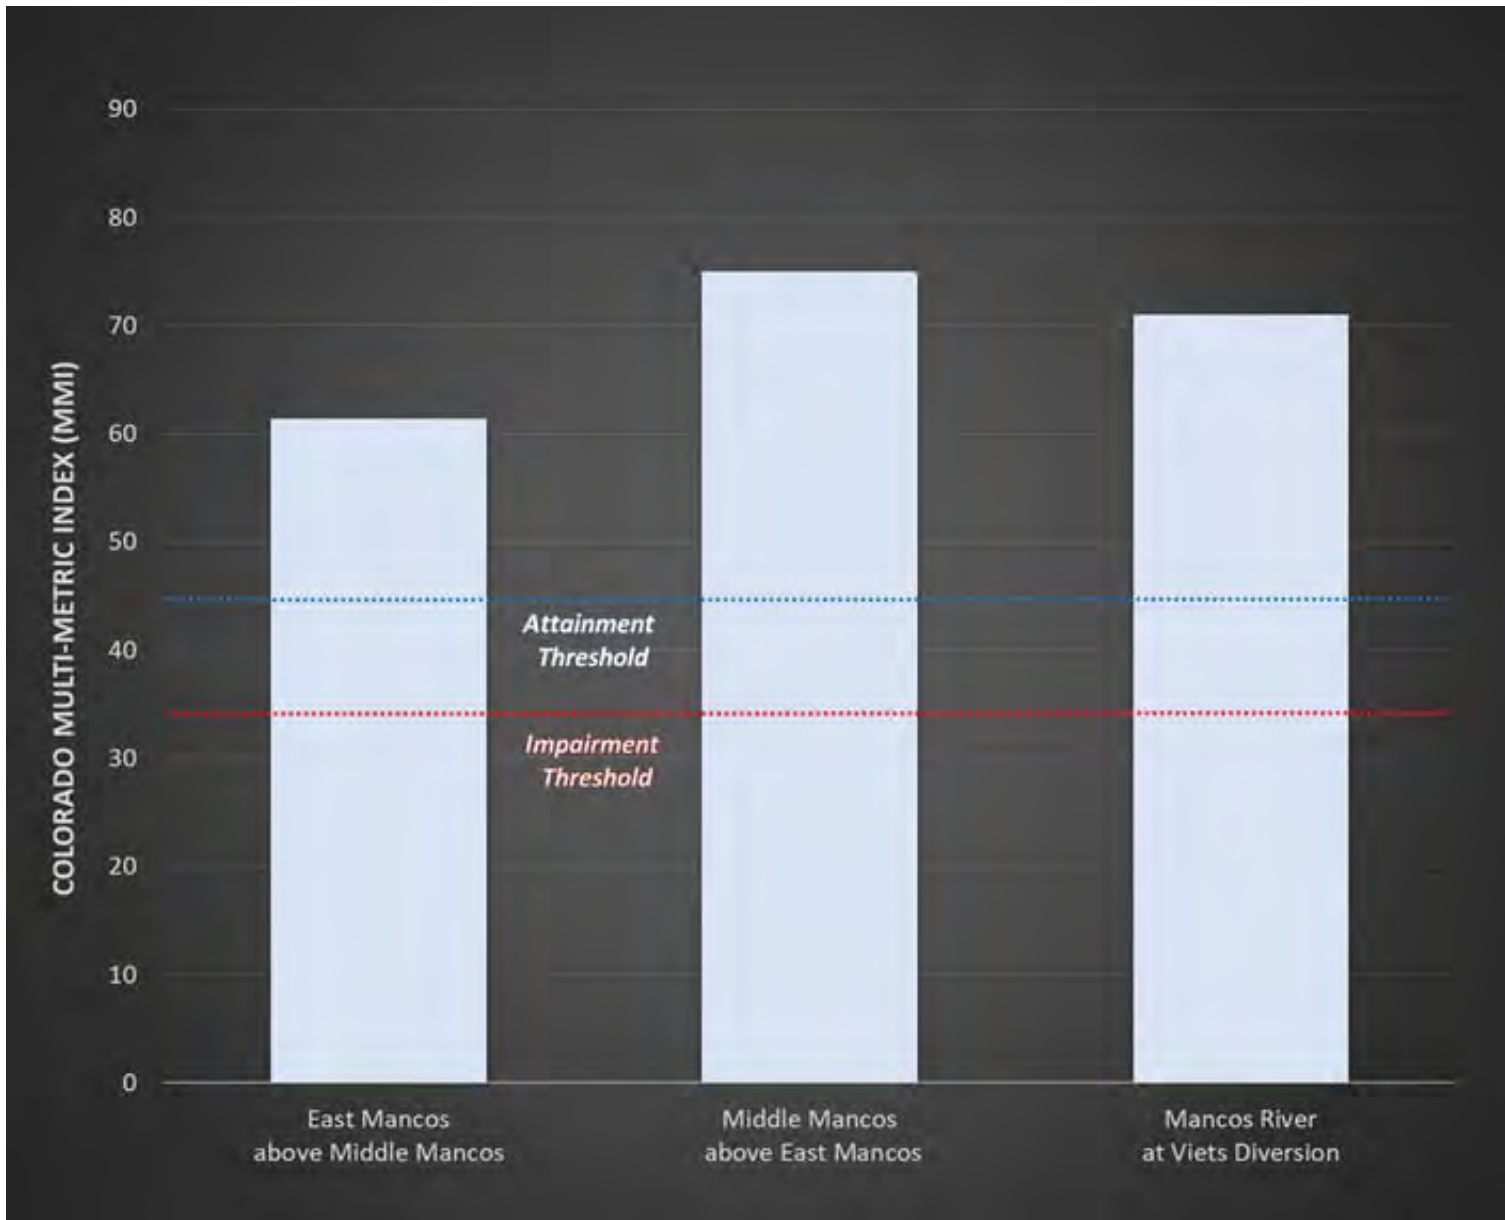
Figure 4-17. Colorado Multi-Metric Index (MMI) in the East Mancos River at mouth (site 25), Middle Mancos River (site 26), and Mancos River at Viets diversion, Sept-Oct 2019.

Comparison of observed water quality in the East Mancos River to water quality standards and toxicity thresholds clearly suggest that conditions are not suitable for aquatic life. The most recent information we have on the status of aquatic life in the East Mancos River is from a benthic macroinvertebrate survey conducted by Mancos Conservation District (MCD) in the fall of 2019. MCD used the Colorado River Watch sampling methodology to collect benthics from three locations: East Mancos above Middle Mancos, Middle Mancos above East Mancos, and Mancos at Viets Diversion. There are substantial differences in the diversity and abundance of benthic macroinvertebrates in the East Mancos compared to the Middle Mancos and downstream Mancos River location. The East Mancos River had extremely low benthic abundance, only nine individuals per square meter. In contrast, the Middle Mancos and Mancos River at Viets had more than 1,000 individuals per square meter (**Figure 4-14**). Diversity was reduced in the East Mancos as well, with fewer total taxa and lower diversity of Ephemeroptera (mayflies), Plecoptera (stoneflies), and Trichoptera (caddisflies) taxa, which are groups of macroinvertebrates known to be sensitive to, or intolerant of, poor water quality (**Figures 4-15 and 4-16**). These observations of lower abundance and diversity of benthic macroinvertebrates in the East Mancos as compared to the Middle Mancos are consistent with previous observations from 2009 (B.U.G.S., 2010). Mayflies are generally known to be particularly sensitive to elevated metal concentrations (Kiffney and Clements, 1993; Besser and Leib, 2007; Clark and Clements, 2006). In the East Mancos, only one mayfly taxa was present (and only two individual mayflies were found), while the Middle Mancos had nine mayfly taxa and the Mancos River at Viets Diversion had six. The mayfly families Ephemerellidae and Heptageniidae are known from the nearby Animas River watershed to be intolerant of elevated metals (Courtney and Clements, 2002; Roberts, 2017). Ephemerellidae and Heptageniidae were present in the Middle Mancos, but none were present in the East Mancos. Somewhat surprisingly, the large differences in abundance and density among sites were only minimally reflected in the Colorado Multi-metric Index (MMI) scores, which indicated that all three sites are in attainment for aquatic life use (**Figure 4-17**).
