## BACKGROUND

- During the summer of 2018, the 416 Fire burned 54,000 acres in southwest Colorado.

## RESEARCH QUESTIONS

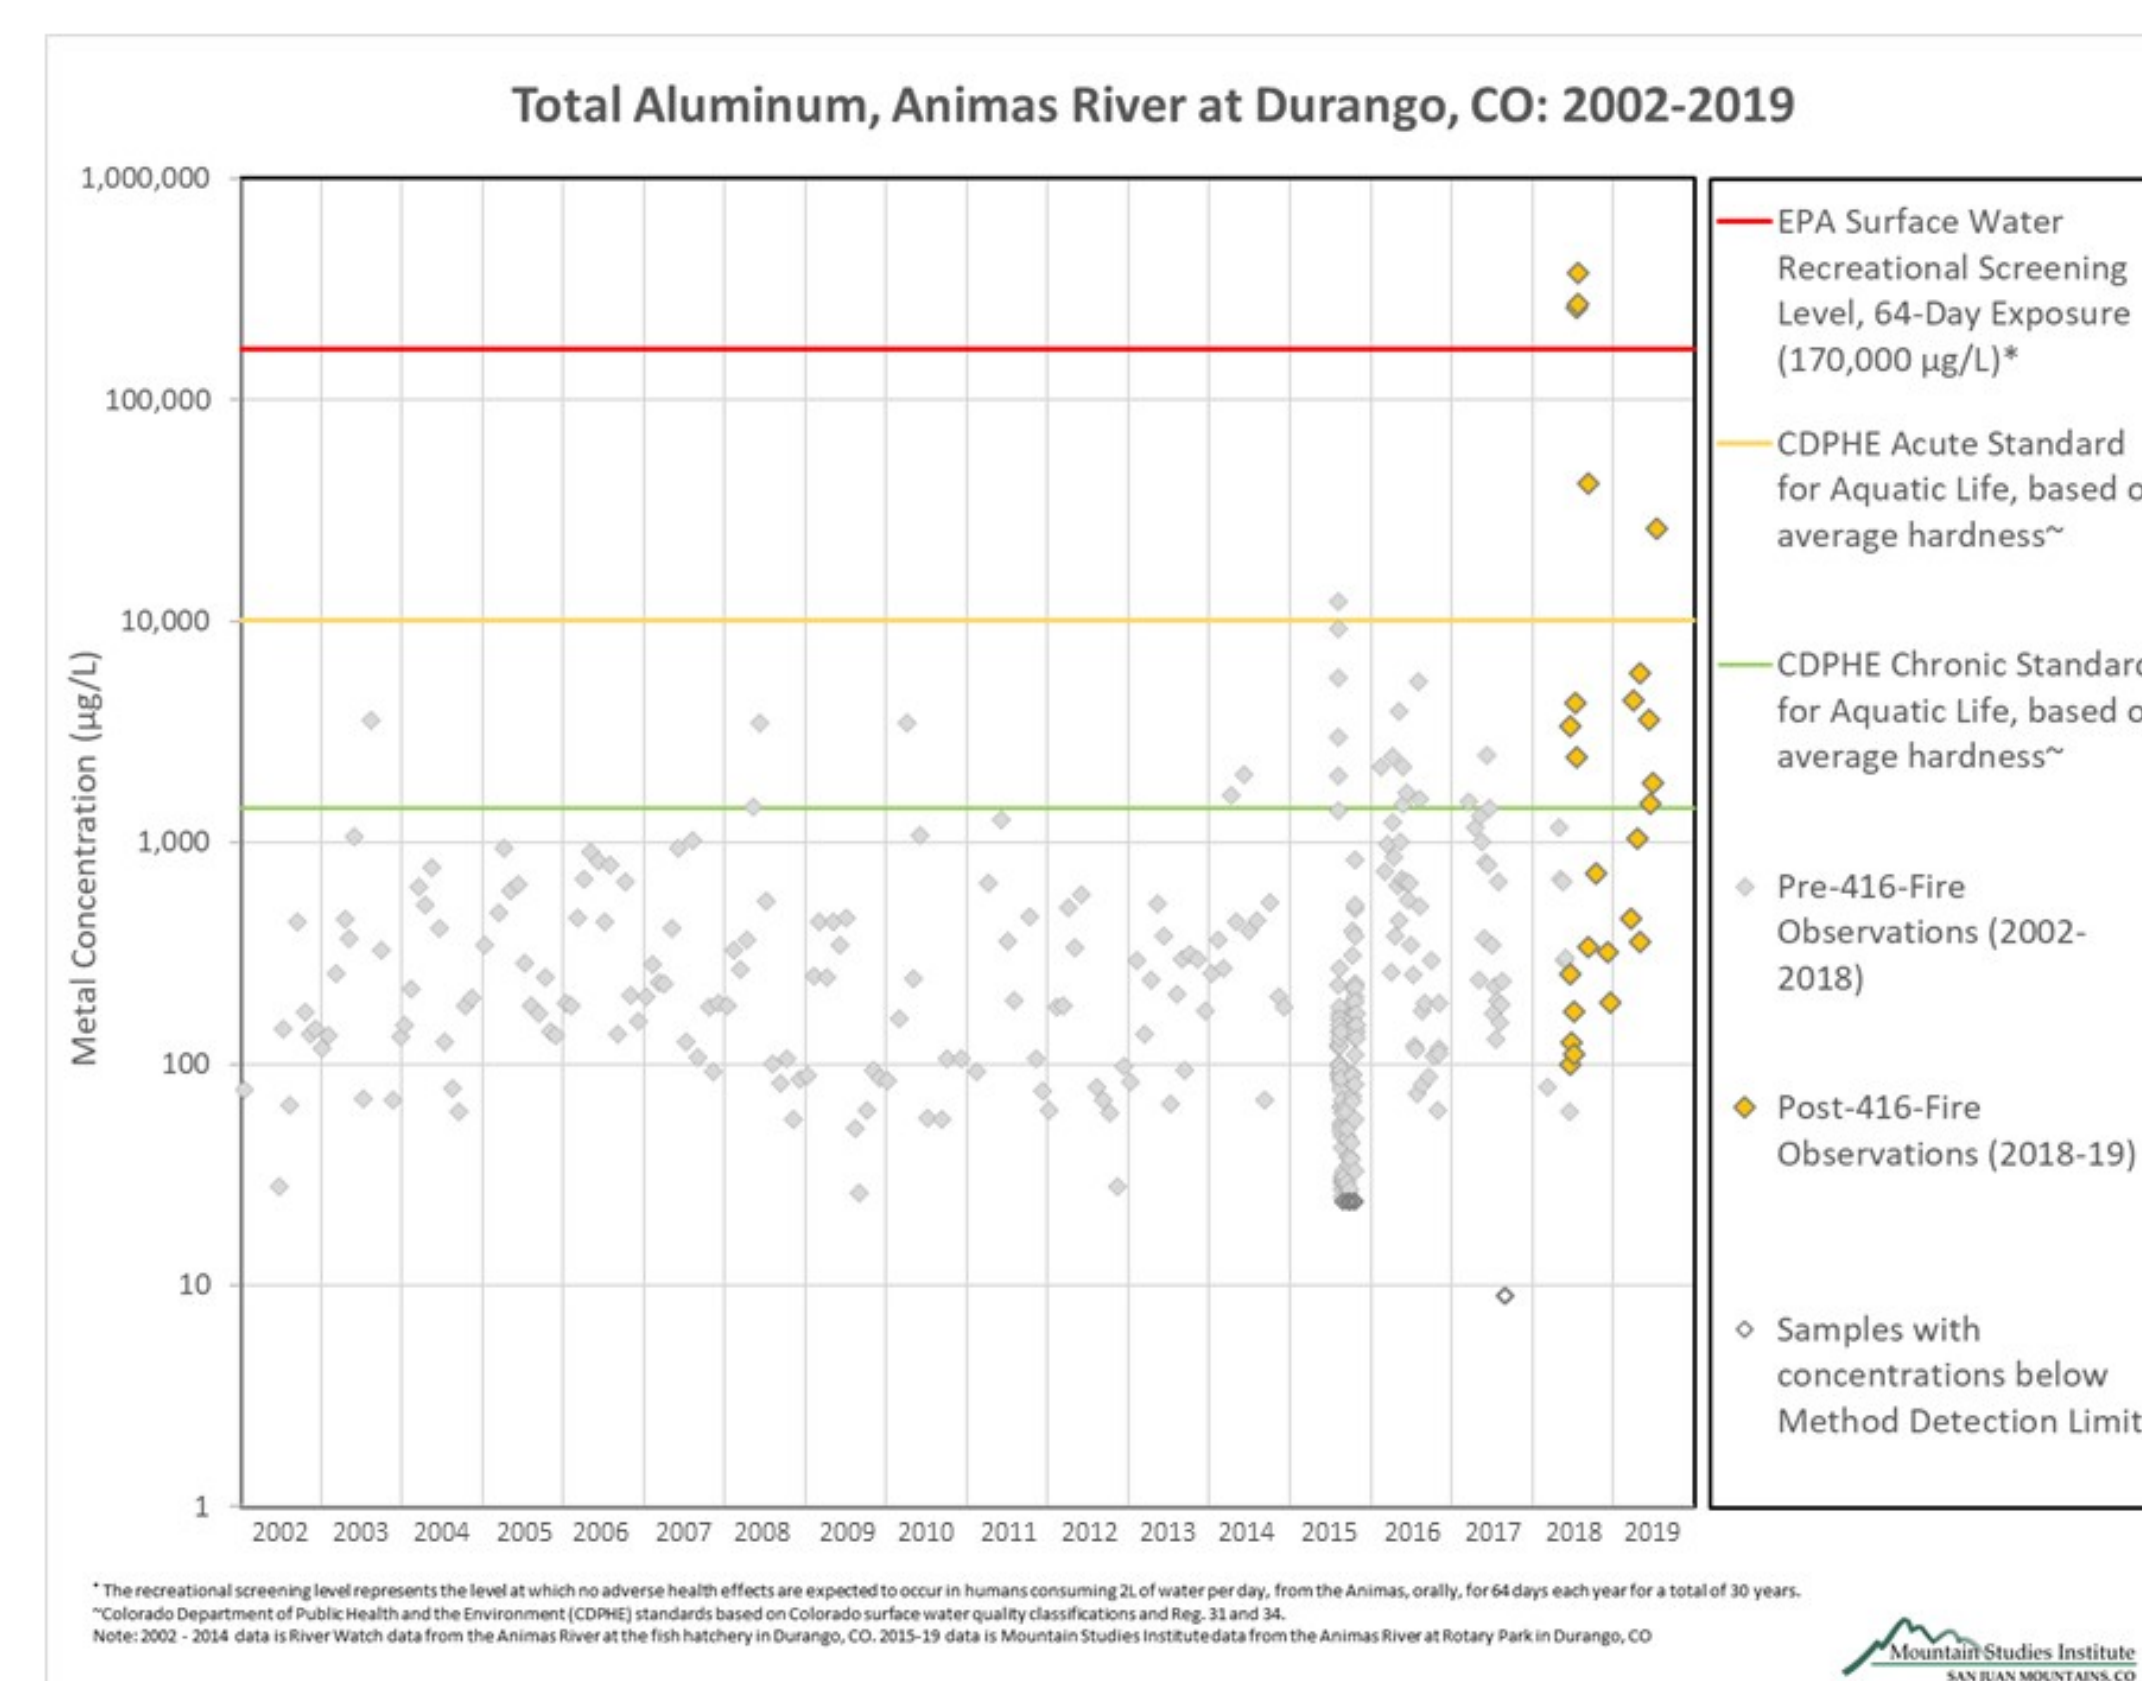
Pre- and Post-fire Aluminum

- Results from one year after the fire demonstrate that:
  - Runoff from the 416-burn scar during storm events caused elevated levels of nutrients, sediment, and metal concentrations. Levels of sediment likely were high enough to inhibit fish and insect gill function and smother habitat. Levels of aluminum, iron, and mercury were high enough to be of concern for aquatic life. Average total aluminum, iron, and lead increased by 54, 38, and 11-fold respectively following the fire.
  - Aquatic insect communities in closest downstream proximity to the burn area had reduced diversity and a shift in community composition toward taxa more tolerant of sediment.

- During storm events following the 416 Fire, we detected levels of total aluminum, iron, manganese, and mercury that were unprecedented in the almost twenty year water quality record for the Durango reach of the Animas River, including the 2015 Gold King Mine release.
