FUNCTIONAL ASSESSMENT OF THE MANCOS RIVER WATERSHED: MANCOS VALLEY AND ADJACENT AREAS

PETER STACEY
UNIVERSITY OF NEW MEXICO

Prepared Under Contract with the
Mancos Conservation District
Mancos, Colorado
April, 2007

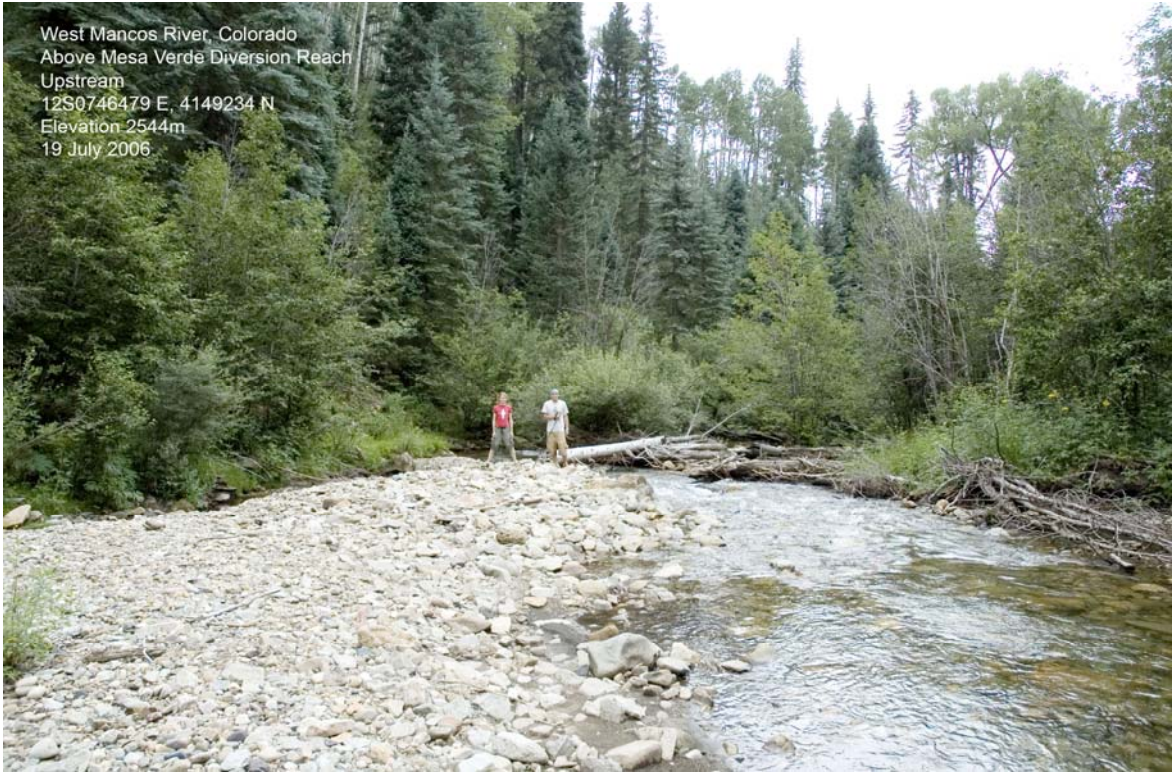
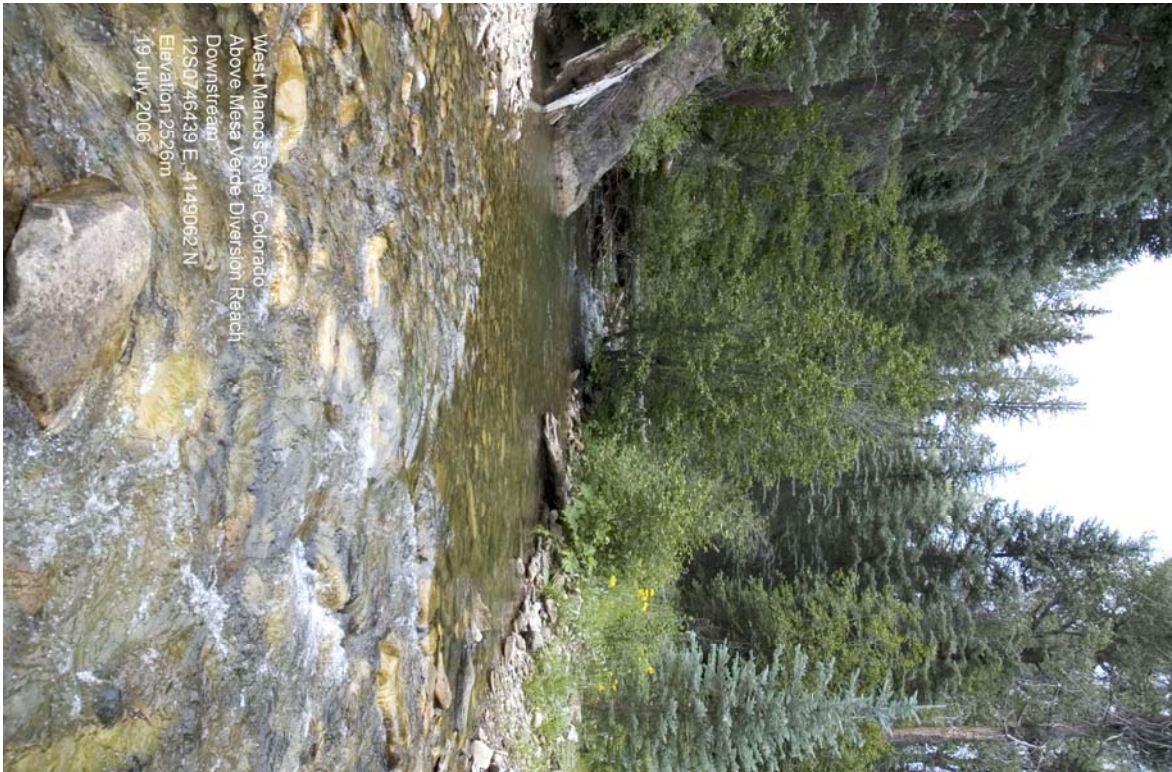
Figure 9. Reference Photos for the Above Mesa Verde Diversion Reach, West Mancos River.

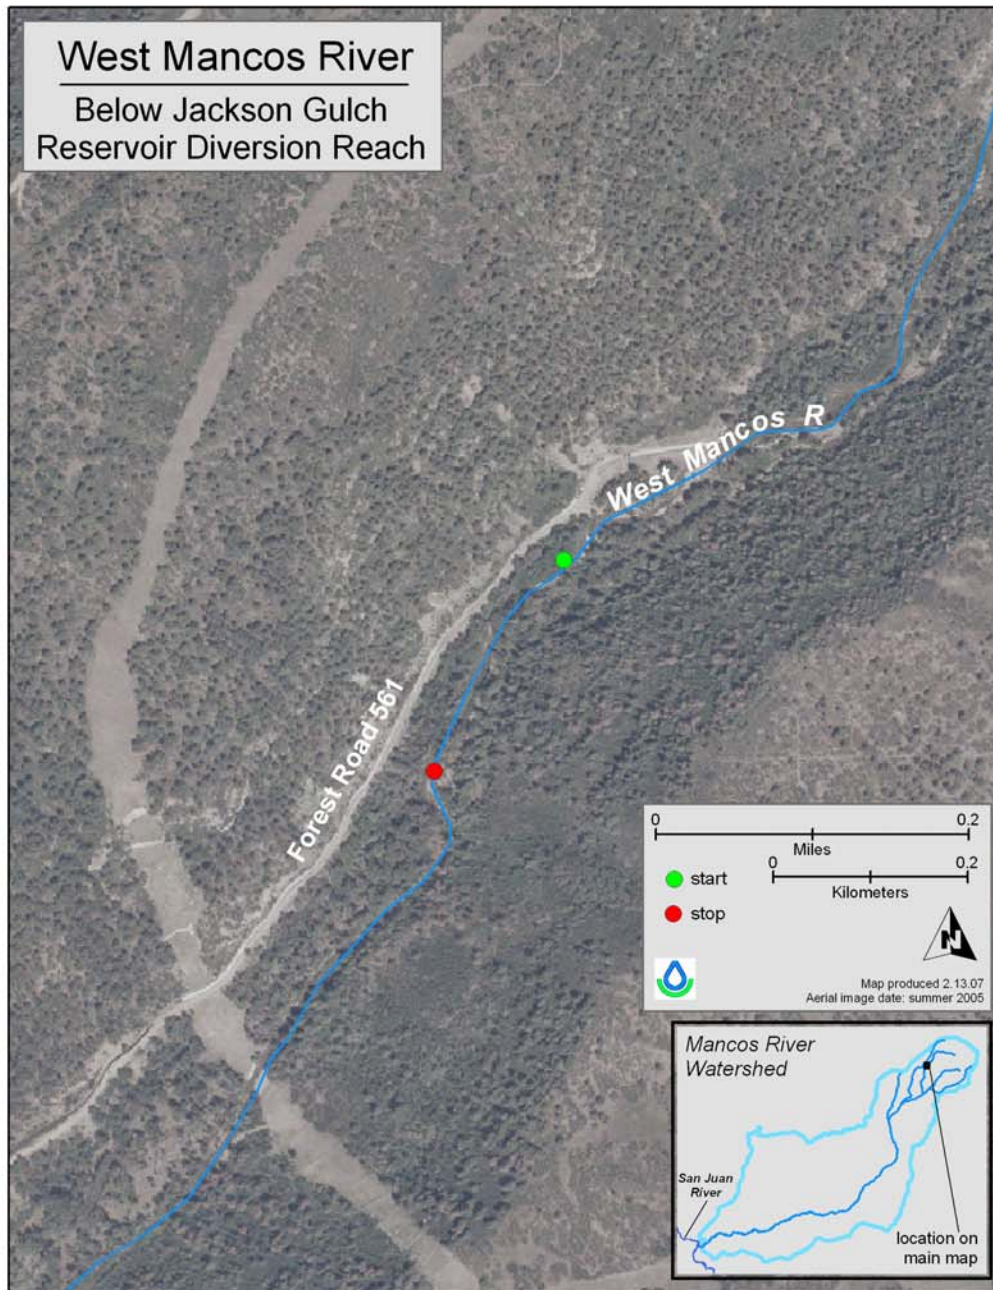
Figure 12. Aerial photo showing the location of the Below Jackson Gulch Reservoir Diversion Reach, West Mancos River (*photo compiled by Marianna Young*).

In the Hydrogeomorphology section, this reach received a poor rating for floodplain connection. This was due to the presence of a levee on the east side of the channel that resulted from the construction of the Mesa Verde Pipeline, and isolated the stream from its floodplain in this section. The stream channel itself is wide and shallow, also probably the result of pipeline construction. As a result, hydraulic habitat diversity was only good. However, where the pipeline was located away from the channel, below the assessment reach, hydraulic habitat diversity became excellent, and as would be expected for this geomorphic setting. Vertical bank stability and riparian soil integrity was excellent through the entire reach, reflecting the absence of livestock grazing, roads, or other impacts. There are no beavers in this reach, although the habitat would be suitable for them.

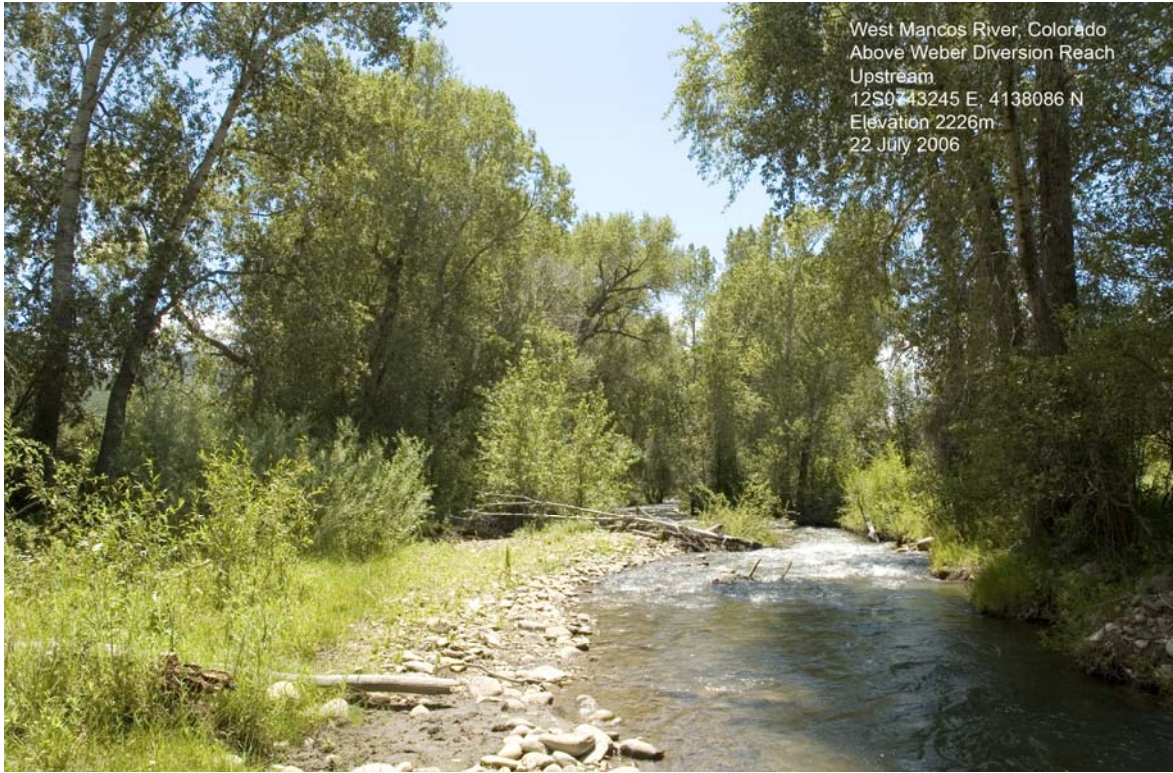
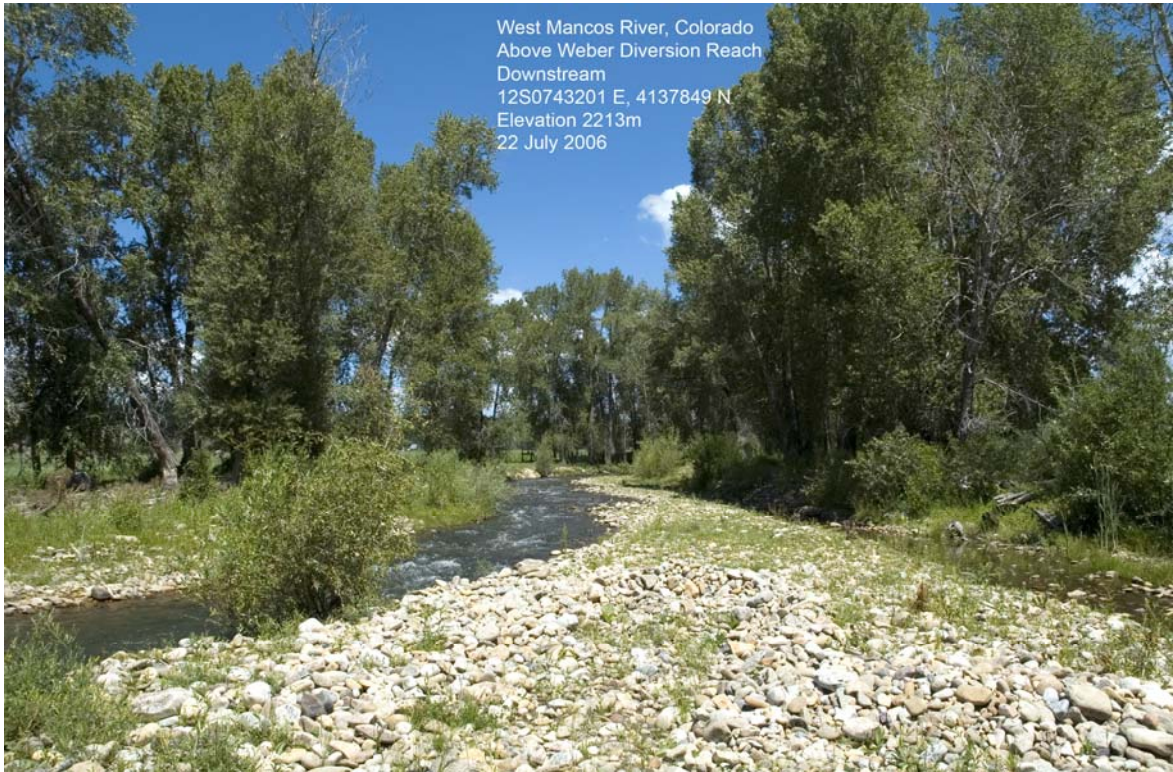
Figure 15. Reference Photos for the Above Weber Diversion Reach, Mancos River.

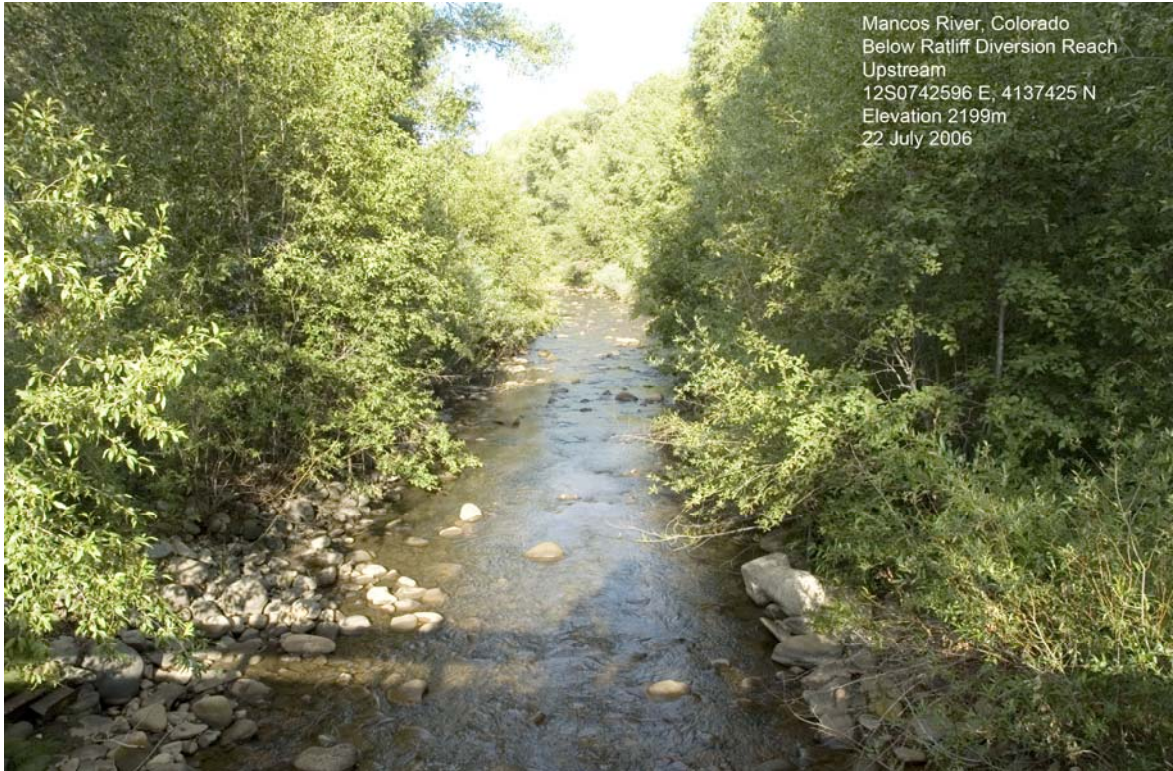
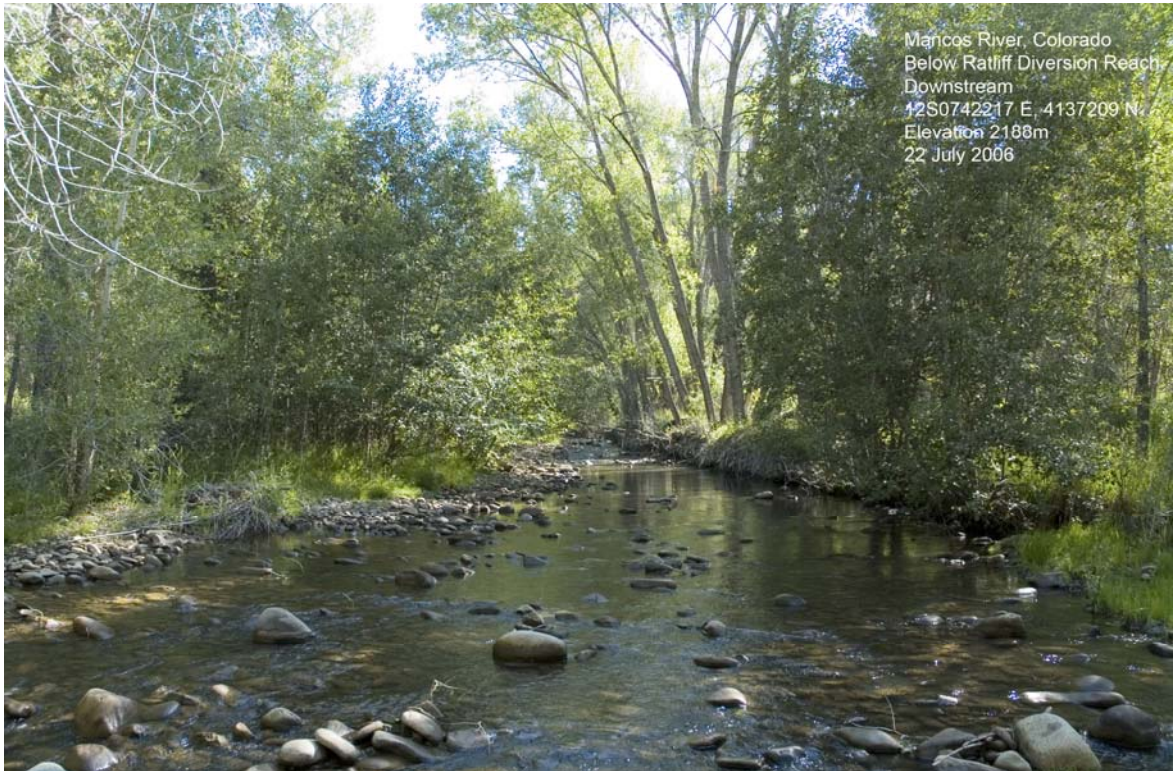
Figure 17. Reference Photos for the Below Ratliff Diversion Reach, Mancos River.

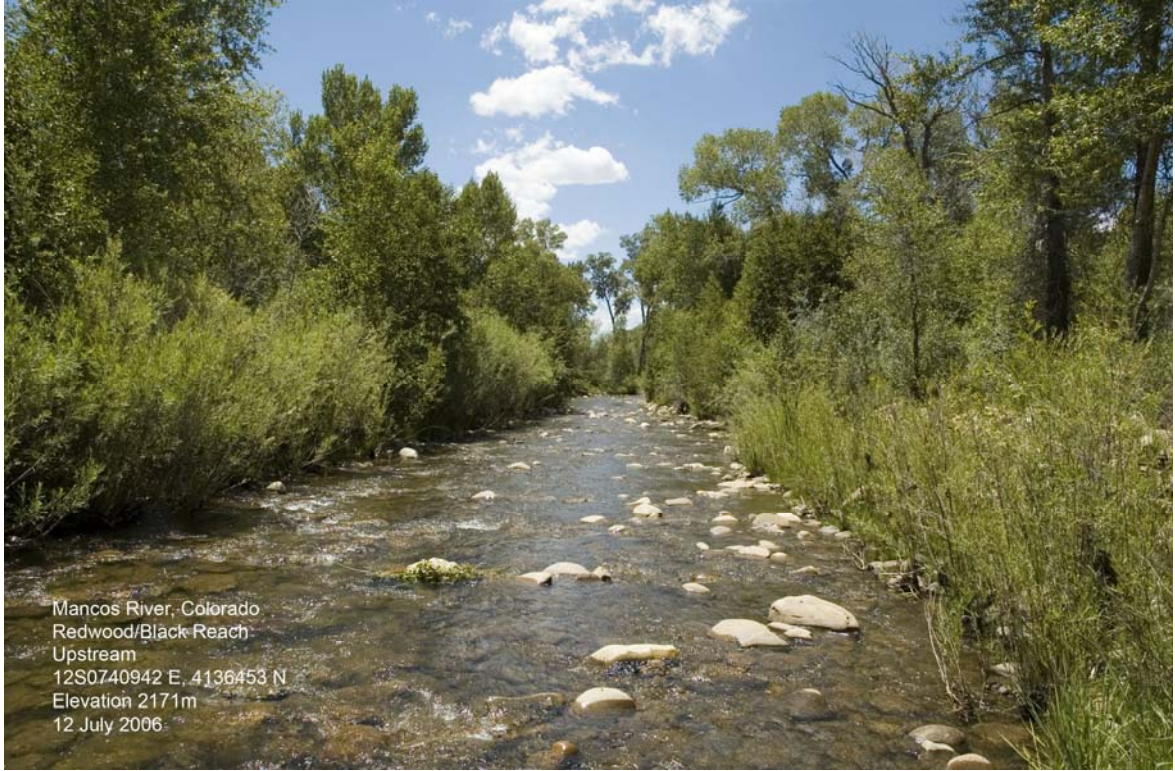
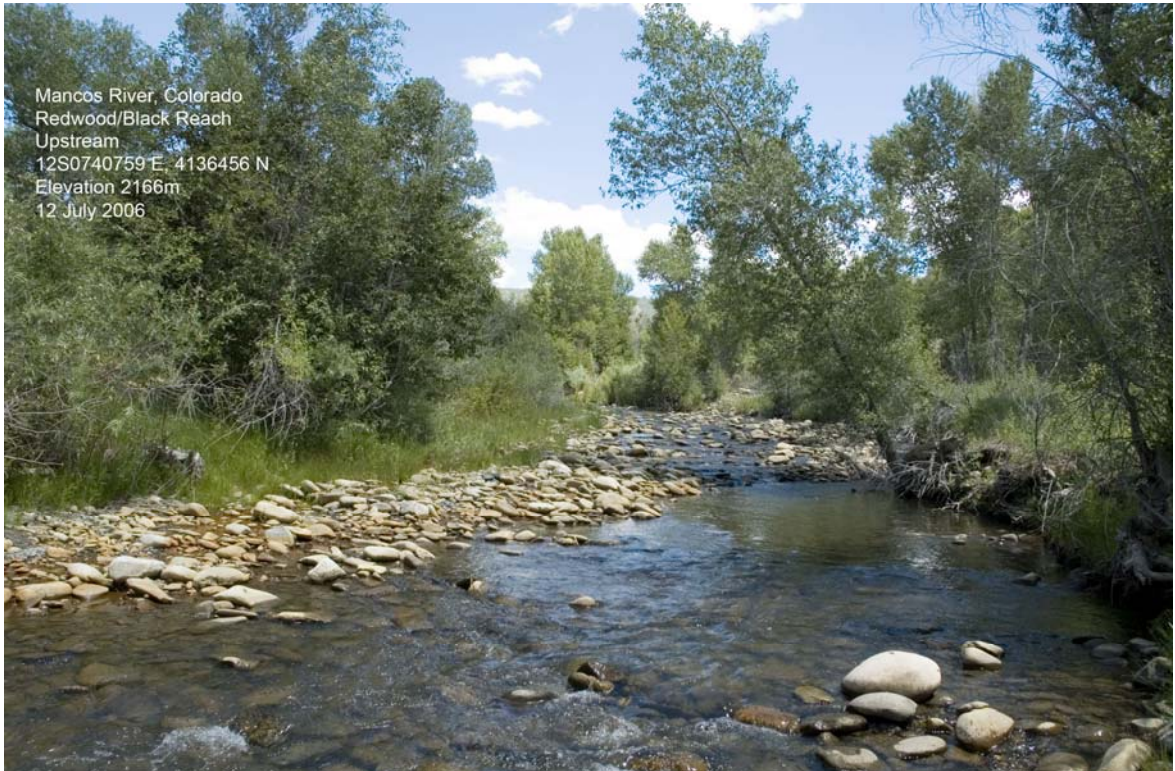
Figure 19. Reference Photos for the Redwood/Black Reach, Mancos River.

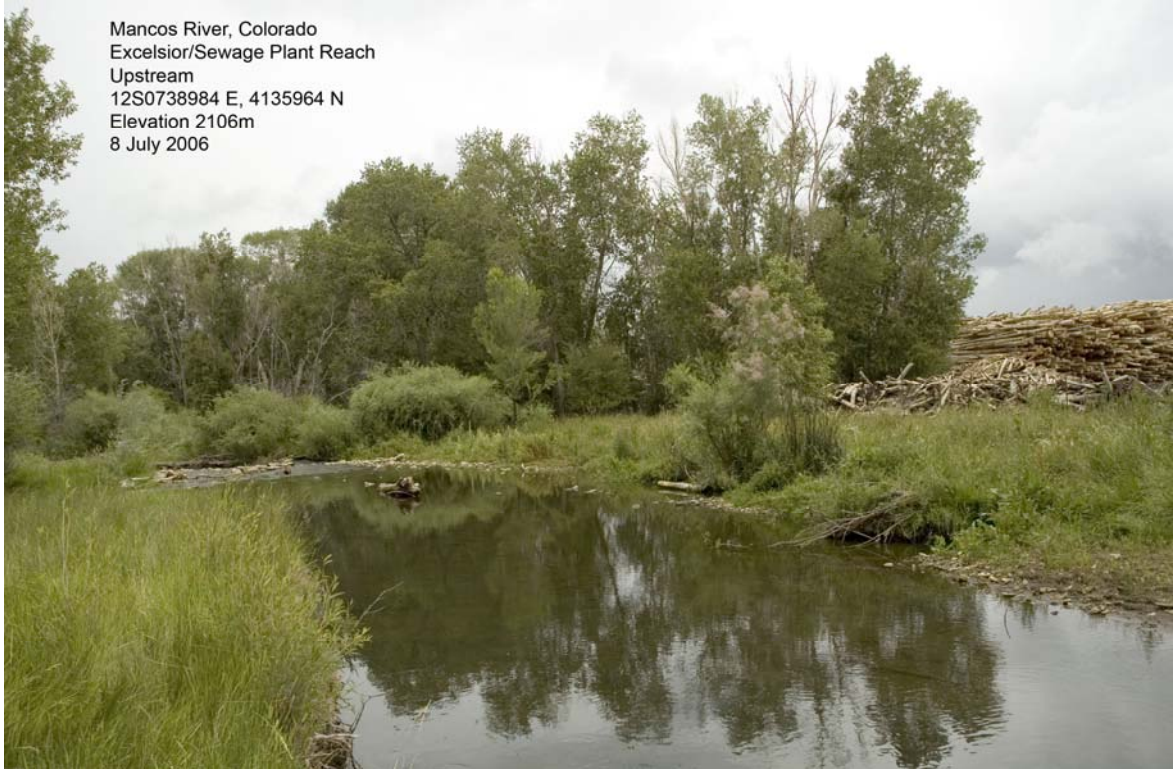
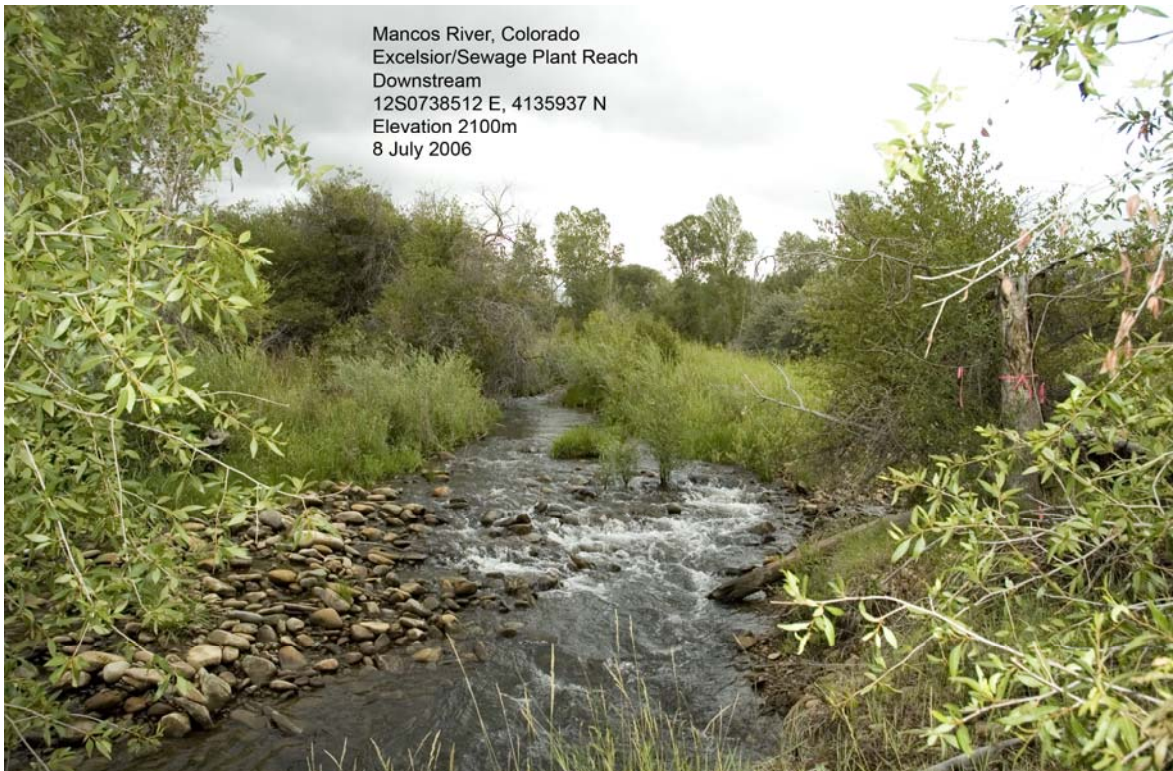
Figure 21. Reference Photos for the Excelsior/Sewage Plant Reach, Mancos River.

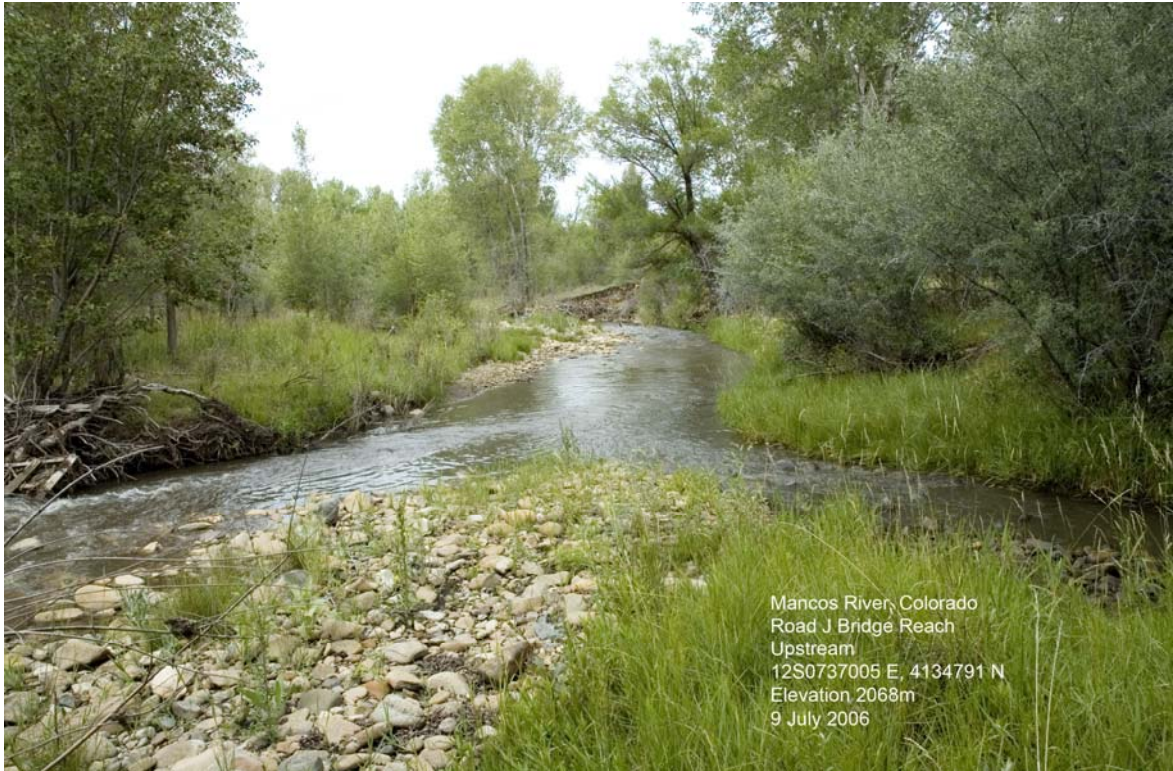
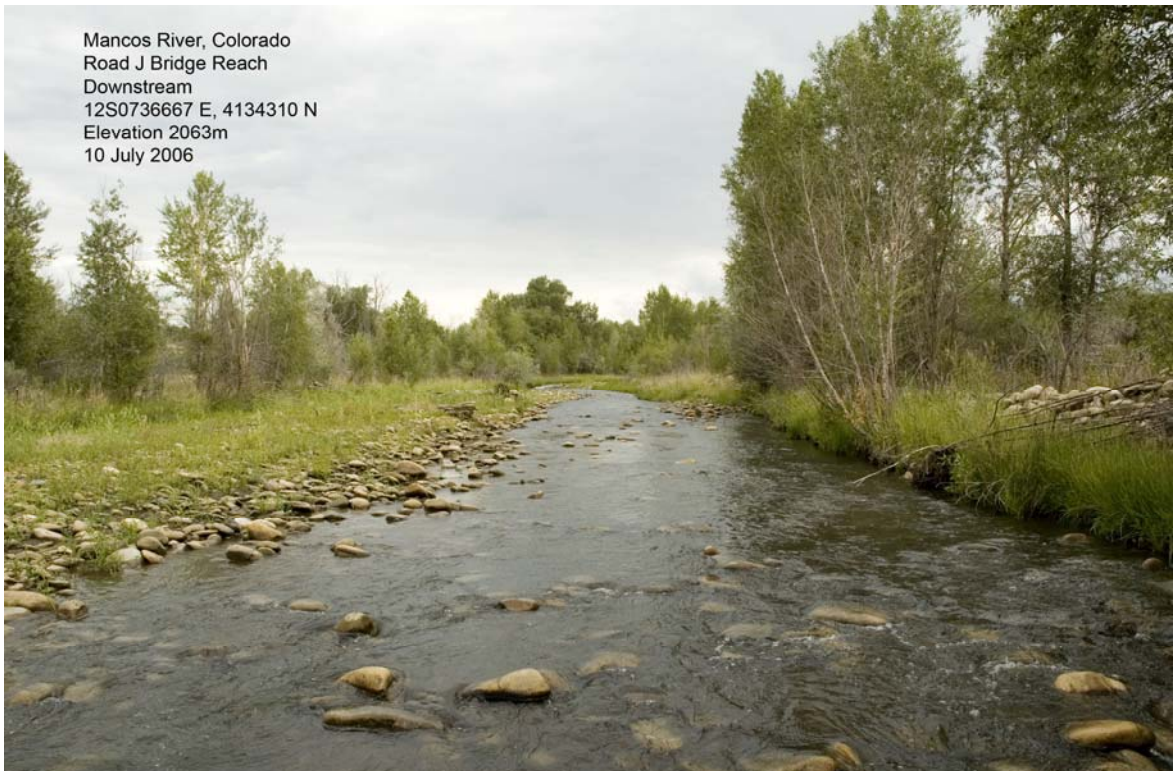
This reach is located just upstream from the Road J Bridge, and begins just below the confluence of Chicken Creek and the Mancos River. Chicken Creek at this point is highly modified and resembles an irrigation ditch. The channel of the Mancos River in this reach is wide and shallow, like many other reaches in the valley. Old cobble levees, one to two meters high, line the channel banks for most of the length of the reach. There are pastures in the historic floodplain on the south-eastern side of the reach, and mixed pastures and houses on the north-western side. The return of irrigation water has created side flows in the old floodplain, and the formation of wet meadows in some areas.

Algal growth was rated as good, but channel shading was only fair as a result of the lack of vegetation

Figure 23. Reference Photos for the Road J Bridge Reach, Mancos River.

along the cobble levees that line the channel. Water temperatures probably increase rapidly in this reach during sunny days.

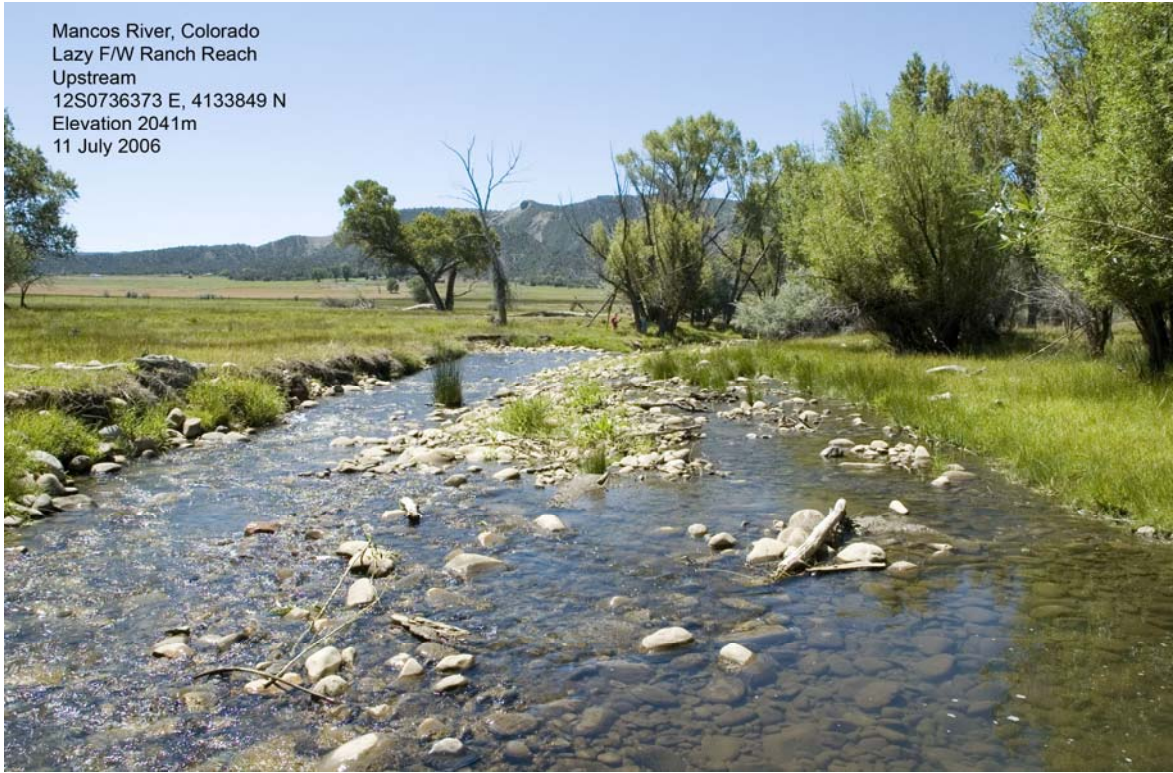
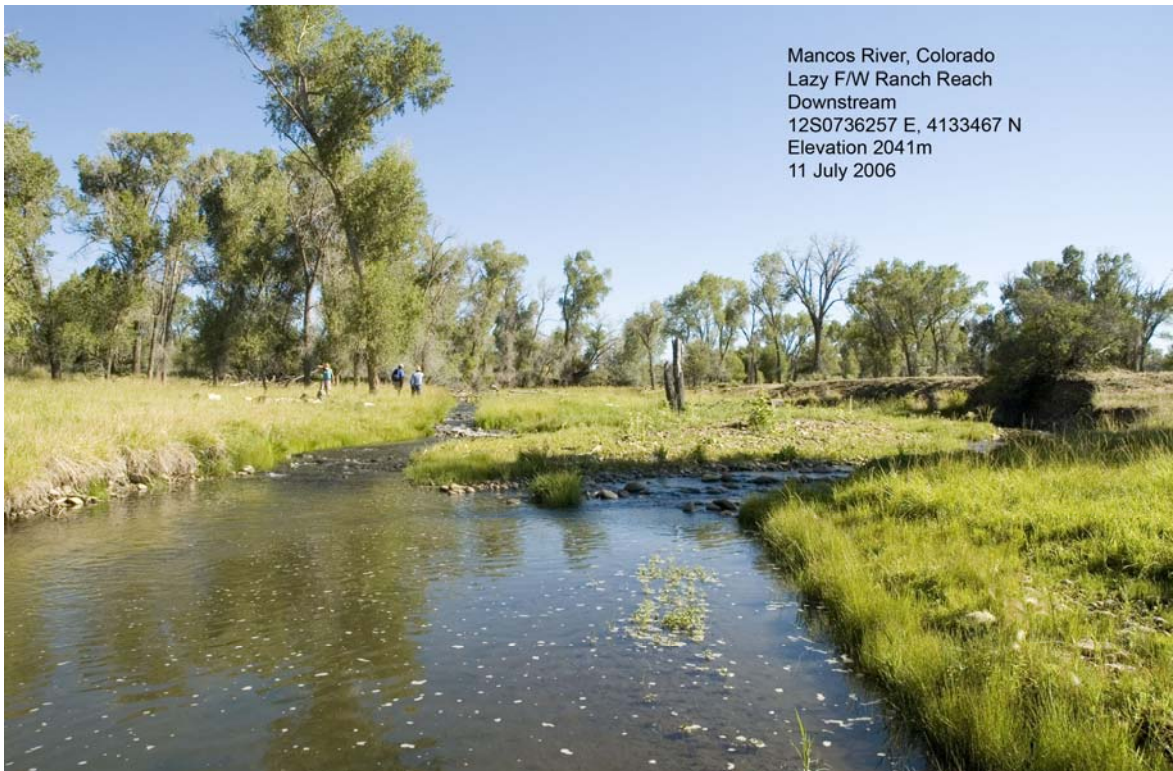
Figure 25. Reference Photos for the Lazy F/W Ranch Reach, Mancos River.

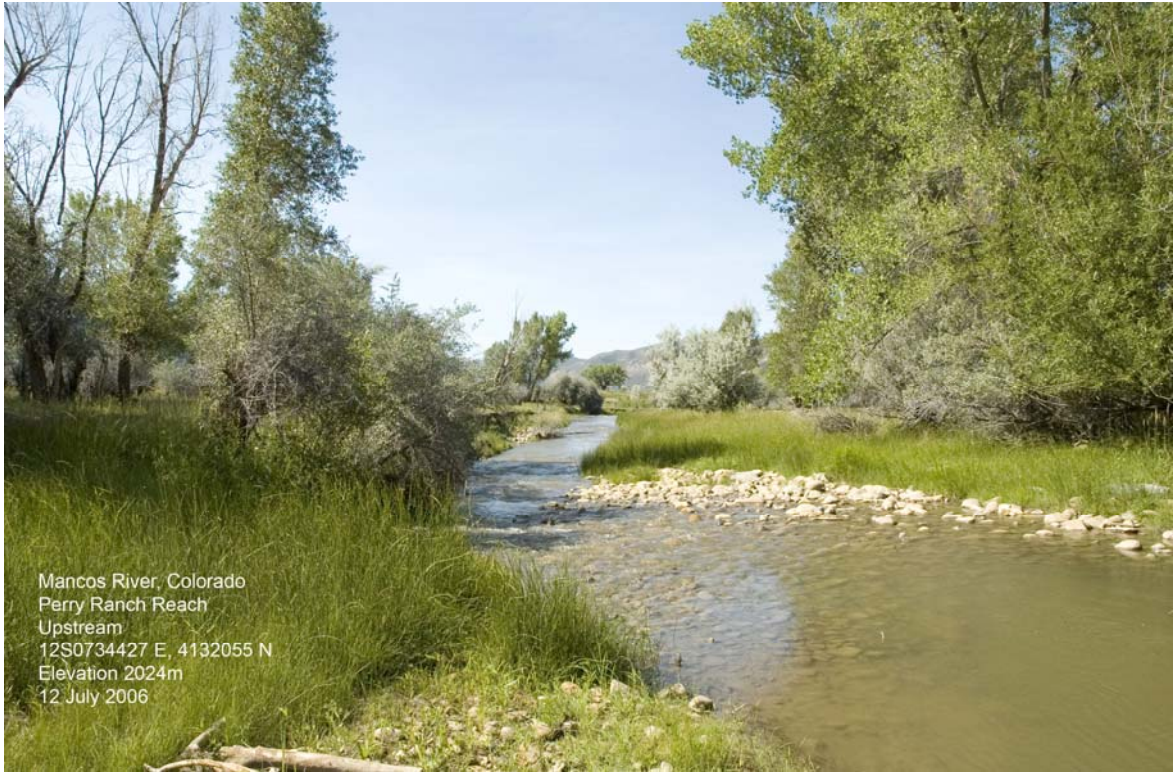
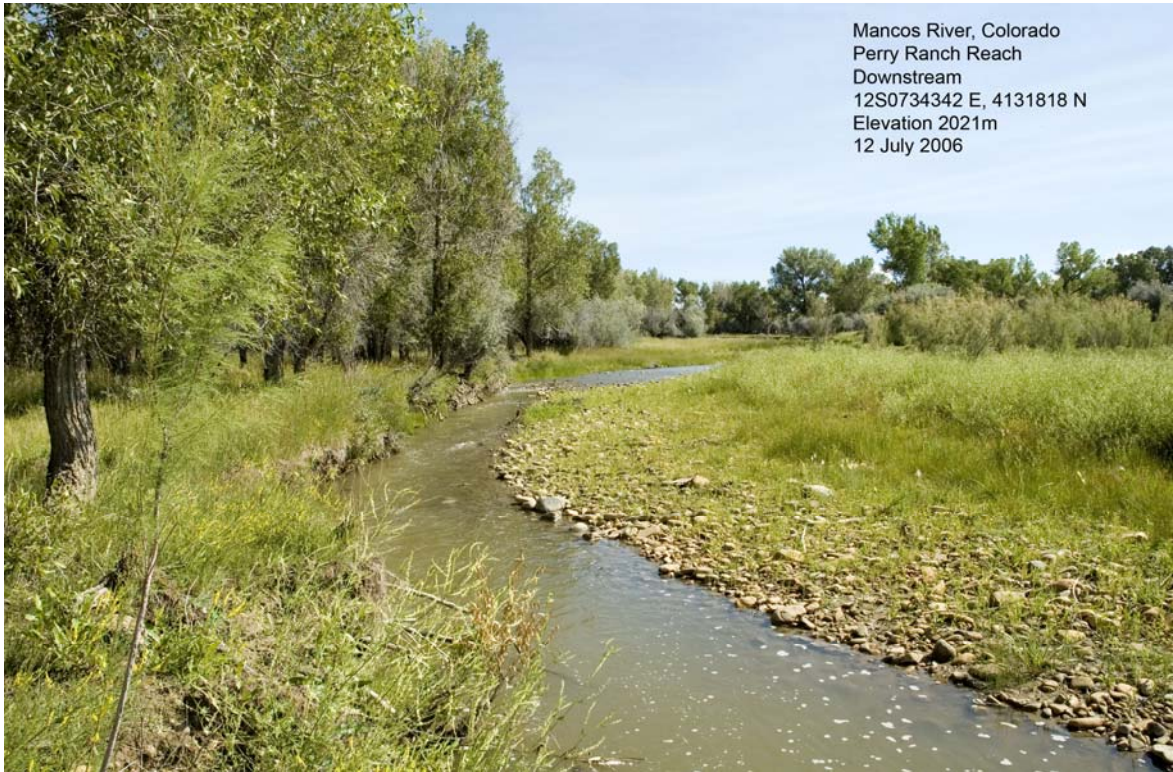
Figure 27. Reference Photos for the Perry Ranch Reach, Mancos River.

This reach is located on the Perry Ranch. The Mancos River at this point starts to turn north and south, before it enters Mancos Canyon. The ranch is an active livestock operation, and the floodplain on both sides of the stream had been grazed regularly in the years prior to the survey. The owners have discussed fencing off the riparian zone in the future. There are no levees in this reach. There is some return irrigation flow. On the west side, this has resulted in wet meadows at the base of the terrace forming the primary floodplain, and below the road. There are also wet areas on the east side, but these are generally above the historic floodplain.

Algal growth was poor, presumably as a result of nutrient input from livestock and possibly from

fertilizer. Solar shading was fair, as a result of only limited amounts of riparian vegetation along the stream banks.

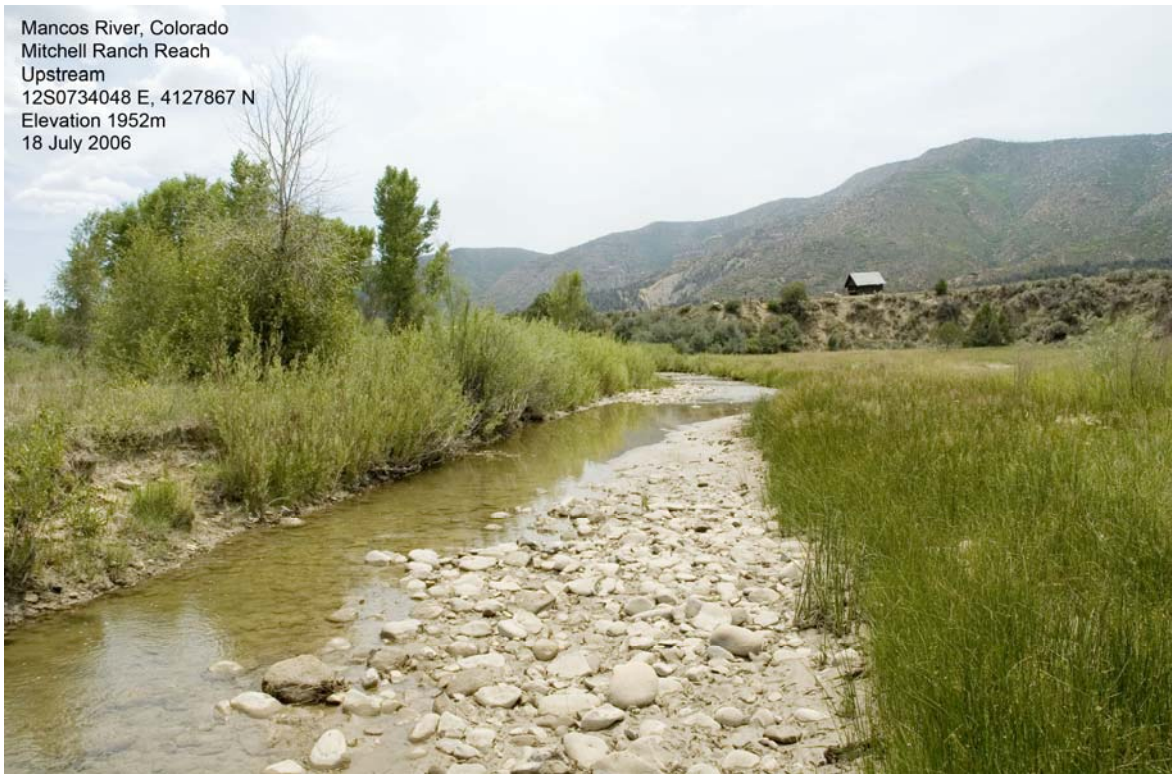
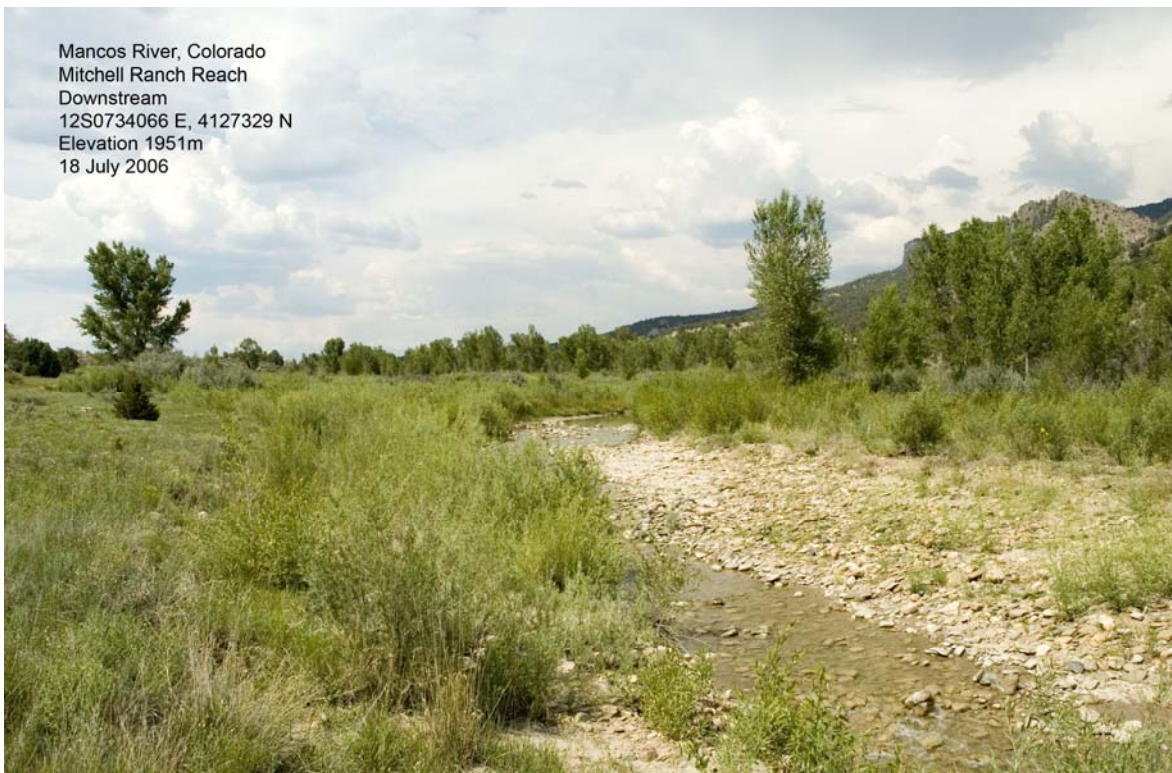
Figure 31. Reference Photos for the Mitchell Ranch Reach, Mancos River.

This reach is located in the lower portion on Mancos Valley, and is approximately 200 meters downstream from the confluence of Mud Creek and the Mancos River. Although the streambed is wide and shallow, it differs from the other reaches in this area in a number of ways. It is not channelized, there are no levees, and the channel itself is actively migrating. There are several meanders, as well as well-developed point bars (see Figure 29A). These features are absent from most other reaches. The riparian vegetation, particularly near the stream, is primarily native rushes and sedges. There are almost no shrubs or trees along the reach. There also are irrigation return flows, particularly on the east side of the floodplain, that have resulted in wet meadows and a cattail marsh in one area. Sheep graze portions of the floodplain, and there also appears to be heavy use of this reach by mule deer. The landowner has added rock erosion control structures in several areas in an effort to limit channel migration.

Hydrogeomorphology was variable. Vertical bank stability along the reach was excellent, indicating that the high levels of sedimentation (see below) were not originating locally. Riparian soil integrity was also excellent, possibly reflecting the current lack of use by livestock. However, floodplain connectivity and beaver activity were poor (the reach would be suitable for beavers when there are sufficient flows), and hydraulic habitat diversity was only fair. There was little active channel migration as was observed upstream on the Soussanna Ranch reach.

Fish and aquatic habitat ranged from good to poor. Pool distribution and overbank cover was good, but underbank cover was limited (fair) and there was no woody debris (poor). Cobble embeddedness was high (46% or a score of fair), and similar to the most downstream sample value in the Soussanna Ranch Reach that is upstream from this location. No aquatic macroinvertebrate insects were observed. There were a few crawfish at the sample sites, and several small unidentified fish were observed elsewhere along the reach.

The riparian vegetation appears to be recovering after a history of heavy grazing. Lower and upper riparian zone vegetation coverage averaged a rating of good, but this was due exclusively to grass/forb and shrub coverage. There was no cover from middle or upper canopy trees in the sample transects. Shrub and tree demography was very good; seedlings were present for both categories, and the only age classes missing were old clumps or snags in both cases. Non-native grass and forb cover was very high (estimated at 70% of total coverage, a rating of poor), but there were very few non-native shrubs and trees. The latter situation is very atypical of similar reaches in the American southwest, where saltcedar and Russian olives are normally very common along streams that have had a long history of grazing as well as the other characteristics of this reach. The levels of current grazing and browsing both received excellent scores, reflecting a lack of use of the riparian zone at the present time by both domestic livestock and native ungulates in this reach.

Terrestrial wildlife habitat was variable, ranging from fair (middle canopy trees) to very good (shrub patches). Fluvial habitat diversity was poor, which probably reflects a lack of channel migration along this reach in the past. However, if current conditions continue, this important fluvial process is likely to reestablish itself within the reach.

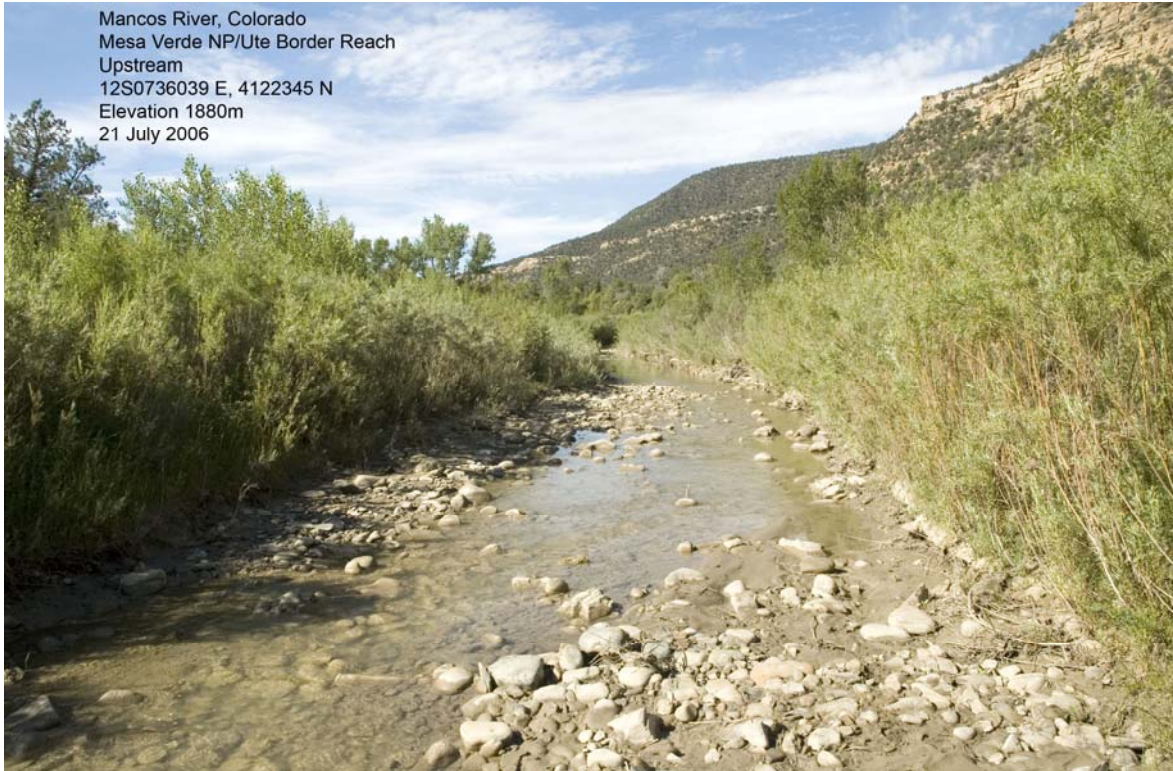
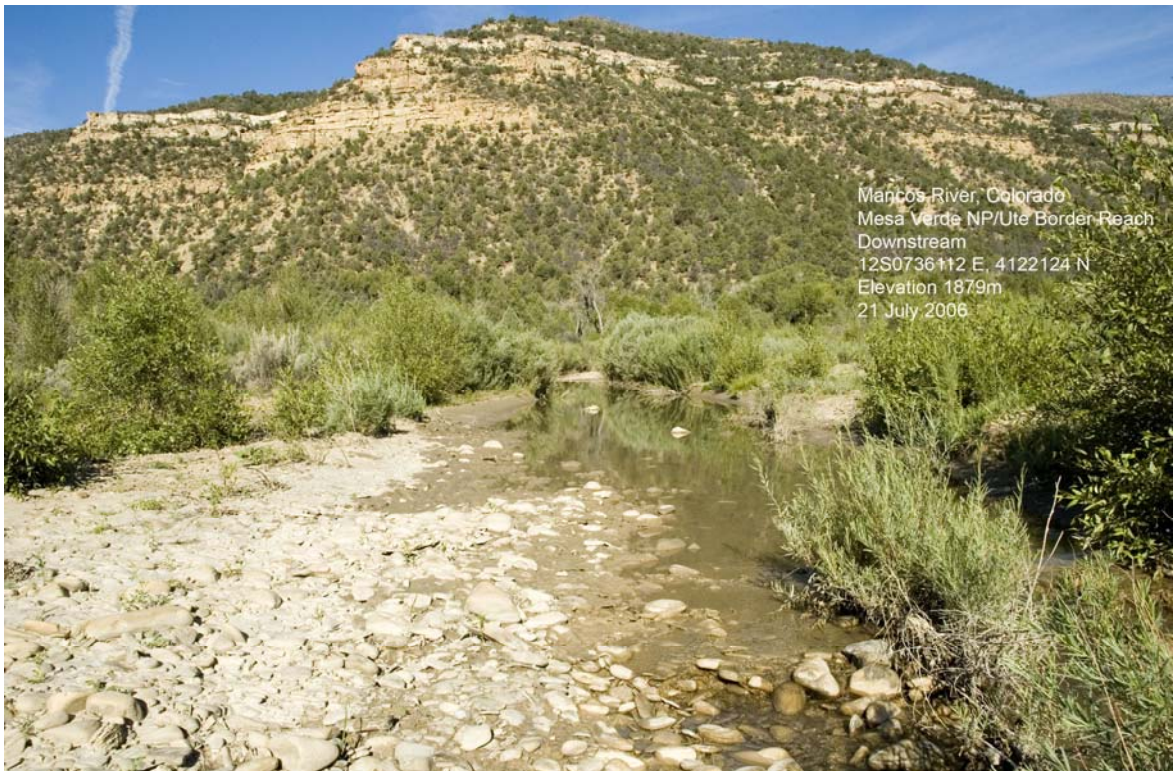
Figure 33. Reference Photos for the Mesa Verde NP/Ute Mountain Ute Indian Reservation Border Reach, Mancos River.

This reach is located within Mancos Canyon, on Mesa Verde National Park lands just upstream from the mouth of Weber Canyon. Weber Canyon is a major drainage that enters the river from the east, and it contains a number of ranches and irrigated pastures. At the time of the assessment, there was little water entering the Mancos River from Weber Canyon. The river here is very low gradient relative to reaches upstream (estimated at 1 meter drop over 200 meter channel length). The width of the flood plain in this section of the canyon is variable; at the assessment reach it was at least 100 meters wide. The stream itself is wide and shallow. There are no levees

and the channel is actively migrating. There are the expected numbers of meanders and point bars. There is considerable sediment in the stream, and many of the cobbles are embedded in a matrix that is dark and presumably contains charcoal from the recent wildfires in Mesa Verde National Park. This matrix was very cohesive, and formed a type of “pavement” along the bottom of parts of the channel. This may have a long-term impact on the health and recovery of the stream. Personnel from the Park indicated that an active program to remove exotic shrubs and trees had recently been completed along this reach. This effort has been successful, as only one individual saltcedar was observed in the survey area. This section of the canyon historically has been used by domestic livestock, but the Park does not allow grazing at the present time. However, there were numerous signs of trespass grazing in the reach at the time of the assessment.

Fish aquatic habitat ranged from poor to excellent. Pool distribution and overbank cover were both excellent (the latter score was the result of dense patches of willows that lined the bank of most of this reach). Cobble embeddedness was poor (68%) and no macroinvertebrate insects were found in the reach. A number of crawfish, and a few small unidentified fish, were observed in the stream. There was no large woody debris—the reason for the absence of this material was not clear given the forested slopes of the canyon and the presence of some large cottonwoods in the flood plain. Underbank cover was rated as fair.
