FUNCTIONAL ASSESSMENT OF THE MANCOS RIVER WATERSHED: MANCOS VALLEY AND ADJACENT AREAS

PETER STACEY
UNIVERSITY OF NEW MEXICO

Prepared Under Contract with the
Mancos Conservation District
Mancos, Colorado
April, 2007

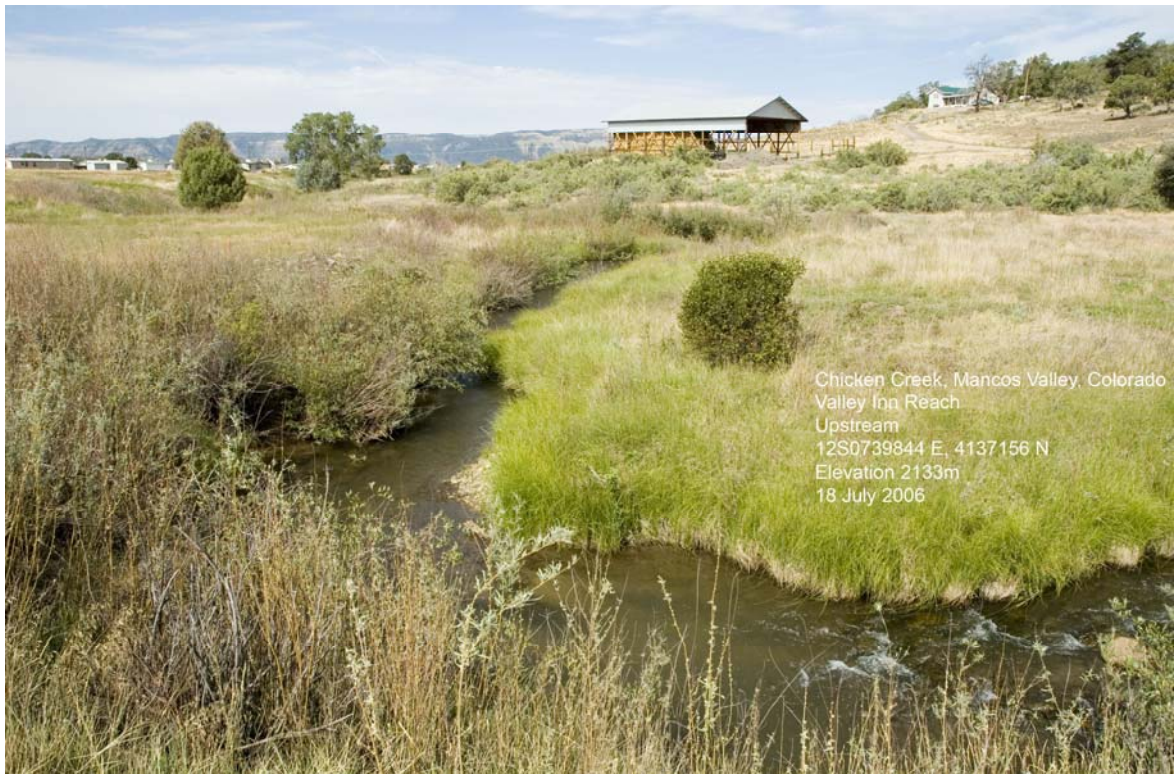
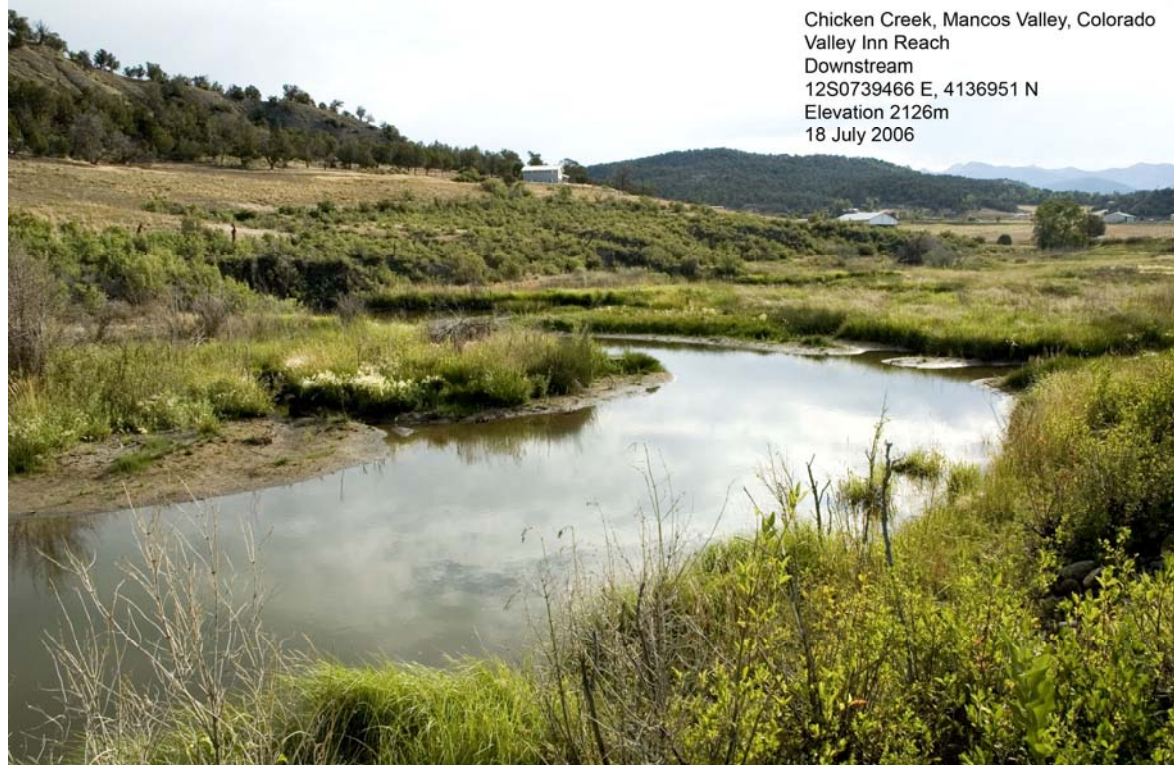
Figure 35. References Photos for Valley Inn Reach, Chicken Creek.

Chicken Creek is a tributary of the Mancos River. It drains a watershed located primarily to the north and west of the town of Mancos, and west of the West Mancos River. It joins the main Mancos River southwest of the town (Figure 4). The assessment reach was located where Chicken Creek enters the Mancos Valley, at the northern edge of the town of Mancos. The floodplain and areas surrounding the reach were part of a ranch, and were probably heavily grazed in the past. At the present time, much of the

historic floodplain on the south side of the reach is being prepared for a housing development. Chicken Creek is not a very large stream, and there are a number of small water diversions upstream for irrigation. The channel in this section is primarily narrow and somewhat deep, and has a medium gradient. Although the stream has downcut in the past, it is now developing a new flood plain below the historic one. There is a large beaver dam at the lower end of the reach, which has created a pond, a longer section of slow flows, and an adjacent wet meadow with rich organic soils.

Fish and aquatic habitat was good to excellent. Pool distribution, macroinvertebrate diversity, and overbank cover were all excellent. Underbank cover was very good. Cobble embeddedness was good (30%), presumably due to some areas of bank erosion upstream from the reach. There was also some large woody debris. Although fish were not observed during the assessment, this reach could provide good habitat for native trout, particularly if non-native trout species are absent.

Terrestrial wildlife habitat was poor to fair, reflecting the general lack of shrubs and trees along the reach. Fluvial habitat diversity, in contrast, was excellent, reflecting the healthy condition of the stream channel and the presence of beavers at the downstream end of the reach. This beaver pond and the associated wetlands could serve as a reference condition for the potential hydrological and ecological effects of beavers within Mancos Valley and the surrounding areas.

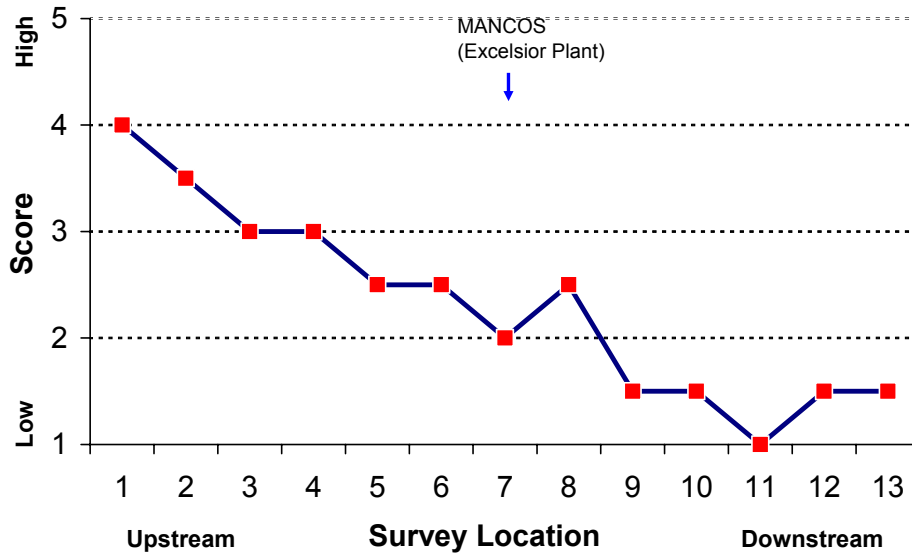
Figure 40. Mean scores for non-chemical Water Quality for reaches in the Mancos Valley and adjacent upstream and downstream areas (see text).

Figure 40 gives the mean non-chemical water quality scores for the reaches in this analysis. The scores are high before the river enters the Valley and then decline significantly by the time the river enters Mancos Canyon at the bottom end of the Valley.

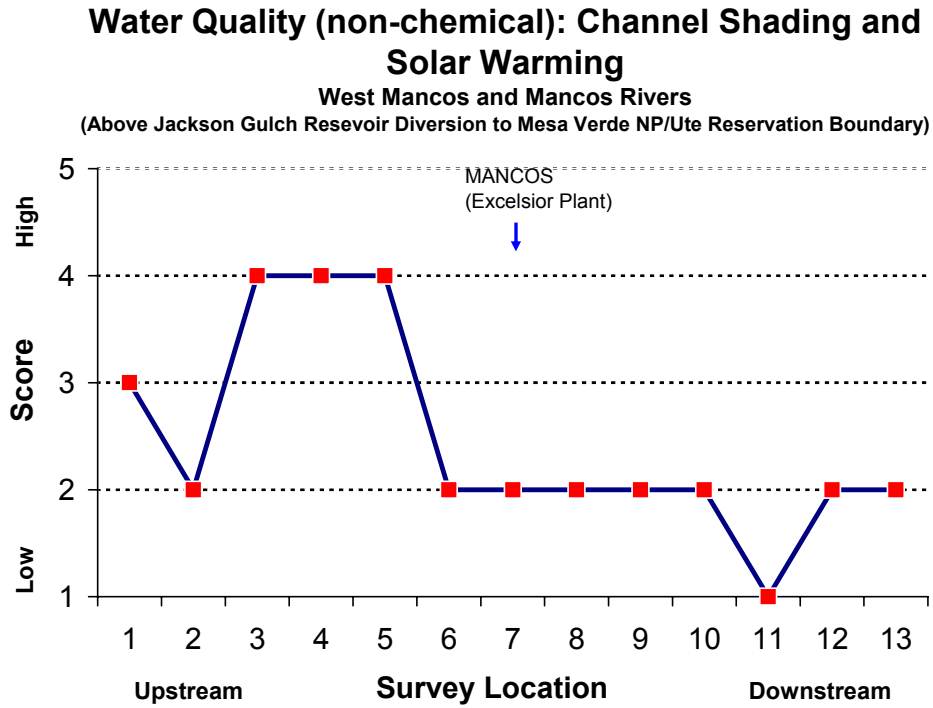
Figure 42. Scores for Channel Shading in reaches in the Mancos Valley and adjacent upstream and downstream areas (see text).

As shown in Figure 42, the amount of channel shading was variable. It was poorer than expected in the upstream reaches on the West Mancos. This was due to the fact that the channel in these reaches was wide and shallow, as a result of past ditch and diversion structure construction activities. The scores were higher for the reaches in the upper part of the valley, where there was well developed stream-side vegetation. But in the lower part of the Valley, shading was low, due to both channel morphology (wide and shallow) and the lack of overhanging vegetation. The high scores in the upper valley suggest that the river could be well shaded through all of its length in the Valley and Mancos Canyon with appropriate management and restoration of the taller vegetation.

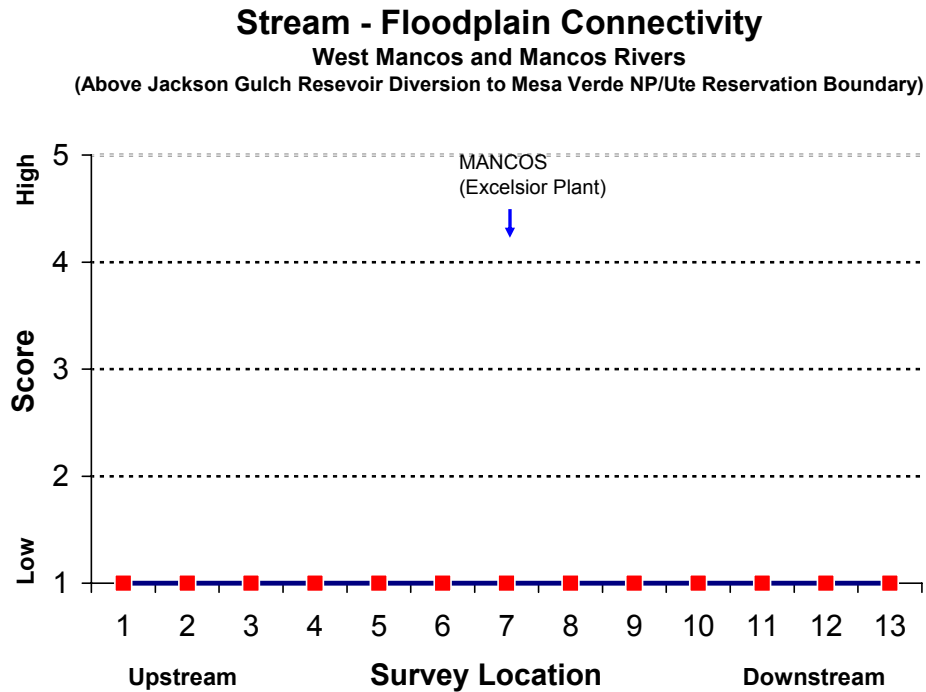
Figure 44. Scores for Stream-Floodplain Connectivity in reaches in the Mancos Valley and adjacent upstream and downstream areas (see text).

As shown in Figure 44, above, the flood plain in the survey area is almost completely disconnected from the active stream channel: all reaches received the lowest possible score of 1. As a result, the flood plain of the Mancos River in this area probably rarely receives any overbank flooding, except during periods of extremely high flows. There was little evidence that this type of flooding had occurred recently in any of the reaches examined. In most stream and river systems in the American Southwest, where the channel is as isolated as it is from its flood plain as it is in the Mancos Valley, the flood plain typically would have dried up, and there would normally be very little riparian vegetation present in the URZ. In spite of the lack of channel connectivity and overbank flooding, the riparian vegetation in most of the study reaches within the Mancos Valley itself is currently very healthy. Grass cover is extensive (Figure 63), and there are numerous wet meadows and even some cat-tail marshes throughout the entire riparian zone. The shrubs and trees that are present are healthy, and there are numerous seedlings of both willows and cottonwoods in the flood plain (see Figures 66 and 67 below). Both of these plants require moist soil conditions to germinate and grow. Because the amount and the condition of the riparian vegetation currently found in the flood plain is not consistent with the channel geomorphology of the Mancos River in this area, and the apparent lack of frequent overbank flooding due to channel incision and the presence of levees in many reaches, there must be some other input of surface and underground water flow into the flood plain. This flow must be from sources adjacent to, but outside the floodplain.

We found that the flood plain of the Mancos River within Mancos Valley is in very good condition, even though the river channel is actually isolated from it adjacent flood plain throughout most of the valley (Figure 44, above). Although there is little active downcutting or erosion of the stream banks at the present time, the river in most reaches is wide and shallow, and the bottom and the sides of the channel are lined with medium to large cobbles. The wide and shallow channel shape, which would usually be indicative of poor conditions, is due in the Mancos Valley primarily to the presence of levees along the river, particularly both immediately upstream and downstream from the town of Mancos itself. However, constructed levees are generally absent from some of the reaches in the lower part of the Valley, and in those areas the river is starting to exhibit the type of meandering pattern that would be expected to occur naturally.

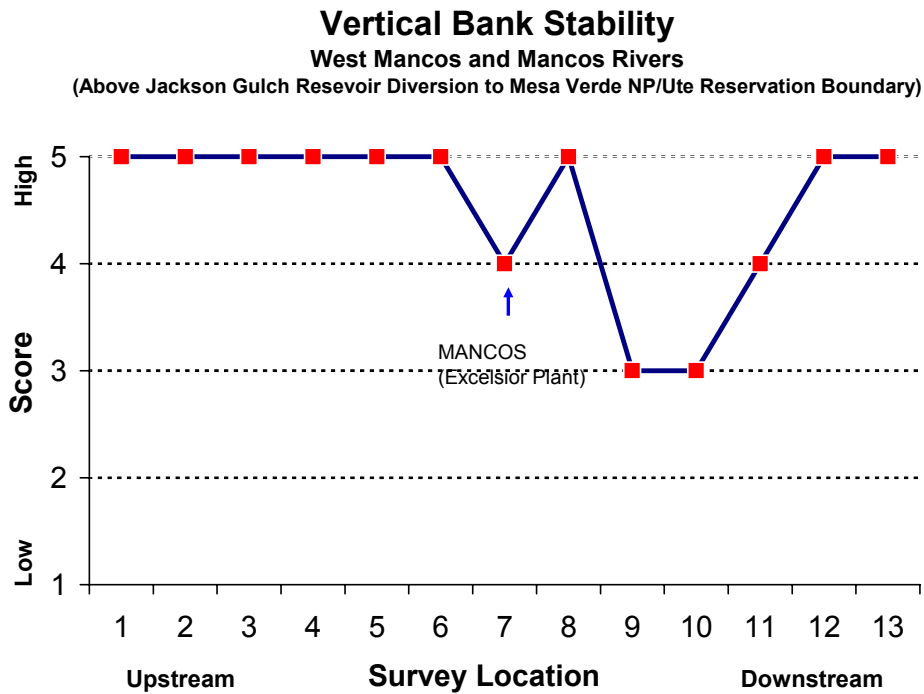
Figure 45. Scores for Vertical Bank Stability for reaches in the Mancos Valley and adjacent upstream and downstream areas (see text).

Scores for Vertical Bank Stability were generally very good. This resulted from a combination of the presence of levees on the banks in many upstream areas, along with well developed vegetation elsewhere. The areas where the scores were lower tended to be located in the reaches where there was

substantial livestock use; however the situation in these reaches did not appear to be problematic because the channel was undergoing normal migration where the banks were unstable. Overall, the high scores for vertical bank stability are one reason why there is little active erosion or heavy sediment loads in this part of the Mancos River.

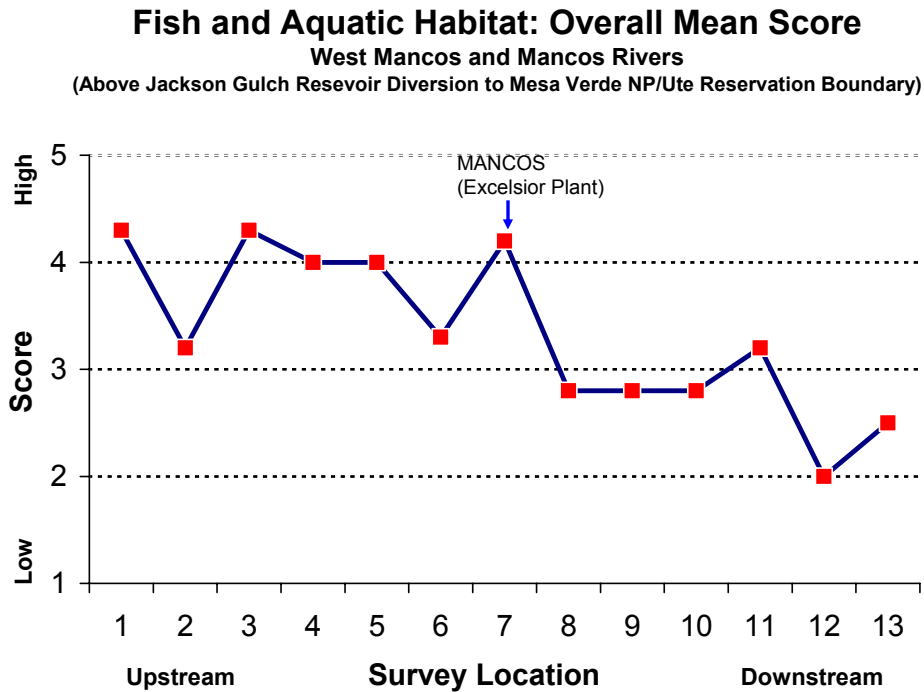
Figure 49. Mean scores for Fish and Aquatic Habitat for reaches in the Mancos Valley and adjacent upstream and downstream areas (see text).

As shown in Figure 49, the mean scores for fish and aquatic habitat were generally good in the reaches above the town of Mancos. Although there were a few problems in this area (see individual scores below), with minor restoration this part of the river would be likely to provide good habitat for native cold water fish species, including native trout. The condition of reaches in the lower part of the

valley below Mancos was not as good. Establishing native fish populations in this area would be more problematic, although still potentially possible. There was slight improvement of the fish and aquatic habitat in the last reach, the Mesa Verde/Ute Reservation reach in Mancos Canyon, although there were specific problems in that reach that made it currently unsuitable for many native species (see discussion above). It is possible that the reaches in Mancos Canyon were originally occupied by more warm water tolerant species than the upper reaches.

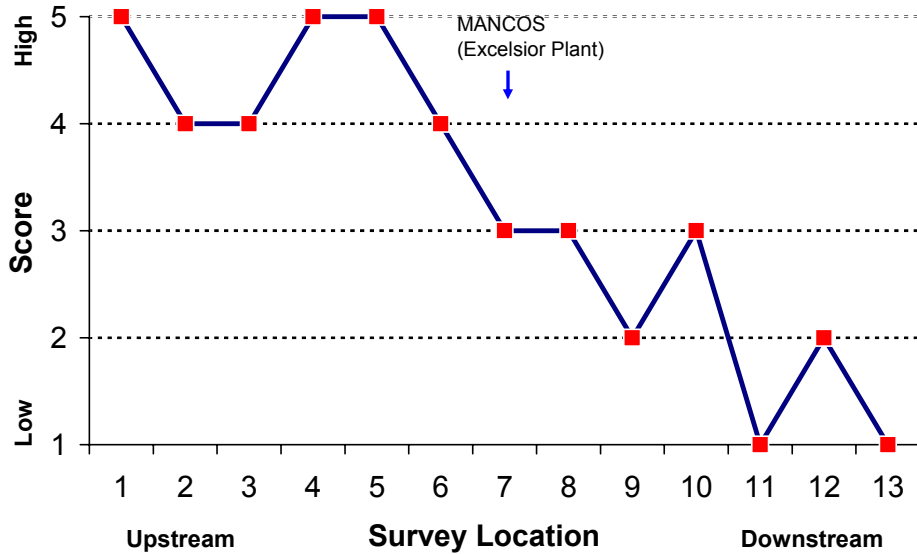
Figure 52. Scores for Cobble Embeddedness for reaches in the Mancos Valley and adjacent upstream and downstream areas (see text).

Figure 52 gives the scores for this variable. The level of cobble embeddedness was very good or excellent in the reaches above Mancos Valley, as well as at most of the above the town of Mancos itself. However, below the town, the degree to which silt and other sediments covered the cobbles increased, to the point where in the lower reaches the level of embeddedness was likely to limit both fish and aquatic insect production. This situation was probably the result of both reduced water flow (progressively more water is removed from the river for irrigation as one moves downstream, with the major removals occurring just above the town of Mancos), as well as increased sediment deposition into the channel due to lower levels of vegetation on the hillside surrounding the river in the lower parts of the valley. The cobbles in the lowest reach, at the Mesa Verde National Park- Ute Indian Reservation border, were almost fully covered by sediments and ash from runoff from the areas impacted by the recent fires on the west side of Mancos Canyon.

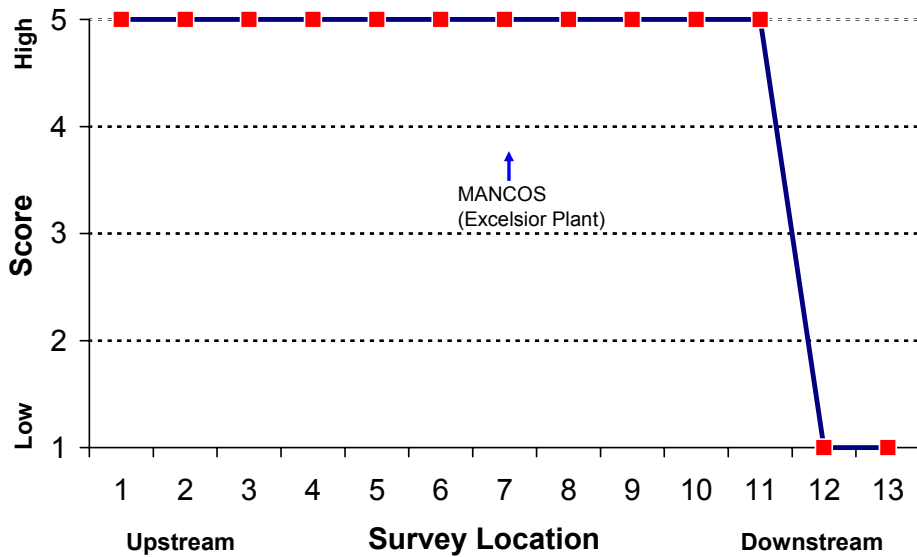
Figure 53 gives the scores for the diversity of aquatic macroinvertebrates themselves in the study reach. These species, which in this section of the Mancos River include primarily the aquatic larvae of insects such as caddis flies, mayflies, and stone flies, and similar species, not only provide food for fish, but their presence is a good indicator of stream health and water quality, including such factors as temperature stress, nutrient and pollutant loads, dissolved oxygen levels, and sediment loads (see above). Almost all of the reaches received excellent scores for this variable, indicating water quality is generally very good throughout the Valley, and that the town of Mancos is not having a major impact on water quality. The exception was the two most downstream reaches, where there were no aquatic insects whatever, and only a few crawfish were found. The absence of the insect macroinvertebrates appeared to be due to a combination in the lower reaches of low water flows (resulting in temperatures stress), possibly high nutrient loads (see Figures 41 and 42, above) and high levels of cobble embeddedness (Figure 52).

Figure 53. Scores for Aquatic Macroinvertebrate Diversity for reaches in the Mancos Valley and adjacent upstream and downstream areas. The two lower reaches held only crawfish (see text).

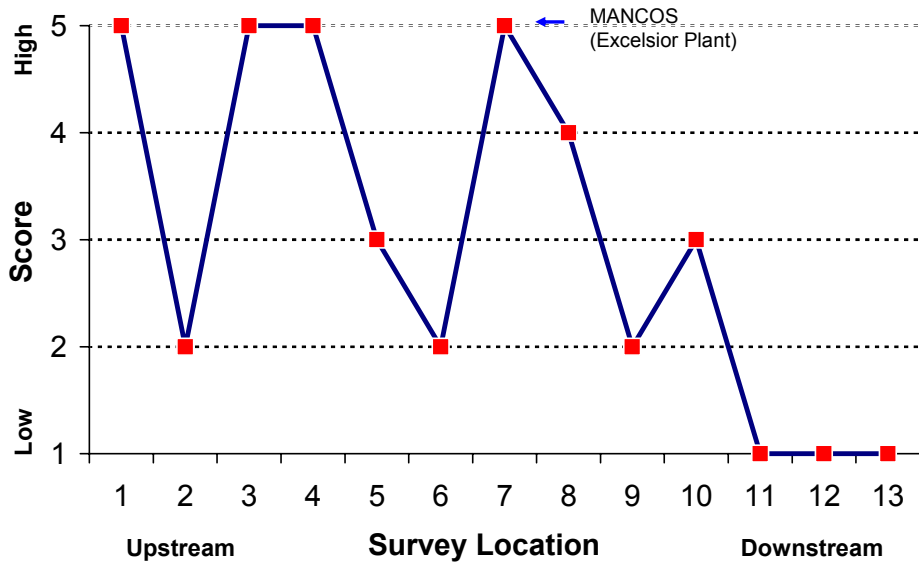
Figure 54 gives the scores for the amount of large woody debris that was found in the survey reach. LWD was defined as pieces of wood that were at least 15 cm (6”) in diameter and at least 1 m (3 ft) in length. Large woody debris that is resting in the stream channel or along the banks and at least partial submerged provides important fish and amphibian habitat, for nursery cover, feeding areas, and protection from predators. LWD also play an important role in shaping channel morphology and capturing silt, particularly in small and medium sized streams and rivers like the Mancos. Streams with adequate amounts of large woody debris tend to have greater habitat diversity, a natural number of meanders, and has greater resistance to negative impacts of high water flow. As seen in Figure 16, most of the reaches in the upper parts of the survey area had adequate or better amounts of LWD, although there were exceptions in the agricultural areas just above the town of Mancos. There was significantly less woody debris in the reaches in the lower parts of the valley; this probably was the result of both fewer trees along the banks that could fall into the river, as well of reduced water flows that would carry LWD that entered the channel in the upper parts of the area further downstream. As expected, much of the LWD in the reaches above the valley was pine and aspen trees, while downstream it consisted primarily of cottonwood. The latter decomposes quickly, and this factor may also contribute to the lack

Figure 54. Scores for Large Woody Debris for reaches in the Mancos Valley and adjacent upstream and downstream areas (see text).

of LWD in the lower reaches. The addition of LWD to the middle and lower reaches could result in a significant improvement in fish habitat and overall channel morphology.

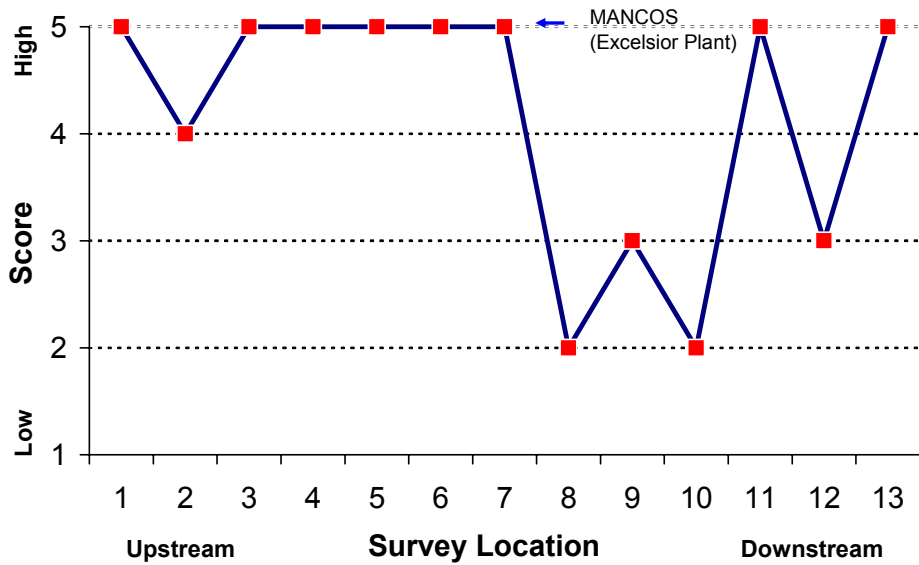
Figure 55. Scores for Overbank Cover and Terrestrial Invertebrate Habitat for reaches in the Mancos Valley and adjacent upstream and downstream areas (see text).

The final variable in the Fish and Aquatic Habitat sections examines the amount of terrestrial vegetation on the stream bank that actually overhangs the water, also is important for fish production and survival. Both the plant material itself and the insects that live on the vegetation can drop directly into the channel, providing a critically important source of food, energy and nutrient input into the stream for fish and other aquatic species. Overhanging vegetation also provides shading, and bank protection and sediment trapping during high flow events. As shown in Figure 55 above, the scores for overbank cover were generally excellent in the tributaries and upper parts of the valley. Below the town of Mancos, the scores fell to low levels in some reaches, where there was little vegetation at all along the stream banks. However, two of the three furthest downstream reaches again achieved excellent scores, indicating that this component of fish habitat quality could recover in the lower scoring areas with appropriate management.

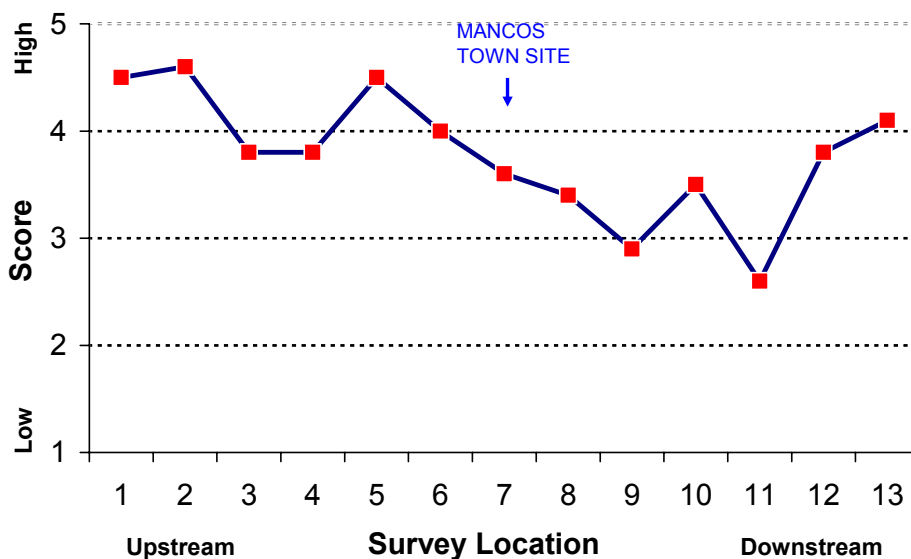
Figure 56. Mean scores for the Riparian Vegetation survey variables for reaches in the Mancos Valley and adjacent upstream and downstream areas (see text).

Figure 56 gives the mean scores for Riparian Vegetation in the survey area. The condition of the vegetation was generally very good in the survey reaches above the town of Mancos (including several agricultural areas), declined somewhat in the lower parts of Mancos Valley, and then began to improve again as the River left the valley and entered Mancos Canyon. The reasons for this trend are discussed in the following sections.

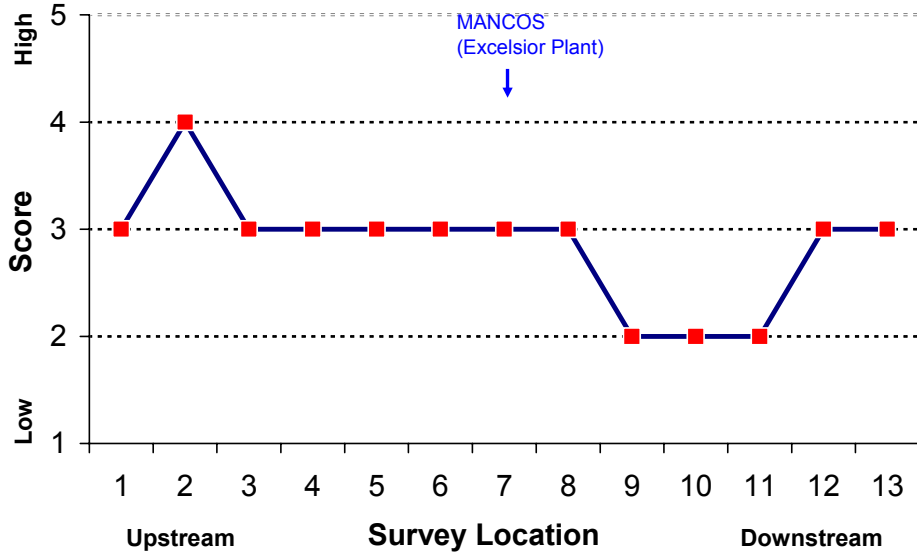
Figure 57. Scores for overall Plant Cover in the Lower Riparian Zone for reaches in the Mancos Valley and adjacent upstream and downstream areas (see text).

The mean cover scores for the lower riparian zone (the zone directly adjacent to the active stream channel) were generally only good, even in the most upstream reaches (Figure 57). Grass cover in this zone was usually less than 70%, except at the reach that was located within the town of Mancos (Figure 59). This was due primarily to the presence of levees in many of the reaches, which were made of cobble and did not provide good growing sites for grasses and forbs. There was also some effect from livestock use in several of the reaches in the lower part of Mancos Valley. Shrub cover in the LRZ was variable (Figure 60), with high values in the upstream tributaries, within the town of Mancos itself, and also after the river entered Mancos Canyon. The low cover values in the reaches just upstream and downstream from the town of Mancos appear to primarily reflect high levels of browsing by native ungulates (primarily mule deer) in these reaches (see Figure 72, below). Middle and upper tree canopy cover in the LRZ were also generally low (Figures 61 and 62), particularly in the lower reaches. The absence of tree cover in much of this area is probably a result of levee construction, combined with past high levels of browsing by both domestic livestock and native ungulates.

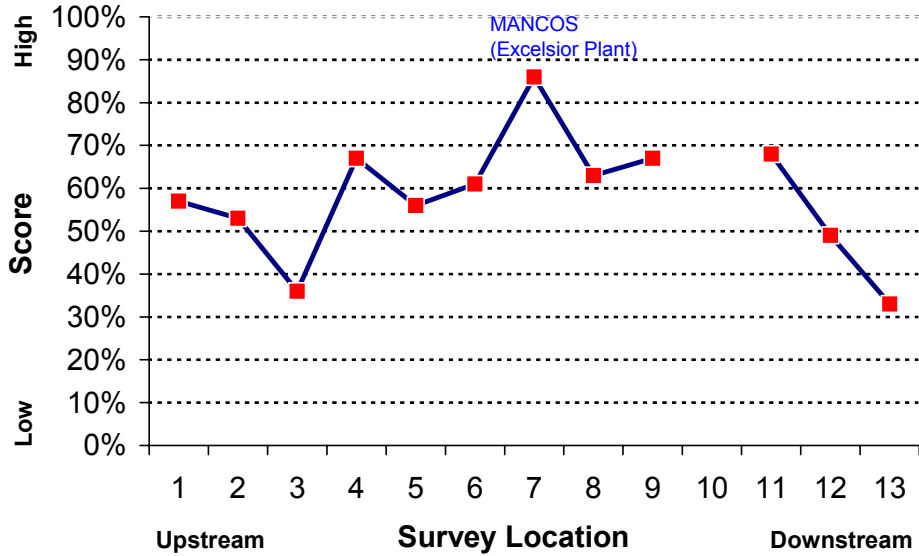
Figure 59. Values for the percentage of area with grass and forb plant cover in the Lower Riparian Zone for reaches in the Mancos Valley and adjacent upstream and downstream areas (see text).

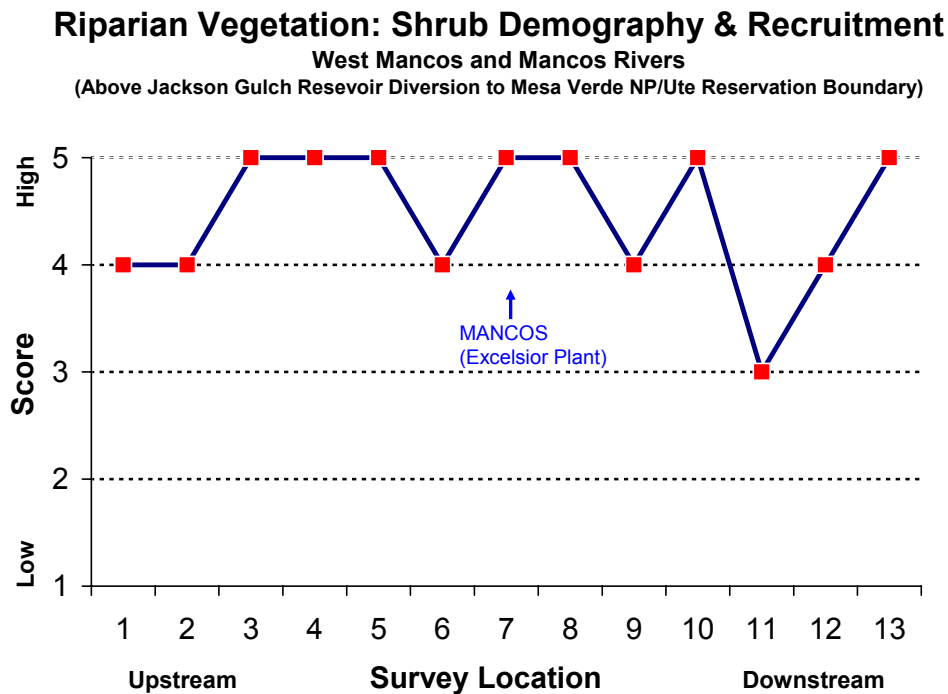
The other variables in Riparian Vegetation section of the RSRA survey examine additional factors that affect the current and future health of the riparian vegetation in both the lower and upper riparian zones. Figure 67 gives the scores for the demographic structure and the recruitment of the dominant native shrub species along each reach, and Figure 68 gives results for the same variables for the dominant native tree species. For the reaches in the Mancos Valley and adjacent areas, the dominant native shrubs were willow and in a few lower reaches, buffaloberry, while the dominant riparian trees in all areas was either narrowleaf or Fremont cottonwood. In order for there to be healthy populations of both woody plant groups in the future, individuals of all age classes should be present in the riparian zone, including seedlings, immatures or saplings, mature individuals, and dead clumps (shrubs) or standing dead snags (trees). When one or more age classes of the dominant species is missing from an area, it indicates that something in the past or something is now disrupting the natural processes of reproduction and individual plant replacement. In time, if that is happening, there may be a complete loss of the species in the area as the older individuals die off and are not replaced by any younger plants.

As shown in Figures 67-68, the scores for native shrub and tree demography and recruitment were generally very good or excellent, and for almost all reaches, either all or all but one of the four ages classes were present. This indicates that there has been ongoing recruitment of shrubs and trees in these reaches for a number of years, and that if current recruitment continues individuals that die off as they age are likely to be replaced by new shrubs and trees. In a few reaches, particularly in some of the more heavily grazed sections, one or more age classes are missing at the current time, and particular attention should be given to the successful recruitment of seedling shrub and trees in these areas for the future (see notes to individual surveys).

Figure 67. Scores for Native Shrub Demography and Recruitment for reaches in the Mancos Valley and adjacent upstream and downstream areas (see text).

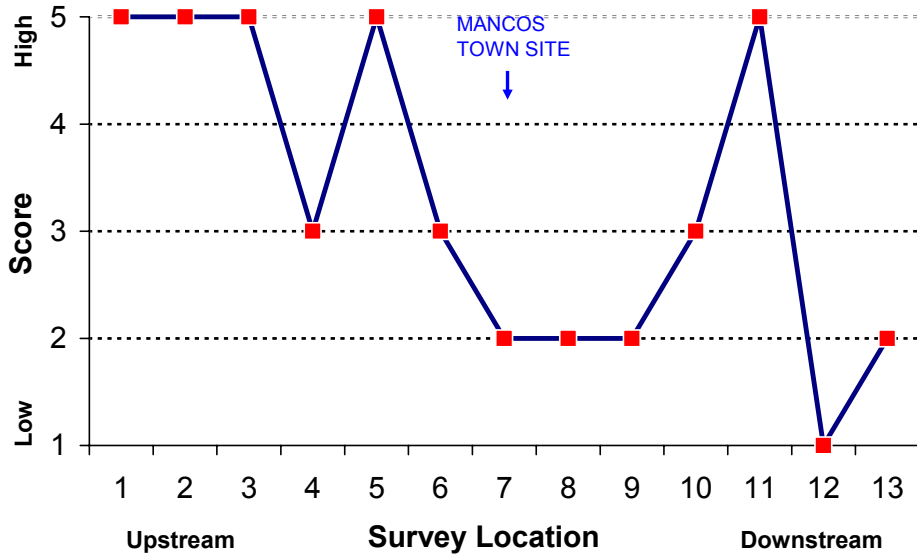
Figure 69 presents the scores for the estimated relative amount of cover within the survey reach that was provided by non-native grasses and forbs, compared to that provided by native species. While non-native grasses and forbs were almost entirely absent in the reaches above Mancos Valley, there were increasing levels of these species as one moved further downstream. Interestingly, non-native grasses and forbs were again almost entirely absent from one of the lower reaches (reach number 11). This was an area where there were no levees lining the channel, and where the stream was naturally meandering. As a result, the riparian soils in this section of the river were very moist and rich in organic matter. This finding suggests, as has been noted elsewhere, that non-native species are most likely to invade a riparian area when the natural hydrological processes and soils have been disturbed.

Figure 69. Scores for relative amount of cover created by Non-Native Grass and Forb species, for reaches in the Mancos Valley and adjacent upstream and downstream areas (see text).

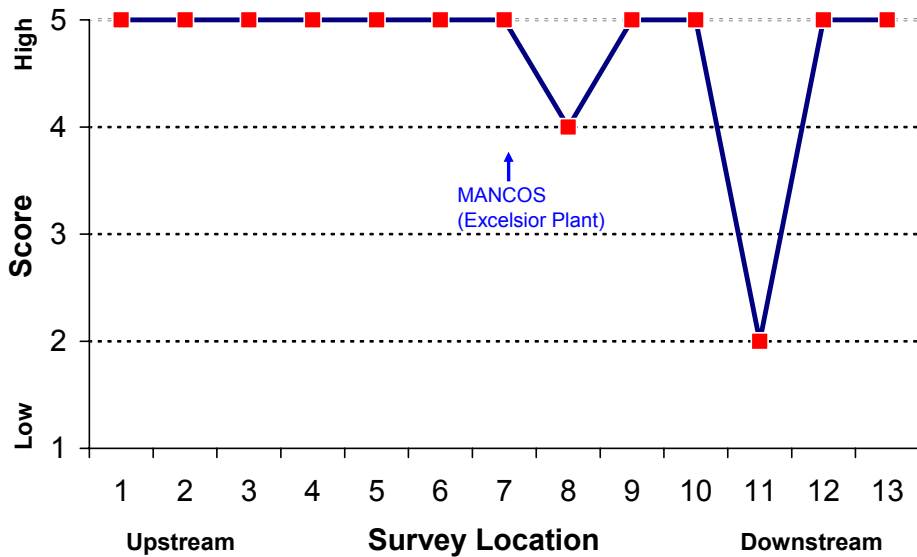
Figure 70 provides the same scores for cover from non-native shrubs and trees. In contrast to most other rivers of a similar size and elevation in the American southwest, there were no or almost no non-native woody plants in the riparian area of the upper reaches, and relative few in the lower parts of the valley as well. There were small numbers of Russian olive and saltcedar in some of the lower reaches, and these populations appear to moving slowly upstream. Saltcedar had been actively removed from the reach in Mancos Canyon by Mesa Verde National Park, and additional removal programs currently underway or planned within the Valley may halt or slow this invasion. However, the small numbers of non-native

Figure 70. Scores for relative amount of cover created by Non-Native Shrub and Tree species, for reaches in the Mancos Valley and adjacent upstream and downstream areas (see text).

woody species present throughout Mancos Valley at the current time is exceptional, and is probably due at least in part to the moist soils and well-developed native riparian vegetation in much of the flood plain that results from the leakage of water from the irrigation ditches within the valley.

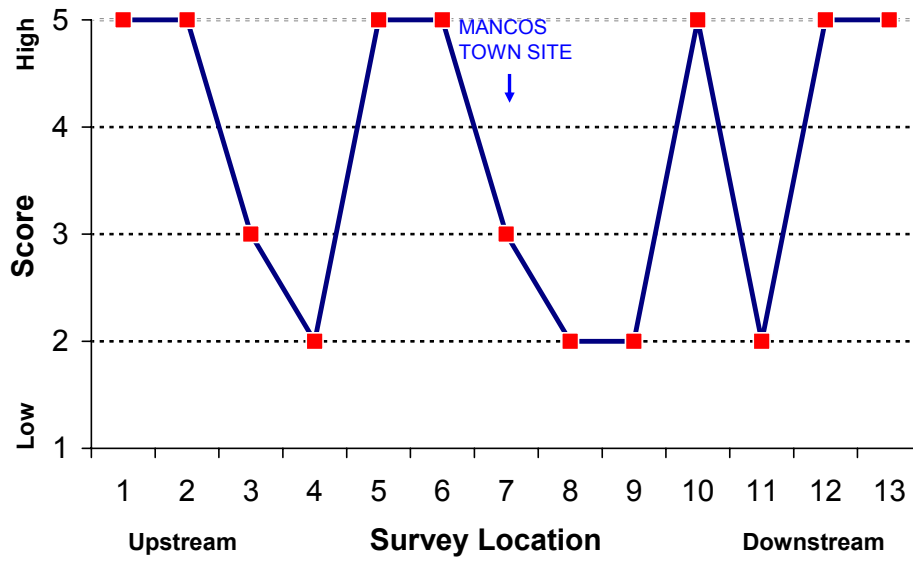
Figure 71. Scores for extent of Mammalian Herbivory, or grazing impacts on ground cover (grasses and forbs) in the lower and upper riparian zones for reaches in the Mancos Valley and adjacent upstream and downstream areas (see text).

The final two variables in this section examine the impacts of large mammal use of vegetation in the upper and lower riparian zones. Figure 71 presents the scores for the level of grazing on grasses and forbs in both zones, as determined by the percentage of samples in the survey transect where the plants had been clipped off, compared to those samples where there was no evidence of clipping (see the RSRA User’s Guide for a discussion of the survey protocol). Most of the grazing in the riparian zone within the Mancos Valley is done by domestic livestock, although deer and elk may also graze occasionally in some reaches, particularly in areas outside the valley. Intense levels of grazing can affect the condition of ground cover, encourage the invasion of exotic species, lead to increased soil compaction and erosion, and change overall ecosystem function. As seen in Figure 71, grazing impacts were highly variable among the survey reaches, with high rates of grazing seen primarily in areas where the reach was part of an active domestic livestock pasture. The level of grazing in these pastures was having a negative impact upon the health of the riparian ecosystem in those reaches, and the planned exclusion of livestock from the riparian corridor in several of these reaches will clearly be beneficial.

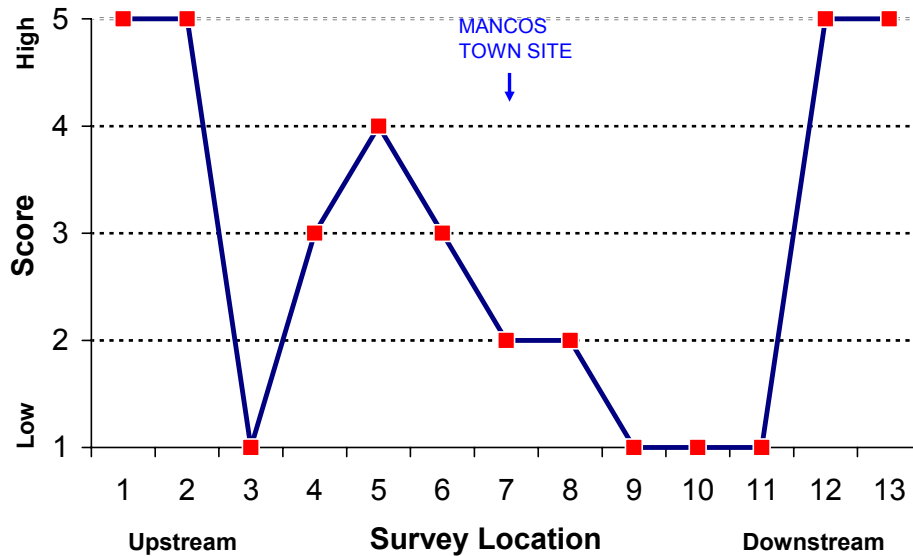
Figure 72. Scores for extent of Mammalian Browsing impacts on woody vegetation (shrubs and small trees) in the lower and upper riparian zones for reaches in the Mancos Valley and adjacent upstream and downstream areas (see text).

The second major impact of large mammals on riparian vegetation is when the animal eats, or browses, the end or the growing tip of the branches of woody plants, including both shrubs and small trees. Browsing can affect the health of these plants by stopping the future growth of the branch that has been eaten, and continued high levels of utilization will eventually result in the death of the plant. Over time, this can cause the loss of all shrubs and trees in a local area, a situation that is commonly seen in many of the riparian areas in the American southwest and elsewhere. Figure 72 presents the scores for mammalian browsing, as determined by the percentage of shrubs and small trees that showed evidence of clipping at the tips of the branches somewhere on the plant, relative to those that did not show such evidence (see the RSRA User’s Guide for a discussion of the survey protocol). Browsing impacts were again highly variable among reaches, with very little browsing seen in the two upper and two lowest reaches, and high rates of browsing observed in the reaches around and downstream from the town of Mancos. Although we did not directly attempt to determine the specific mammal species that were responsible for the heavy browsing levels in these reaches, a number of the most impacted reaches were located in areas where there was no evidence of current domestic livestock use. In addition, we frequently encountered mule deer while conducting the surveys, particularly in areas that were close to the town of Mancos. This pattern suggests that deer are the major browser at the present time, although domestic livestock may also eat some woody vegetation, particularly when other foods are scarce. The level of browsing that was observed in the most impacted reaches is sufficient to influence the future recruitment of woody vegetation in those areas, and if continued may lead to the loss of most or all of the shrubs and trees in those areas.

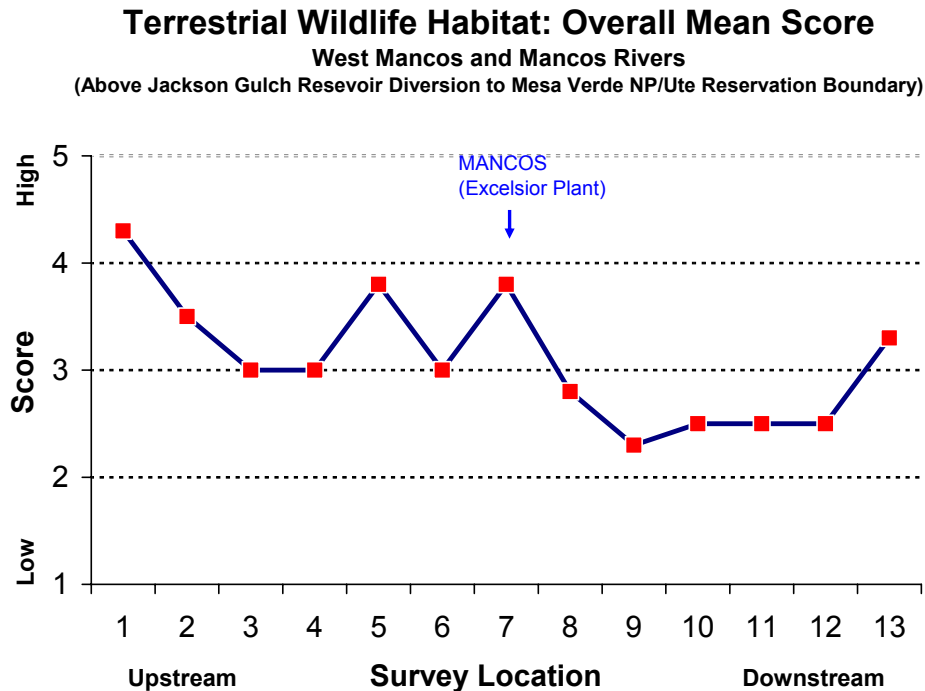
Figure 73. Mean scores for the Terrestrial Wildlife Habitat survey variables for reaches in the Mancos Valley and adjacent upstream and downstream areas (see text).

Figure 73 gives the mean scores for the Terrestrial Wildlife Habitat variables. Overall, the reaches above the town of Mancos scored as having good or better habitat for terrestrial wildlife, while habitat quality declined in the lower parts of Mancos Valley, although the habitat began to improve again as the river moved into Mancos Canyon.

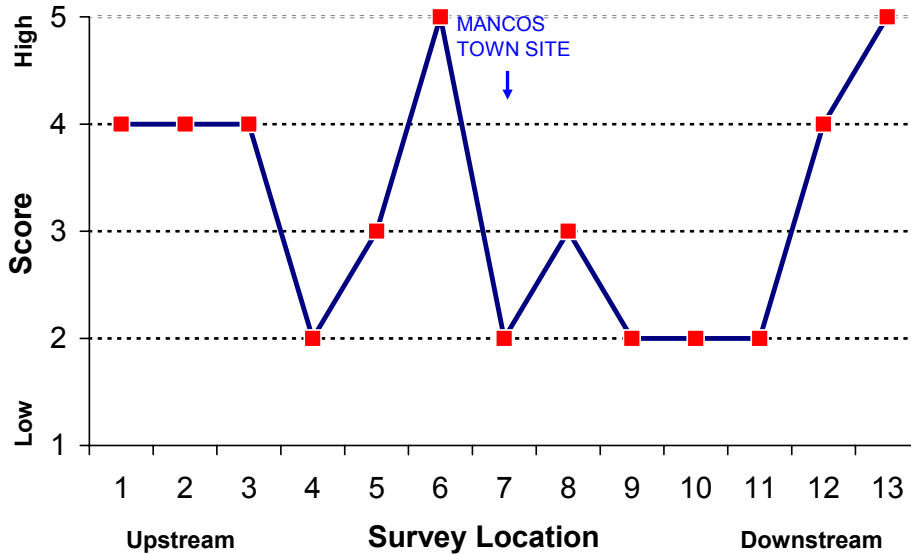
Terrestrial Wildlife Habitat: Shrub Patch Density (<15')
West Mancos and Mancos Rivers
 (Above Jackson Gulch Reservoir Diversion to Mesa Verde NP/Ute Reservation Boundary)

Figure 74. Scores for Shrub Patch Density for reaches in the Mancos Valley and adjacent upstream and downstream areas (see text).

longer be able to breed or survive in the impacted areas. As shown in Figure 74, the density of shrub patches (primarily willows) was very good or excellent in some reaches, but such patches were almost entirely absent in other reaches, particularly in the lower parts of Mancos Valley. These reaches would not be suitable habitat for species that depend upon such patches, like many duck species that need dense willows to hide their nests from predators. However, seedling shrubs are now growing in many of these areas (Figure 67, above). This suggests that these areas can improve as wildlife habitat with appropriate management of both the wild ungulates (deer and elk) and of domestic livestock, as well as the maintenance of the moist soil conditions that allow for seed germination and vigorous plant growth within the flood plain.

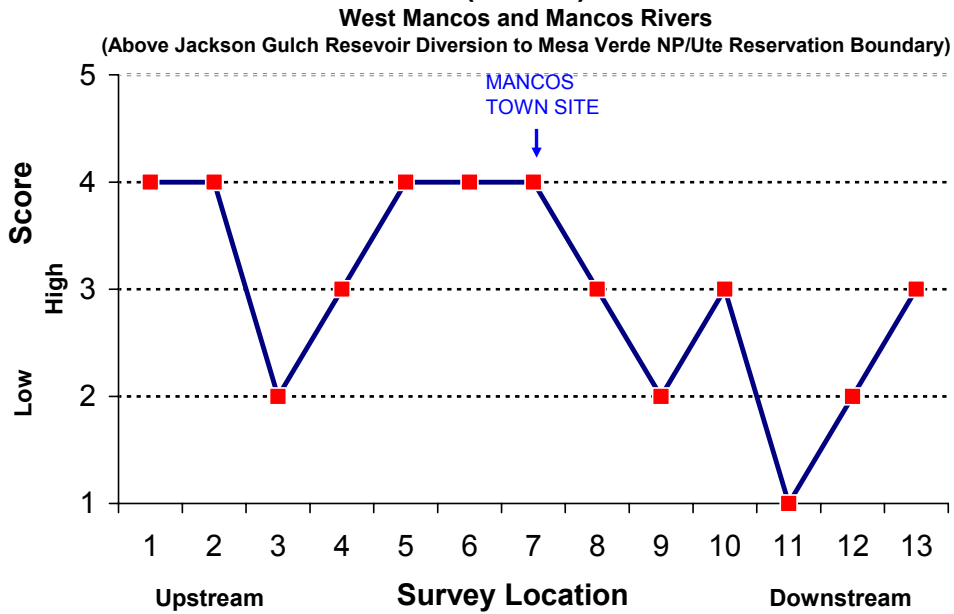
Terrestrial Wildlife Habitat: Middle Canopy Tree Density (15'-30')

Figures 75-76 give the scores for patch density and connectivity in the Middle and Upper Canopy tree layers. Reaches above the town of Mancos generally score high on these two variables, while those below the town scored lower. In some reaches, there were only isolated individuals of middle and upper canopy trees, and as a result, there were no patches of this type of vegetation. These reaches would not be suitable habitat for the wildlife species that require dense habitat patches in these two layers. In other reaches, patches of one layer were present, but none of the other layer (e.g., reach number 6). This type of variation is usually the result of past land use practices on that particular reach: for example, seedling recruitment may have occurred during one period in the past, but may have ended at a subsequent date when the use of the reach changed. As a result, there might be a number of large trees present along the stream in that area, but no mid-sized individuals (or visa versa). However, as with the shrub component, there were seedling cottonwoods present in almost all of the reaches in Mancos Valley and the adjacent areas. This again suggests that these components of wildlife habitat will improve in the future with appropriate management of native and domestic ungulates, and the maintenance of a healthy flood plain.

Figure 75. Scores for Middle Canopy Tree Patch Density for reaches in the Mancos Valley and adjacent upstream and downstream areas (see text).

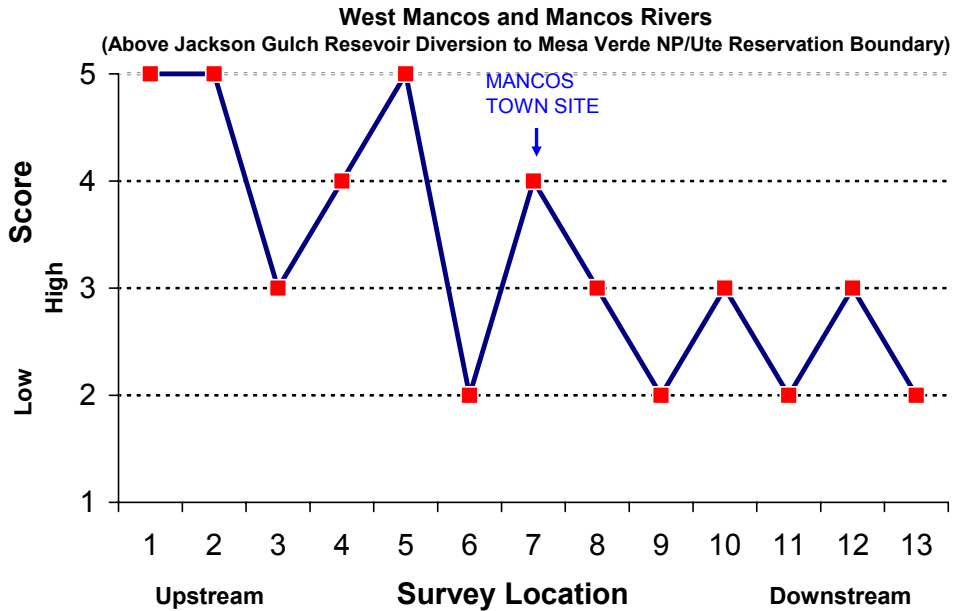
Terrestrial Wildlife Habitat: Upper Canopy Tree Density (>30')

Figure 76. Scores for Upper Canopy Tree Patch Density for reaches in the Mancos Valley and adjacent upstream and downstream areas (see text).

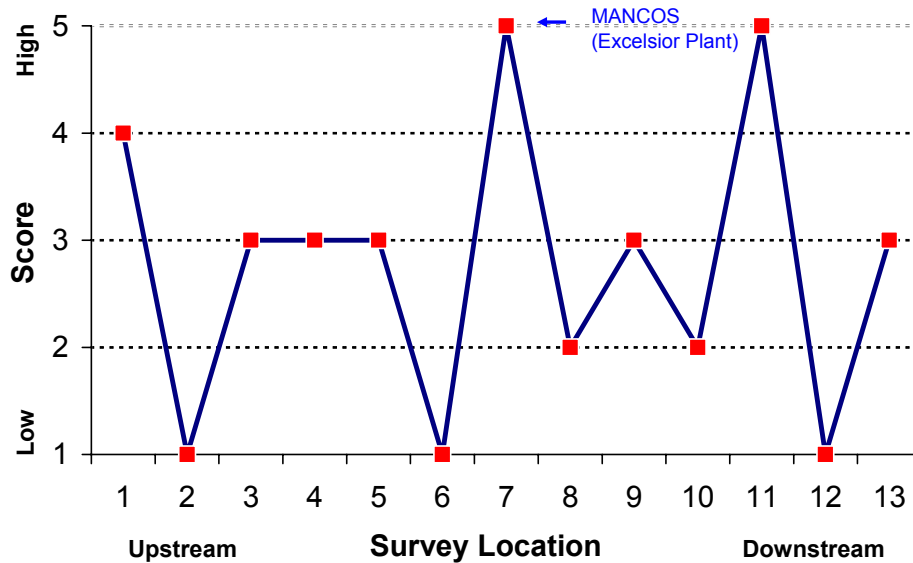
Terrestrial Wildlife Habitat: Fluvial Habitat Diversity
West Mancos and Mancos Rivers
 (Above Jackson Gulch Reservoir Diversion to Mesa Verde NP/Ute Reservation Boundary)

Figure 77. Scores for Fluvial Habitat Diversity for reaches in the Mancos Valley and adjacent upstream and downstream areas (see text).

The final component of wildlife habitat section is shown in Figure 77, which gives the scores for the diversity of fluvial, or above-water, habitats within the stream and flood plain on each reach. Natural hydrological, geological and ecological processes create a variety of fluvial landforms, including terraces, bars, oxbows, wet marshes, and fluvial marshes, which provide the habitats needed by many different species of terrestrial riparian wildlife. For example, Spotted Sandpipers (*Actitis macularia*) will only nest in stream-riparian habitats with exposed sand or gravel bars, and northern leopard frogs (*Rana pipiens*) normally occur only in areas with standing water such as marshes and ponds. In contrast, in highly degraded systems with extensive erosion and downcutting, there may be only a single fluvial landform: a straight and single-depth channel, steep sided banks without vegetation, and a flat and dry flood plain. Many species of terrestrial wildlife that may have been originally present along the reach may be unable to reproduce or survive under those conditions. As seen in Figure 77, the scores for fluvial habitat diversity varied widely throughout the survey area, from excellent (high diversity) to poor (no diversity). This variation occurred even between adjacent reaches (reach numbers 6 and 7, as well as numbers 11 and 12). The lack of diversity of fluvial habitats generally was the result of the past channelization of the stream within a reach, along with the presence of levees that has prevented new channel meandering and overbank flooding. In many of the reaches, some of the fluvial habitats that were present, for example, many of the wet meadows, marshes, and backwaters, were the direct result of water flows from the irrigation ditches in the upland areas adjacent to the flood plain.
